**TB 1-1520-248-30-05**  
U.S. ARMY AVIATION AND MISSILE COMMAND  
REDSTONE ARSENAL, AL 35898-5000  
31 MAY 2005

**INTERMEDIATE WEIGHT REDUCTION IMPLEMENTATION  
ON OH-58D HELICOPTERS  
(NSN 1520-01-125-5476)**

\*TB 1-1520-248-30-05

### INTERMEDIATE WEIGHT REDUCTION IMPLEMENTATION ON OH-58D HELICOPTERS

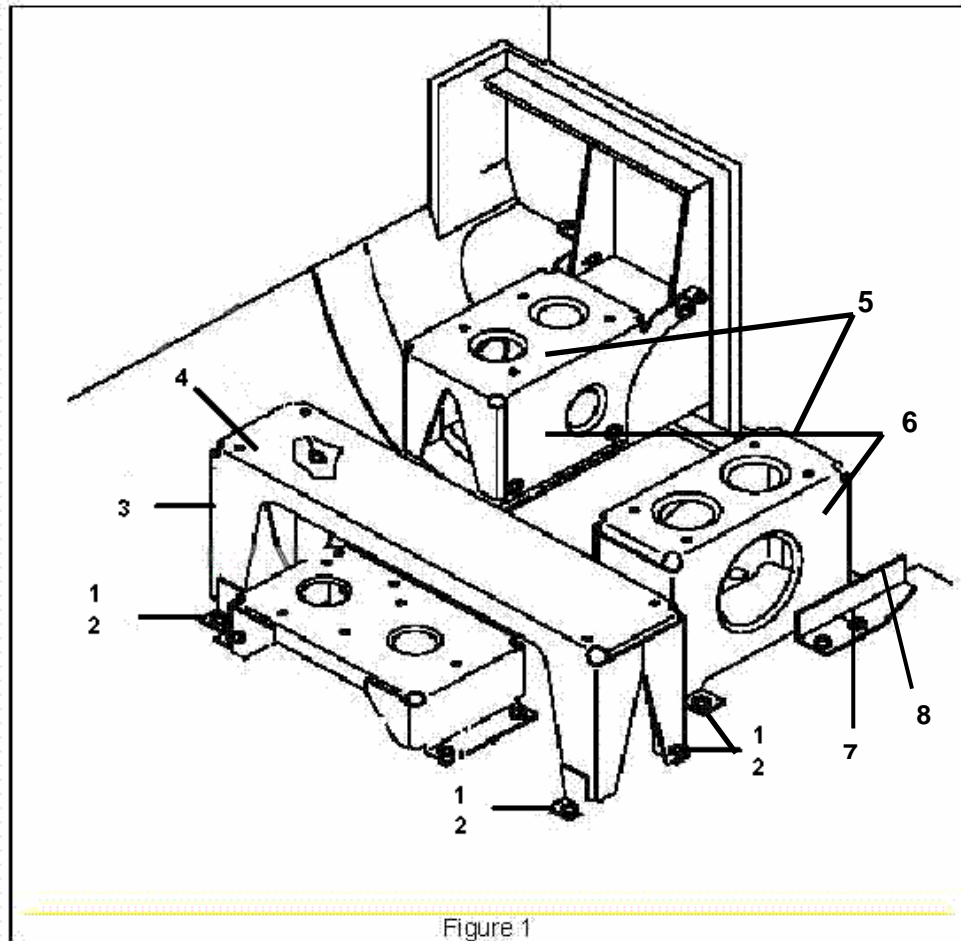
Figure 1

- a. Removal of the HF- R/T Shock Mount. (See Figure 1.)

b. Removal KY-75 Shock Mount. (See Figure 1.)

- (1) Remove right Avionics door.
- (2) Remove four machine screws (1) and four flat washers (2) holding the HF R/T Hard Mount (3) in place.
- (3) Remove HF-R/T shock mount (4) and Hard Mount (3). Disconnect wiring bundles from side of HF-RT Hard Mount.
- (4) Reinstall four machine screws (1) and four flat washers (2) in mounting holes.

- (1) Remove four machine screws (1) and four flat washers (2).
- (2) Remove rivets (7) and "L" shaped bracket (8).
- (3) Remove KY-75 Shock Mount (5) and Brackets (6).
- (4) Reinstall four screws (1) and four washers (2) in mounting holes.

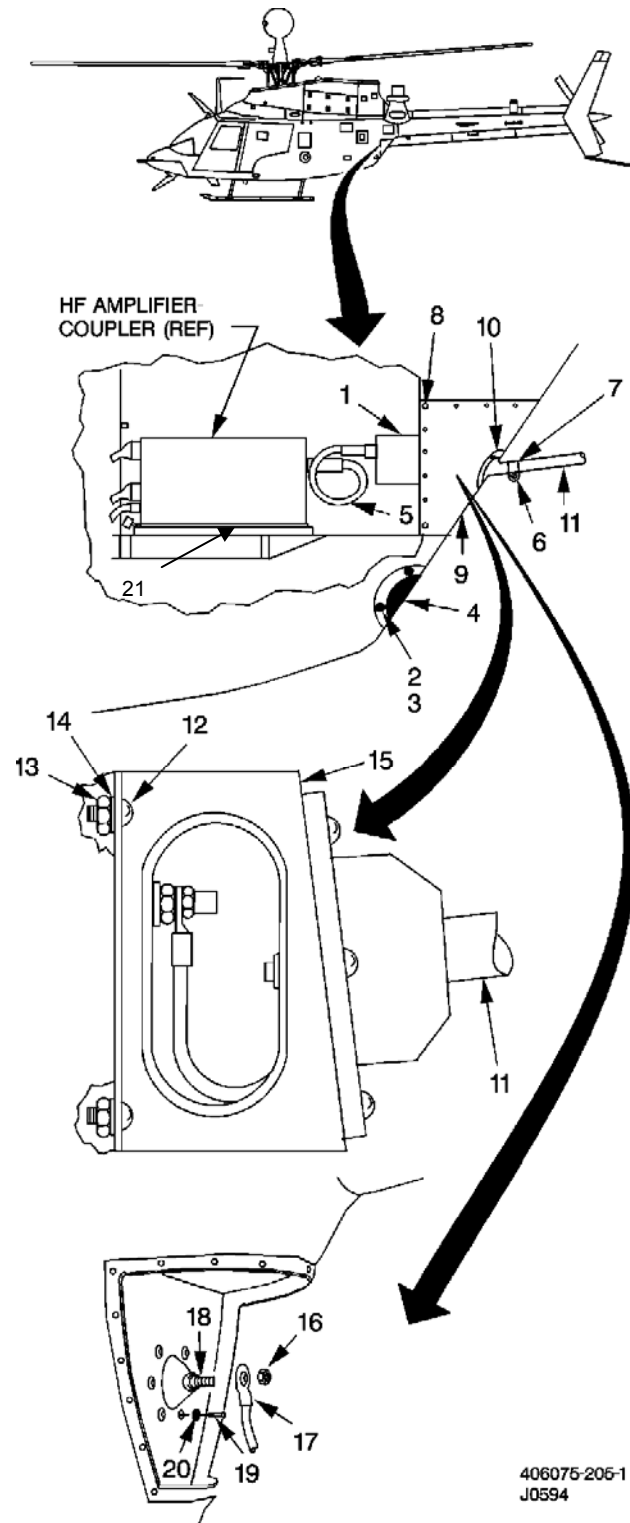
Figure 4

### d. Removal of HF-Antenna Coupler. (If installed.) (See Figure 4.)

### e. Removal of the HF - Amplifier Coupler Mounting Rack. (See Figure 4.)

(1) Gain access to HF antenna coupler (1) by removing four screws (2), washers (3), and exhaust port screen (4).

(2) Disconnect RF cable (5) from HF antenna coupler (1).

(3) Remove four screws (12), nuts (13), and washers (14) from bracket (15).

(4) Remove jamnut (16) and jumper assembly terminal (17) from stud (18).

(5) Support HF antenna coupler (1) and remove six mounting screws (19) and washers (20).

(6) Open aft electrical compartment door and remove HF antenna coupler (1).

(1) Gain access to the aft electronics bay.

(2) Remove screws attaching the mounting rack (21) to the airframe structure.

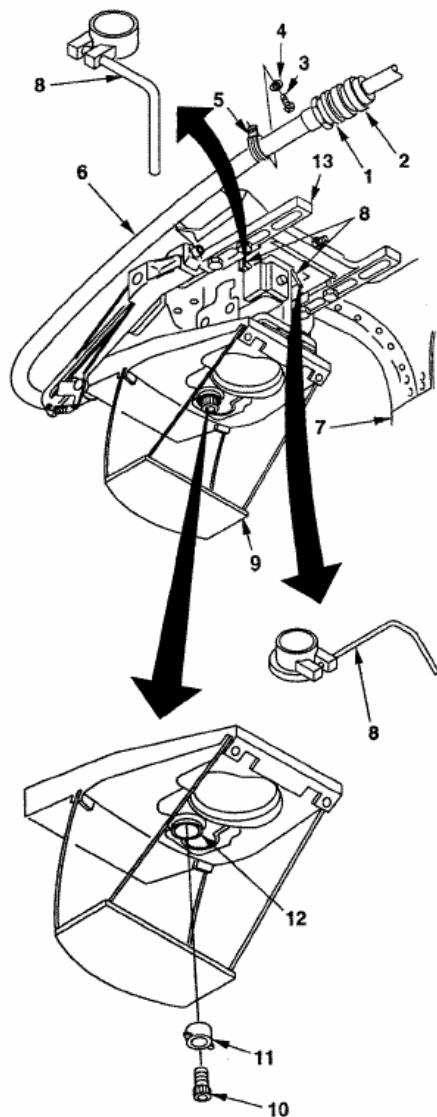
Figure 5

f. Removal of the PDU. (If installed.) (See Figure 5.)

(1) Disconnect electrical connector (1) from helicopter disconnect (2).

(2) Remove screw (3), washer (4), and clamp (5) securing PDU electrical cable (6) to cockpit overhead (7).

(3) Loosen height adjustment lock release levers (8) and adjust PDU (9) to gain access to cap screw (10) and down stop (11).

(4) Lock PDU (9) in position.

(5) Remove cap screw (10) and down stop (11) from front mount post (12).

(6) Loosen height adjustment lock release levers (8) and remove PDU (9) from mount assembly (13).

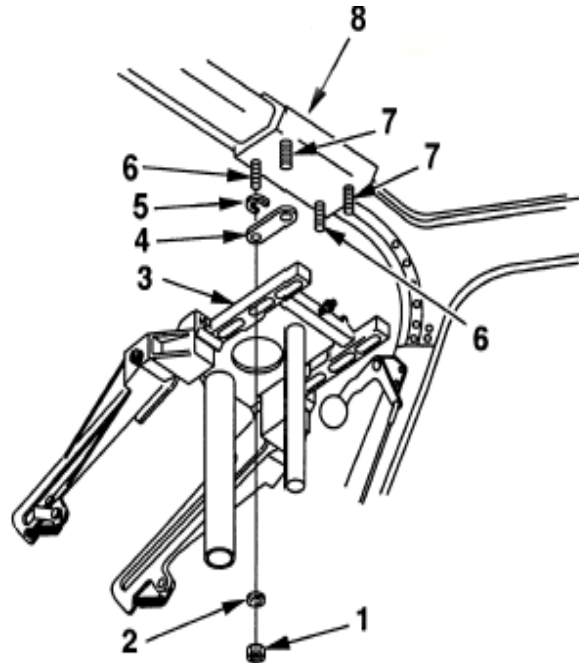
Figure 6

g. Removal of Pilot Display Unit (PDU) Mount Assembly. (See Figure 6.)

(1) Remove four nuts (1) and washers (2) securing mount assembly (3), spacers (4), and shims (5) to forward studs (6) and aft studs (7) on PDU fitting (8).

(2) Remove mount assembly (3), spacers (4), and shims (5) from forward studs (6) and aft studs (7).

(3) Remove the studs (6 and 7) from the PDU Fitting by cutting with a grinder, leaving a small portion of the stud protruding. File remainder of stud level to surface of mount.

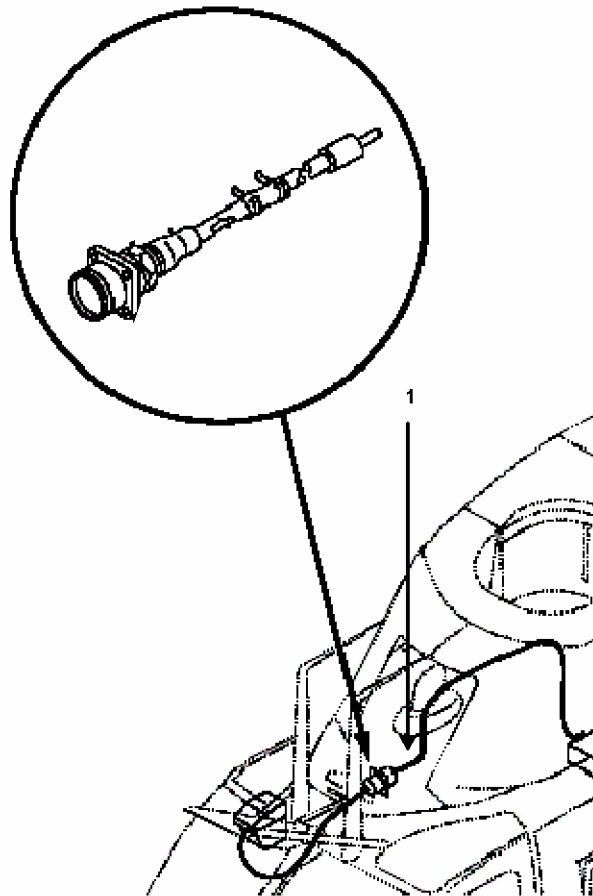
Figure 7

h. Removal of the PDU Cable. (See Figure 7.)

- (1) Gain access to the right side electronics bay and to the pilot area.
- (2) Remove the machine screws and standoffs securing the PDU cable.
- (3) Remove the PDU Cable.
- (4) Remove PDU Cable Bracket (1) held in by 4 rivets.
- (5) Cut off clamp studs on back door frame.

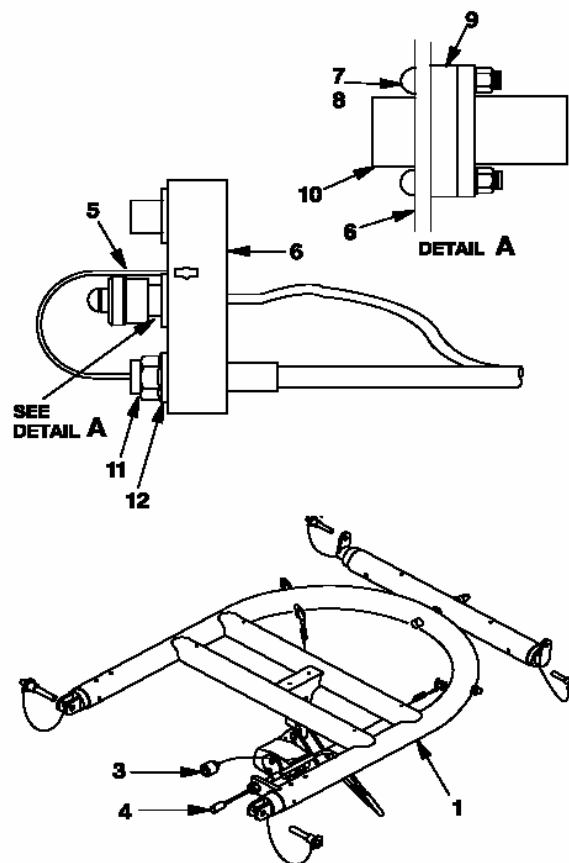
Figure 8

- i. Remove Cargo Handle, Cables. (See Figure 8.)

- (1) Cut cable and electrical wire for emergency release where they enter the lower fuselage.
- (2) Remove rear center console panel under collective.
- (3) Locate and remove cargo release wiring. (See Figure 10, Item 32.)
- (4) Remove bracket assembly (6) and reinstall screws.

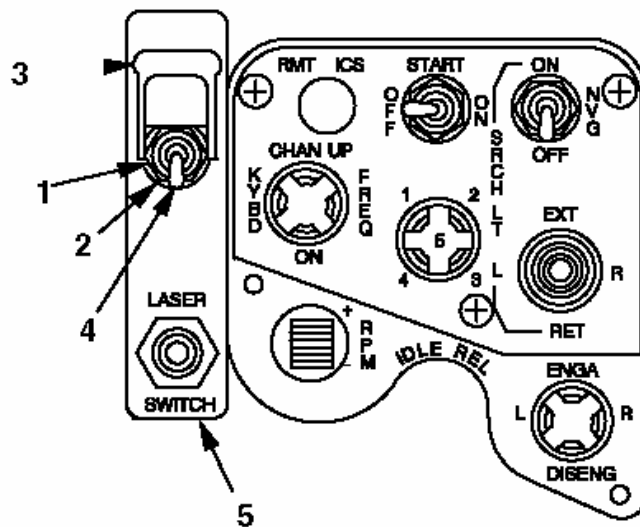
Figure 11

j. Remove Cargo Release Switch. (See Figure 11.)

(1) Cut wires connected to cargo release switch.

(2) Remove nut (1), washer (2), and switch guard (3) from cargo release switch (4).

(3) Remove cargo release switch (4) from switch support (5).

(4) Cut shrink-wrap approximately 1/2 inch to expose cargo wires where they enter the collective.

(5) Cut and cap wires and recover with existing shrink-wrap.

(6) Fabricate a cover plate from 2024 sheet stock to cover area on switch support (5).

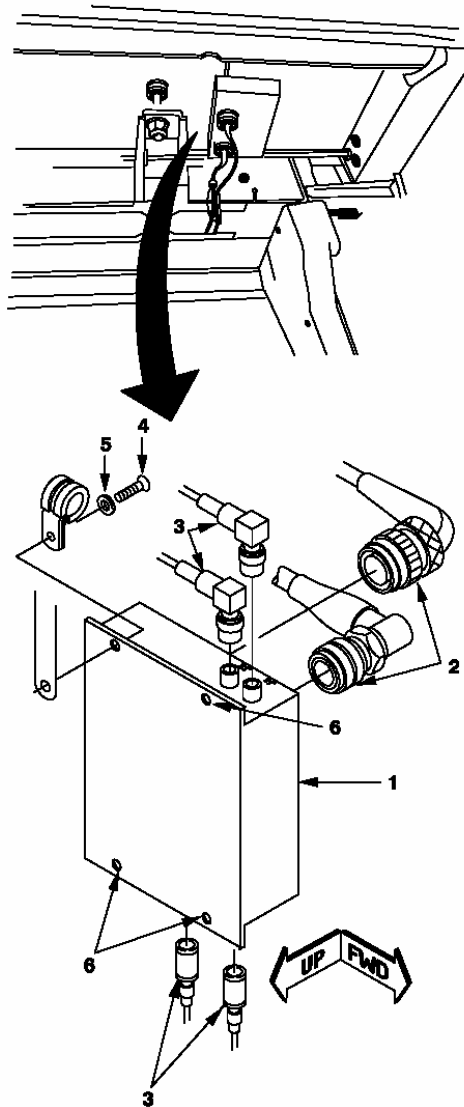
Figure 12

I. Remove FM Comparator. (See Figure 12.) (CDS2 aircraft)

(1) Gain access to comparator (1) on inside roof of helicopter.

(2) Disconnect two electrical connectors (2) and four coax connectors (3) from comparator (1).

(3) While supporting comparator (1), remove one screw (4) and washer (5).

(4) Loosen three captive screws (not shown) (6) and remove comparator (1) from helicopter.

(5) If ARC201 radio is installed, remove stand-off coupler 2304A3.

(6) Replace connector (2304Z2P5) on cable (2ARC186-103A(7)) with new connector (part number M3912/17-0502, NSN 5935-01-046-2037).

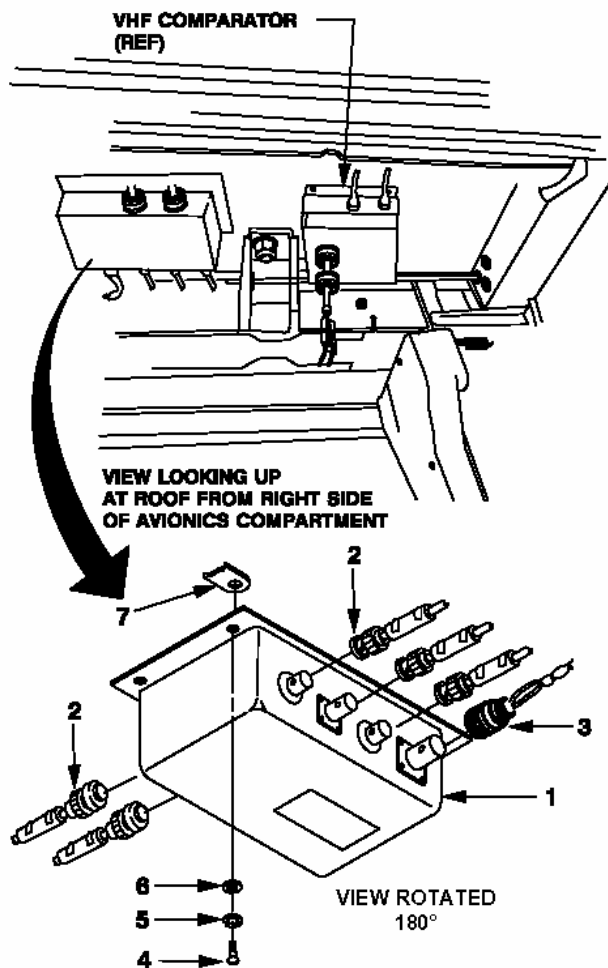
Figure 13

m. Remove FM Antenna Coupler (See Figure 13.) (CDS2 aircraft)

(1) Disconnect five coax connectors (2) from antenna coupler (1).

(2) Disconnect electrical connector (3) from antenna coupler (1).

(4) Support antenna coupler (1) and remove four screws (4), lockwasher (5), and washers (6).

(5) Remove antenna coupler (1) from helicopter.

(6) Remove the three coax cables (2ARC186-34A, -35A, and -36A) between coupler and comparator.

(7) Attach 2304Z2P5 cable connector removed from comparator to 2304Z3P2 cable connector removed from coupler.

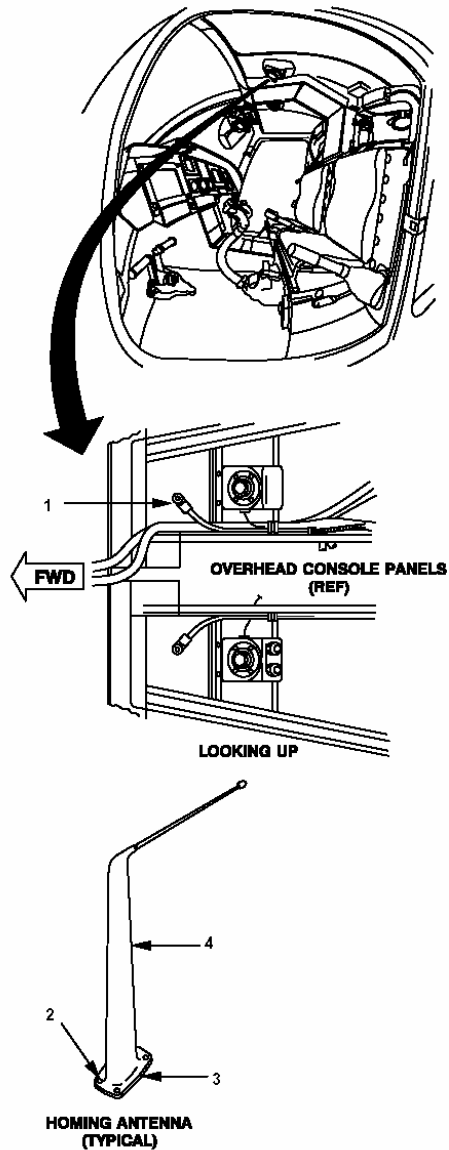
Figure 14

n. Remove FM Antenna. (See Figure 14)

(1) Disconnect coax connector (1) for left side.

(2) Remove old sealing compound from mounting screws (2), mount (3), and surrounding mounting surfaces using plastic scraper.

(3) Remove four mounting screws (2) from mount (3).

(4) Remove homing antenna (4).
