TB 1-1520-248-30-05

**INTERMEDIATE WEIGHT REDUCTION IMPLEMENTATION
ON OH-58D HELICOPTERS**

*TB 1-1520-248-30-05

1. **PURPOSE.** To improve the operational weight conditions and the power available margin of the OH-58D helicopter by removing non-mission essential and/or obsolete components.

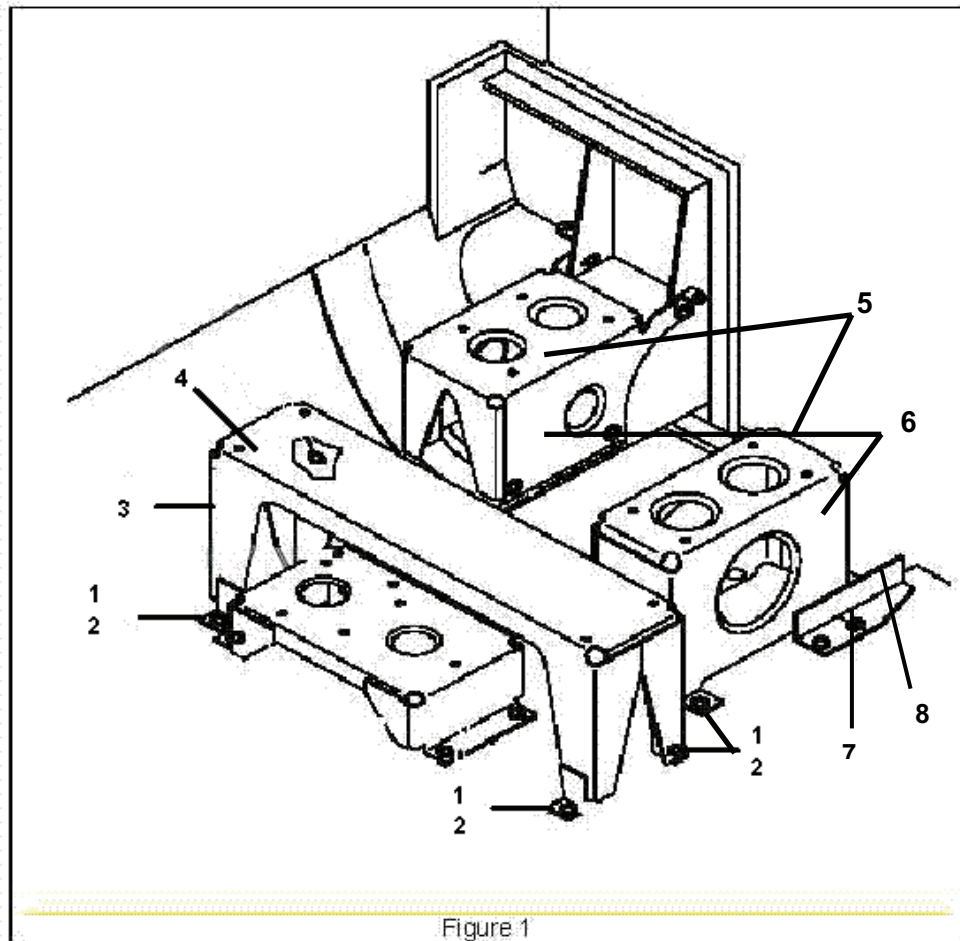
- a. Removal of the HF- R/T Shock Mount. (See Figure 1.)

- (1) Remove right Avionics door.
- (2) Remove four machine screws (1) and four flat washers (2) holding the HF R/T Hard Mount (3) in place.
- (3) Remove HF-R/T shock mount (4) and Hard Mount (3). Disconnect wiring bundles from side of HF-RT Hard Mount.
- (4) Reinstall four machine screws (1) and four flat washers (2) in mounting holes.

b. Removal KY-75 Shock Mount. (See Figure 1.)

- (1) Remove four machine screws (1) and four flat washers (2).
- (2) Remove rivets (7) and "L" shaped bracket (8).
- (3) Remove KY-75 Shock Mount (5) and Brackets (6).
- (4) Reinstall four screws (1) and four washers (2) in mounting holes.

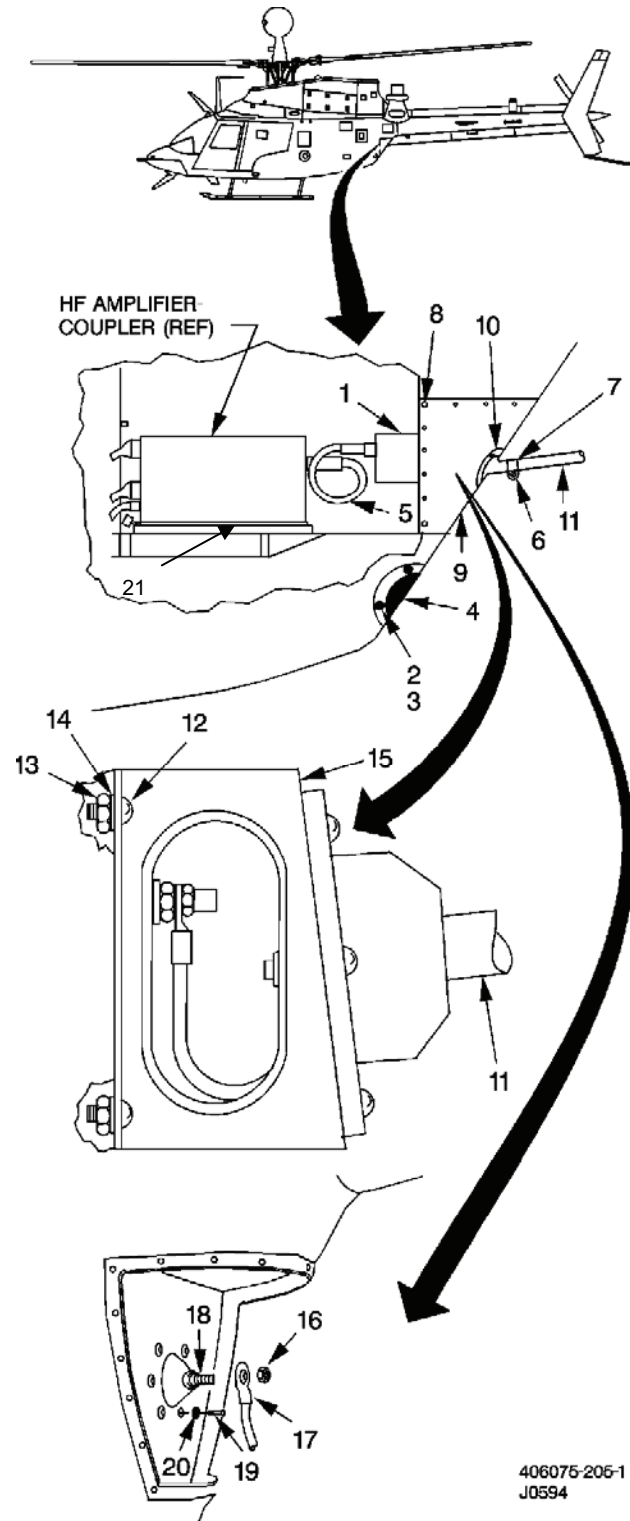
Figure 4

d. Removal of HF-Antenna Coupler. (If installed.) (See Figure 4.)

e. Removal of the HF - Amplifier Coupler Mounting Rack. (See Figure 4.)

(1) Gain access to HF antenna coupler (1) by removing four screws (2), washers (3), and exhaust port screen (4).

(2) Disconnect RF cable (5) from HF antenna coupler (1).

(3) Remove four screws (12), nuts (13), and washers (14) from bracket (15).

(4) Remove jamnut (16) and jumper assembly terminal (17) from stud (18).

(5) Support HF antenna coupler (1) and remove six mounting screws (19) and washers (20).

(6) Open aft electrical compartment door and remove HF antenna coupler (1).

(1) Gain access to the aft electronics bay.

(2) Remove screws attaching the mounting rack (21) to the airframe structure.

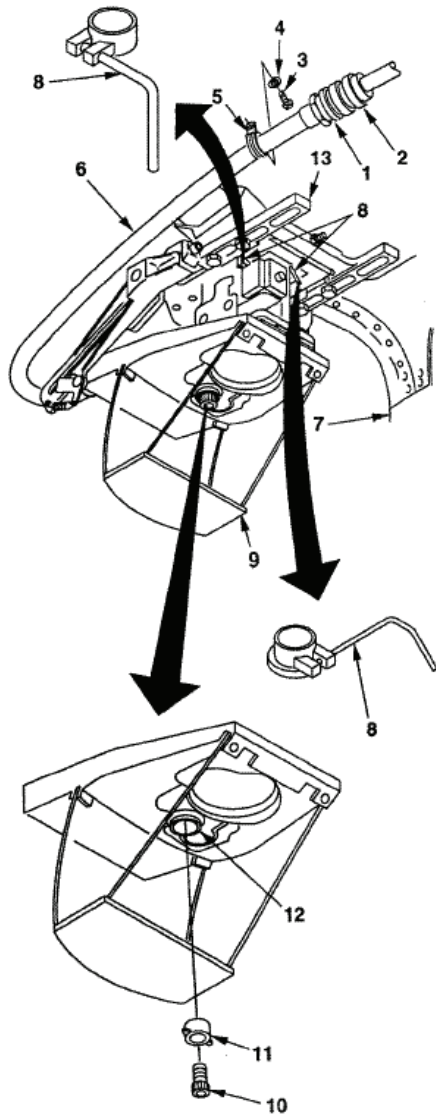
Figure 5

f. Removal of the PDU. (If installed.) (See Figure 5.)

(1) Disconnect electrical connector (1) from helicopter disconnect (2).

(2) Remove screw (3), washer (4), and clamp (5) securing PDU electrical cable (6) to cockpit overhead (7).

(3) Loosen height adjustment lock release levers (8) and adjust PDU (9) to gain access to cap screw (10) and down stop (11).

(4) Lock PDU (9) in position.

(5) Remove cap screw (10) and down stop (11) from front mount post (12).

(6) Loosen height adjustment lock release levers (8) and remove PDU (9) from mount assembly (13).

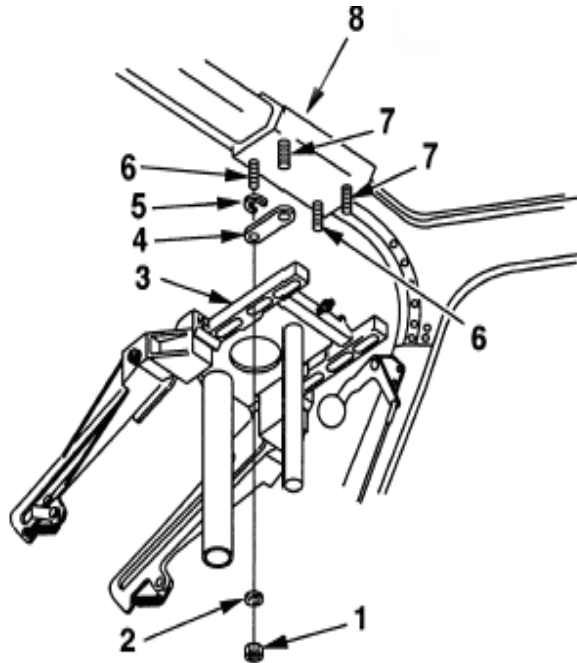
Figure 6

g. Removal of Pilot Display Unit (PDU) Mount Assembly. (See Figure 6.)

(1) Remove four nuts (1) and washers (2) securing mount assembly (3), spacers (4), and shims (5) to forward studs (6) and aft studs (7) on PDU fitting (8).

(2) Remove mount assembly (3), spacers (4), and shims (5) from forward studs (6) and aft studs (7).

(3) Remove the studs (6 and 7) from the PDU Fitting by cutting with a grinder, leaving a small portion of the stud protruding. File remainder of stud level to surface of mount.

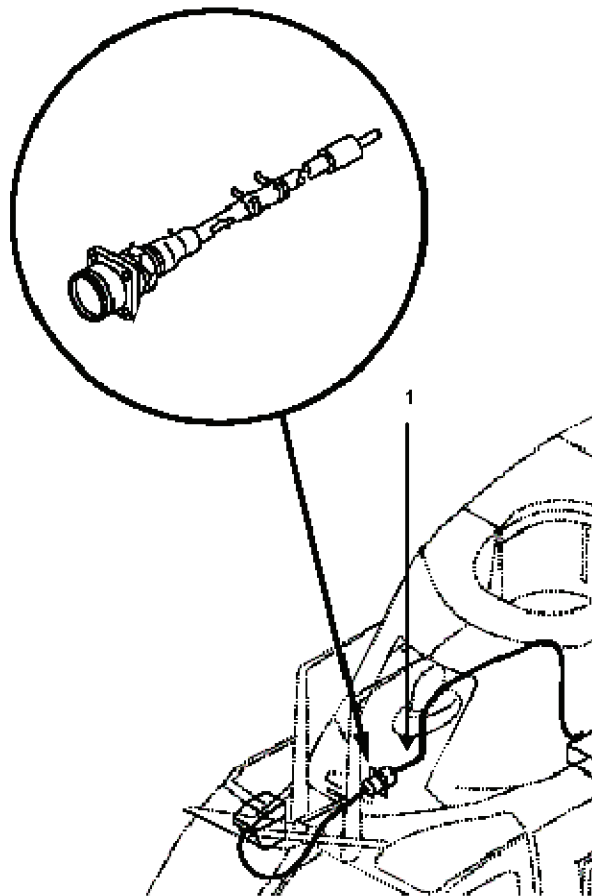
Figure 7

h. Removal of the PDU Cable. (See Figure 7.)

- (1) Gain access to the right side electronics bay and to the pilot area.
- (2) Remove the machine screws and standoffs securing the PDU cable.
- (3) Remove the PDU Cable.
- (4) Remove PDU Cable Bracket (1) held in by 4 rivets.
- (5) Cut off clamp studs on back door frame.

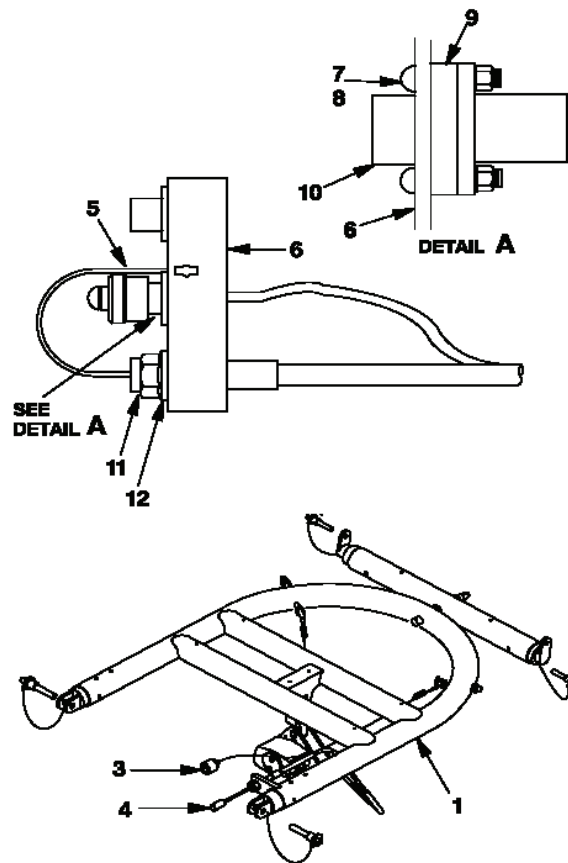
Figure 8

- i. Remove Cargo Handle, Cables. (See Figure 8.)

- (1) Cut cable and electrical wire for emergency release where they enter the lower fuselage.
- (2) Remove rear center console panel under collective.
- (3) Locate and remove cargo release wiring. (See Figure 10, Item 32.)
- (4) Remove bracket assembly (6) and reinstall screws.

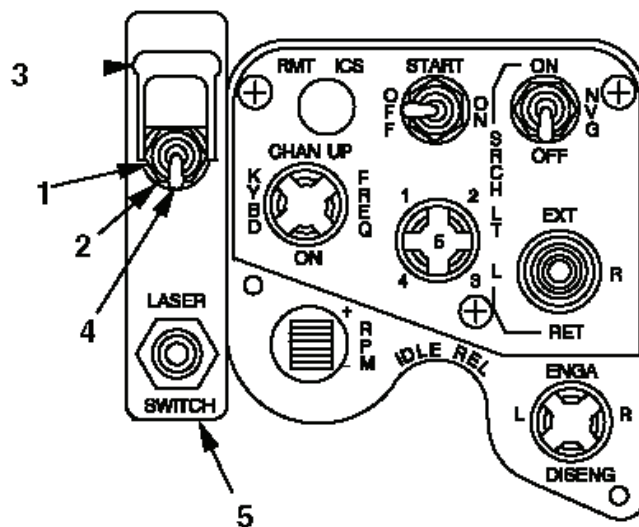
Figure 11

j. Remove Cargo Release Switch. (See Figure 11.)

(1) Cut wires connected to cargo release switch.

(2) Remove nut (1), washer (2), and switch guard (3) from cargo release switch (4).

(3) Remove cargo release switch (4) from switch support (5).

(4) Cut shrink-wrap approximately 1/2 inch to expose cargo wires where they enter the collective.

(5) Cut and cap wires and recover with existing shrink-wrap.

(6) Fabricate a cover plate from 2024 sheet stock to cover area on switch support (5).

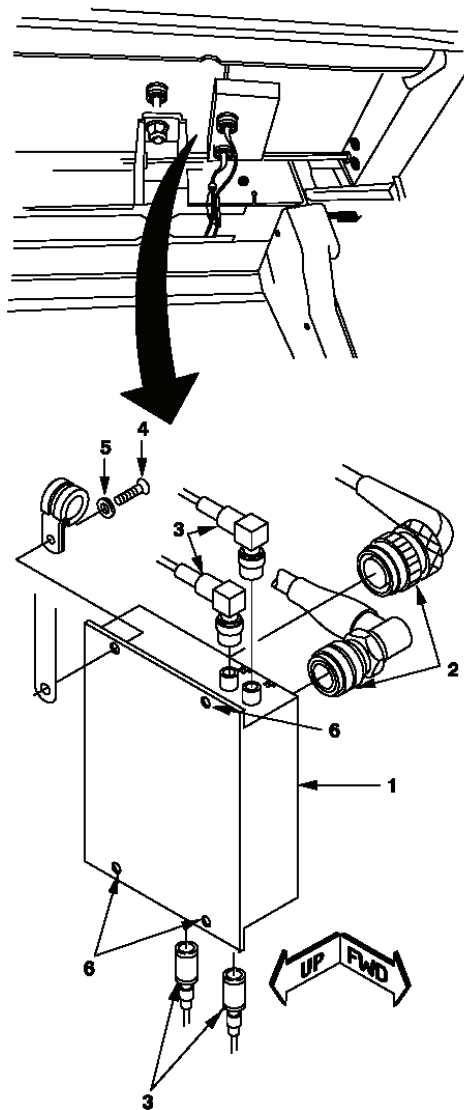
Figure 12

I. Remove FM Comparator. (See Figure 12.) (CDS2 aircraft)

- (1) Gain access to comparator (1) on inside roof of helicopter.
- (2) Disconnect two electrical connectors (2) and four coax connectors (3) from comparator (1).
- (3) While supporting comparator (1), remove one screw (4) and washer (5).
- (4) Loosen three captive screws (not shown) (6) and remove comparator (1) from helicopter.
- (5) If ARC201 radio is installed, remove stand-off coupler 2304A3.

(6) Replace connector (2304Z2P5) on cable (2ARC186-103A(7)) with new connector (part number M39012/17-0502, NSN 5935-01-046-2037).

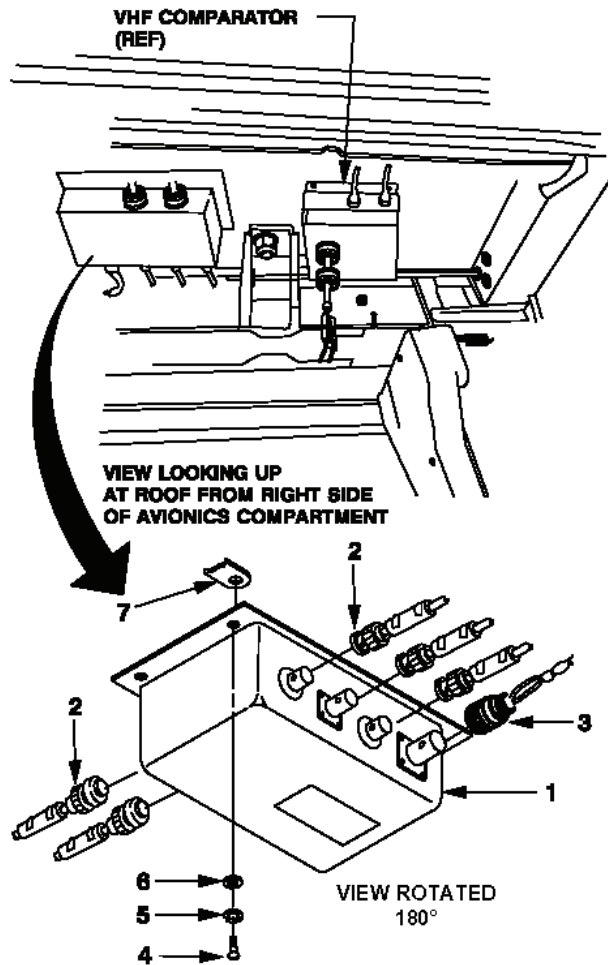
Figure 13

m. Remove FM Antenna Coupler (See Figure 13.) (CDS2 aircraft)

(1) Disconnect five coax connectors (2) from antenna coupler (1).

(2) Disconnect electrical connector (3) from antenna coupler (1).

(4) Support antenna coupler (1) and remove four screws (4), lockwasher (5), and washers (6). Retain for later use.

(5) Remove antenna coupler (1) from helicopter.

(6) Remove the three coax cables (2ARC186-34A, -35A, and -36A) between coupler and comparator.

(7) Disconnect cable from L/H homing antenna, and remove cable 2 ARC 186-39A from coupler to antenna.

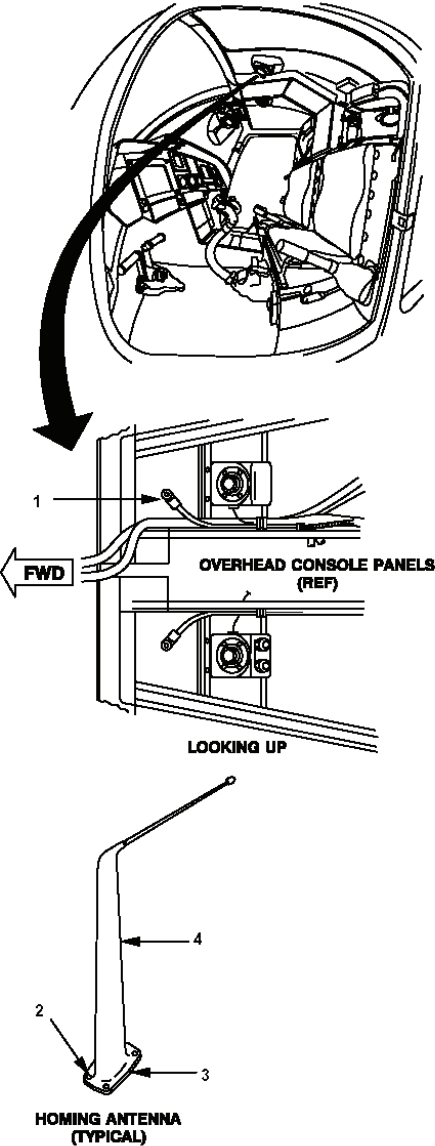
Figure 15 |

n. Remove FM Antenna. (See Figure 15)

(1) Disconnect coax connector (1) for left side.

(2) Remove old sealing compound from mounting screws (2), mount (3), and surrounding mounting surfaces using plastic scraper.

(3) Remove four mounting screws (2) from mount (3).

(4) Remove homing antenna (4).

(5) Fabricate a cover plate from 2024 sheet stock to cover area on roof.
