# DEPARTMENT OF THE ARMY TECHNICAL BULLETIN

## INSPECTION AND REPAIR FOR T55 SERIES ENGINE RESET PROGRAM (T55-L-712 AND T55-GA-714A)

Headquarters, Department of the Army, Washington, D. C.  
30 January 2004

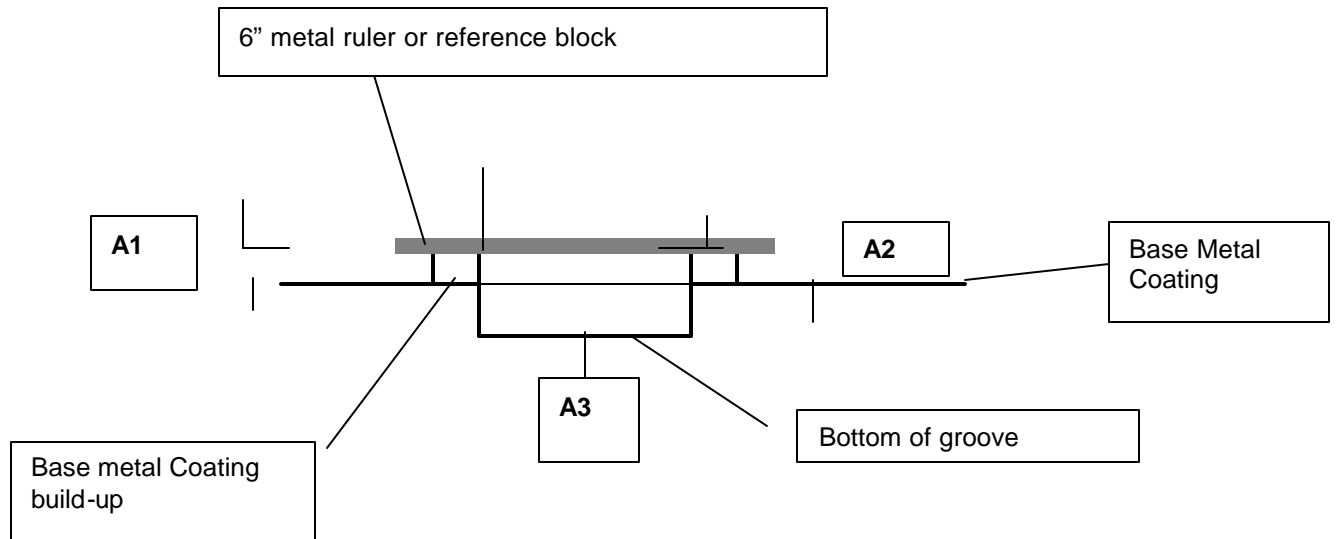
Figure 1A: Measurement with Wire Feeler Gauges

- 1) Measure values from Figure 1A and record values A1, A2, and A3 on data sheet 1.
- 2) Calculate sum by adding A1 and A2
- 3) Calculate Avg. A by dividing sum by 2
- 4) Calculate Depth by subtracting Avg A from A3 ( $A3 - \text{Avg A} = \text{Depth}$ )
- 5) If Depth is less than 0.012 inch then engine acceptable for use
- 6) Repeat process 100 hrs later
- 7) If value recorded as depth has not increased for three consecutive times inspection may be discontinued.
- 8) If value recorded as depth is greater than 0.012-inch engine must be repaired or removed from service.
- 9) Go to task 7.

A1 is the distance from the bottom of the ruler to the bottom of base material.  
A2 is the distance from the bottom of the ruler to the bottom of base material.  
A3 is the distance from the bottom of the ruler to the bottom of groove.

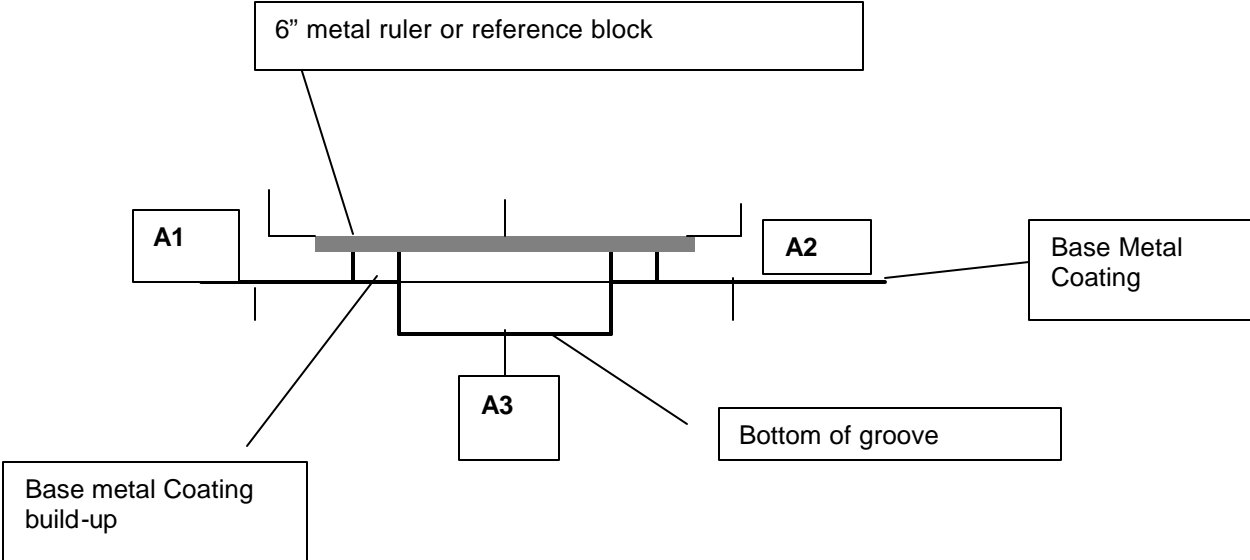
Figure 1B: Measurement with Depth Gauge

- 1) Measure values from Figure 1B and record values A1, A2, and A3 on data sheet 1.
- 2) Calculate sum by adding A1 and A2
- 3) Calculate Avg. A by dividing sum by 2
- 4) Calculate Depth by subtracting Avg A from A3 ( $A3 - \text{Avg A} = \text{Depth}$ )
- 5) If Depth is less than 0.012 inch then engine acceptable for use
- 6) Repeat process 100 hrs later
- 7) If value recorded as depth has not increased for three consecutive times inspection may be discontinued.
- 8) If value recorded as depth is greater than 0.012-inch engine must be repaired or removed from service.
- 9) Go to task 7.

**NOTE**  
A1 is the distance from the top of the ruler to the bottom of base material.  
A2 is the distance from the top of the ruler to the bottom of base material.  
A3 is the distance from the top of the ruler to the bottom of groove.
