## DEPARTMENT OF THE ARMY TECHNICAL BULLETIN

### INSPECTION AND REPAIR FOR T55 SERIES ENGINE RESET PROGRAM (T55-L-712 AND T55-GA-714A)

15 June 2005

**TB 1-2840-265-23**

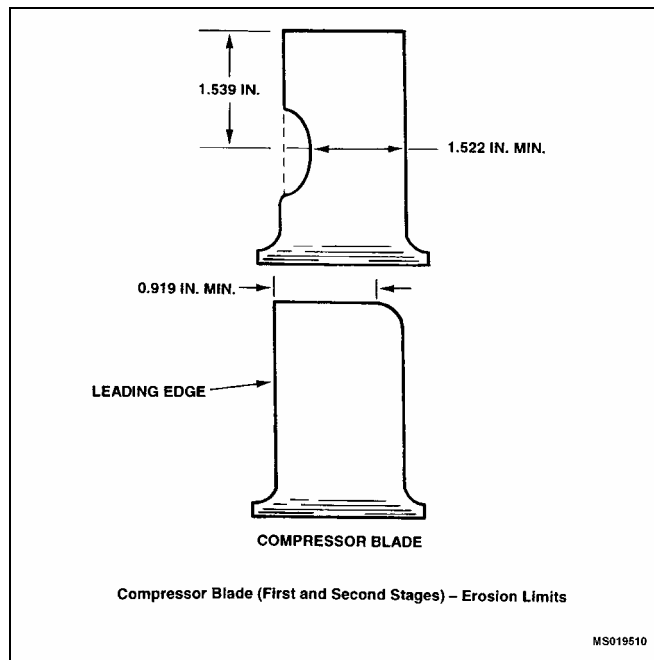
**Figure 1- Compressor Blade Erosion Limits**

- (1) Inspect engines for obvious damage (T55-GA-714A & T55-L712). Visually inspect the compressor section with a suitable flashlight through the inlet housing and the 6<sup>th</sup> stage trailing edge through the Bleed Band cavity. Use inspection criteria in TM 55-2840-254-23, Task 2-33 and figures 1 & 2 below to determine serviceability for both engine types (T55-L712 and T55-GA-714A). If the inspection reveals that more than 50 compressor blades need to be replaced, then proceed to paragraph 7d. If inspection reveals damage not exceeding the 50 blade replacement and/or detected damage is determined to be within the unit's capability and repair authorization, continue with inspection procedures.

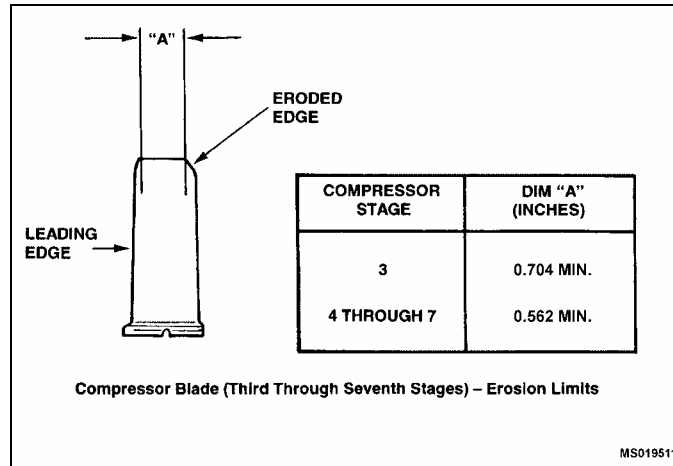
Figure 2- Compressor Blade Erosion Limits

- (4) Inspect compressor blades (T55-GA-714A & T55-L712) reference TM 1-2840-265-23&P, Task 2-30 and TM 55-2840-254-23, Task 2-33 respectively, and figures 1 & 2 above.

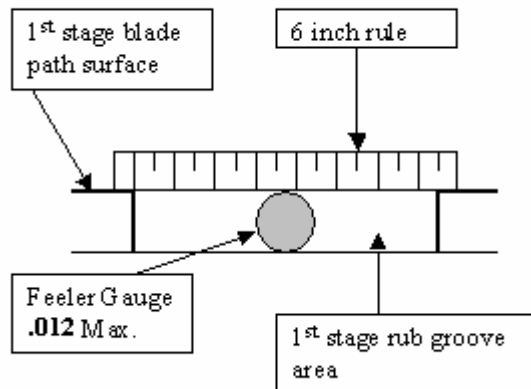
Figure 3- Measurement Compressor Groove Depth

- 1) Inspect the corresponding set of blades for damage and repair or replace as necessary.
- 2) Measure the compressor housing damage with wire feeler gauges, NSN 5220-01-145-7448 or equivalent. Place straight edge perpendicular to damage and determine groove depth with appropriate wire gauge.

- b) If metal damage depth is greater than 0.012 inch, replace compressor case halves. If the metal damage depth is less than 0.012 inch contact a technical POC listed in paragraph 11a.

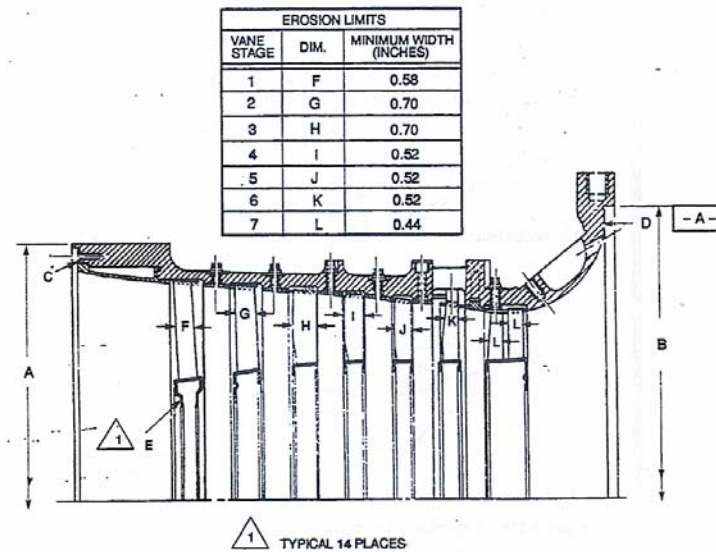
**Figure 4- Erosion Limitations**

- (b) T55-L712: Clean and inspect compressor housing (case-halves) IAW, Tasks 2-21 and 2-22 respectively.
- (3) Inspect Stator Vanes on both engine types (T55-L712 & GA-714A) for erosion, IAW (Figure 4) below and for Foreign Object Damage (FOD) IAW TM 1-2840-265-23&P, Task 2-24 and TM 55-2840-254-23, Task 2-28 respectively.

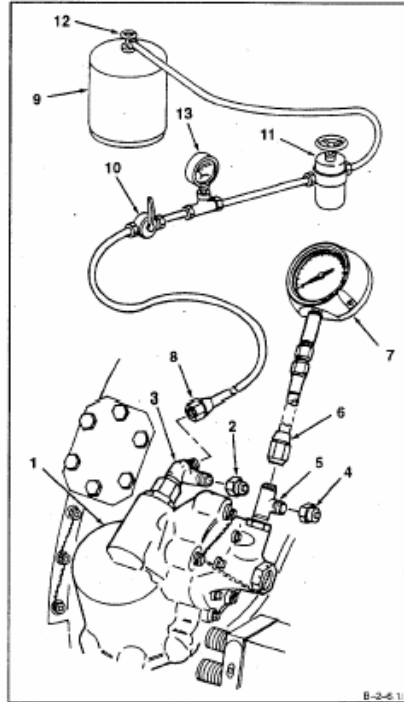
**Figure 5- Test Set Installation**

- (3) Test the air bleed actuator IAW TM 1-2840-265-23&P or as follows: (reference figure 5 below)
    - (a) Check for internal leakage in interstage airbled actuator (1) as follows:

- 6) Open valve (12) of compressed air source (9) and adjust regulator (11) to read 50 psig on gauge (13).
      - 7) Open valve (10) and ensure no air leakage at tees (3 and 5). Pressure gauge (7) shall indicate less than 45 psig. If pressure is greater than 45 psig, replace actuator.

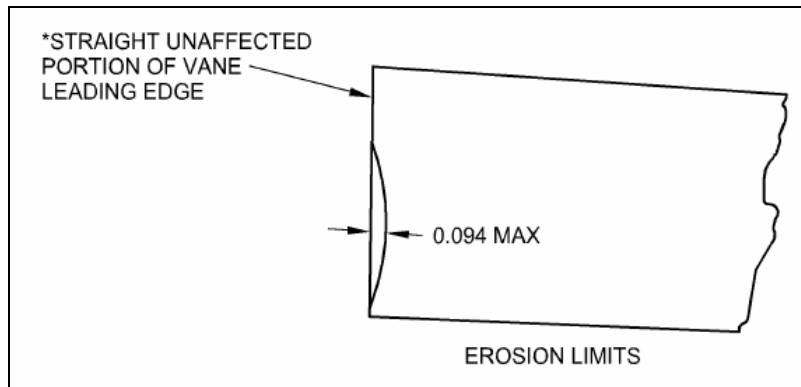
**Figure 6- Air Diffuser Erosion Limits**

- 4) Remove, clean and inspect 1<sup>st</sup> Stage Turbine Disk Assembly IAW Tasks 4-63, 4-64 and 4-65.
- 5) Remove, clean and inspect 1<sup>st</sup> Stage Nozzle IAW Tasks 2-78, 2-79 and 2-80.
- 6) Remove, clean and inspect Diffuser Curl IAW Task 2-78, 2-83 and 2-84.
- 7) Remove, clean and inspect Air Diffuser IAW Task 2-96, 2-97 & 2-98 for erosion on the leading edge not to exceed 0.094 inch; see figure 6 below.
