OCAMA AIRMUNITIONS LETTER
NO. 136-11-56C

SUBJECT: Advance Explosive Ordnance Disposal Technical Information

SUMMARY OF NUCLEAR WEAPONS INCIDENTS (AF FORM 1058) AND
RELATED PROBLEMS JUNE 1960

2. This summary includes the incident at McGuire AFB, New Jersey, on 7 June 1960. This incident will hereafter be referred to as NWI-60-1.

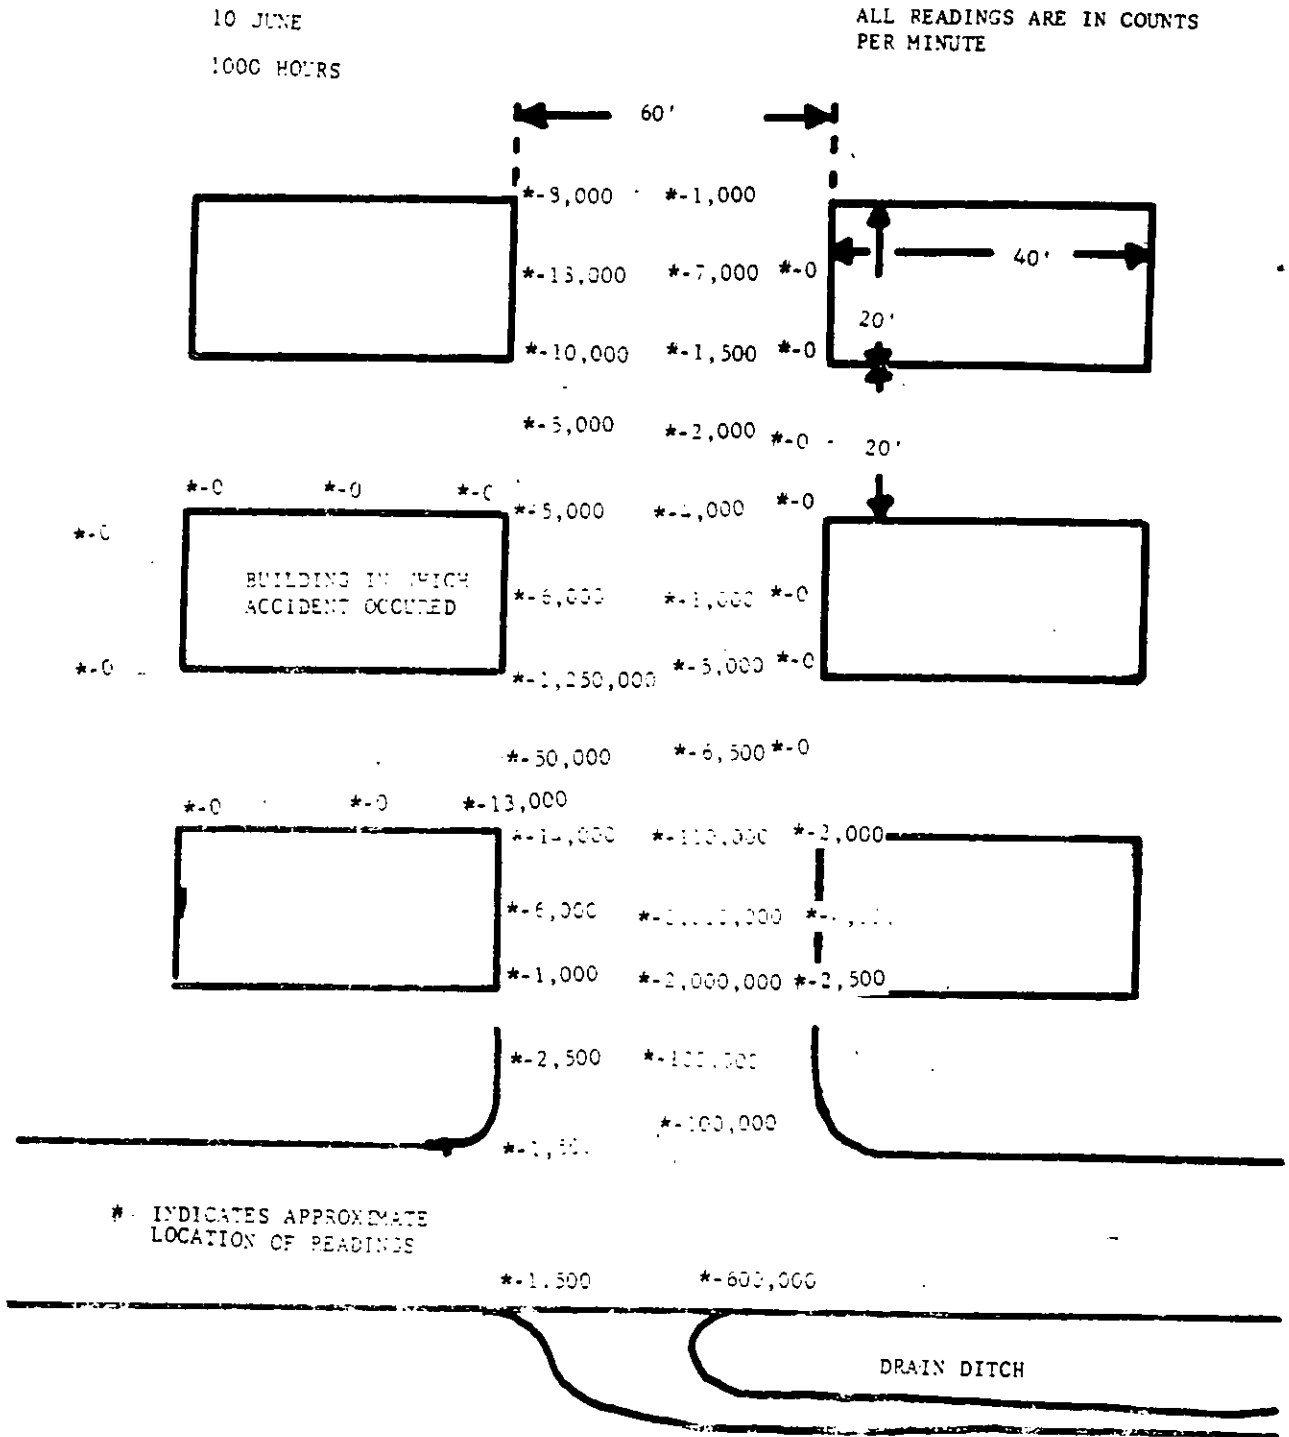
(6) On 10 June the entire area was again surveyed. It was found that during the fire tar had melted and had solidified in sections of the floor in thin layers. Several of the readings were over 2,000,000 CPM. The clean area had zero (0) readings. The center of the road in front of the shelter also raised in contamination reading to 2,000,000 CPM. (2.) The entire area was again washed down and allowed to dry. A slight drop in contamination was found, but readings of the roadway was still over the allowable limits. After the area completely dried, the inside of the shelter was painted with a lead-based paint. A very thick layer of paint was applied. The outside of the shelter was painted, using brooms to spread the paint. A total of

FIGURE 2. Monitoring Survey Results, 10 June 1960.

paint were used. When the paint had dried sufficiently to walk on, monitoring was again resumed. All areas that previously indicated high levels of contamination were effectively covered and zero readings were obtained. A few places on the fringe area indicated minor readings of 50-500 CPM. This reading was determined to be non-hazardous. The EOD personnel terminated operations at 2200 hours (EDST), 10 June 1960.
