**AIRCRAFT
ACCIDENT INVESTIGATION BOARD
REPORT**

**US ARMY UH-60
BLACK HAWK HELICOPTERS
87-26000 AND 88-26060**

TECHNICAL REPORT F-15 MAINTENANCE

Aircraft Evaluated: F-15C, Tail Number 79-0025

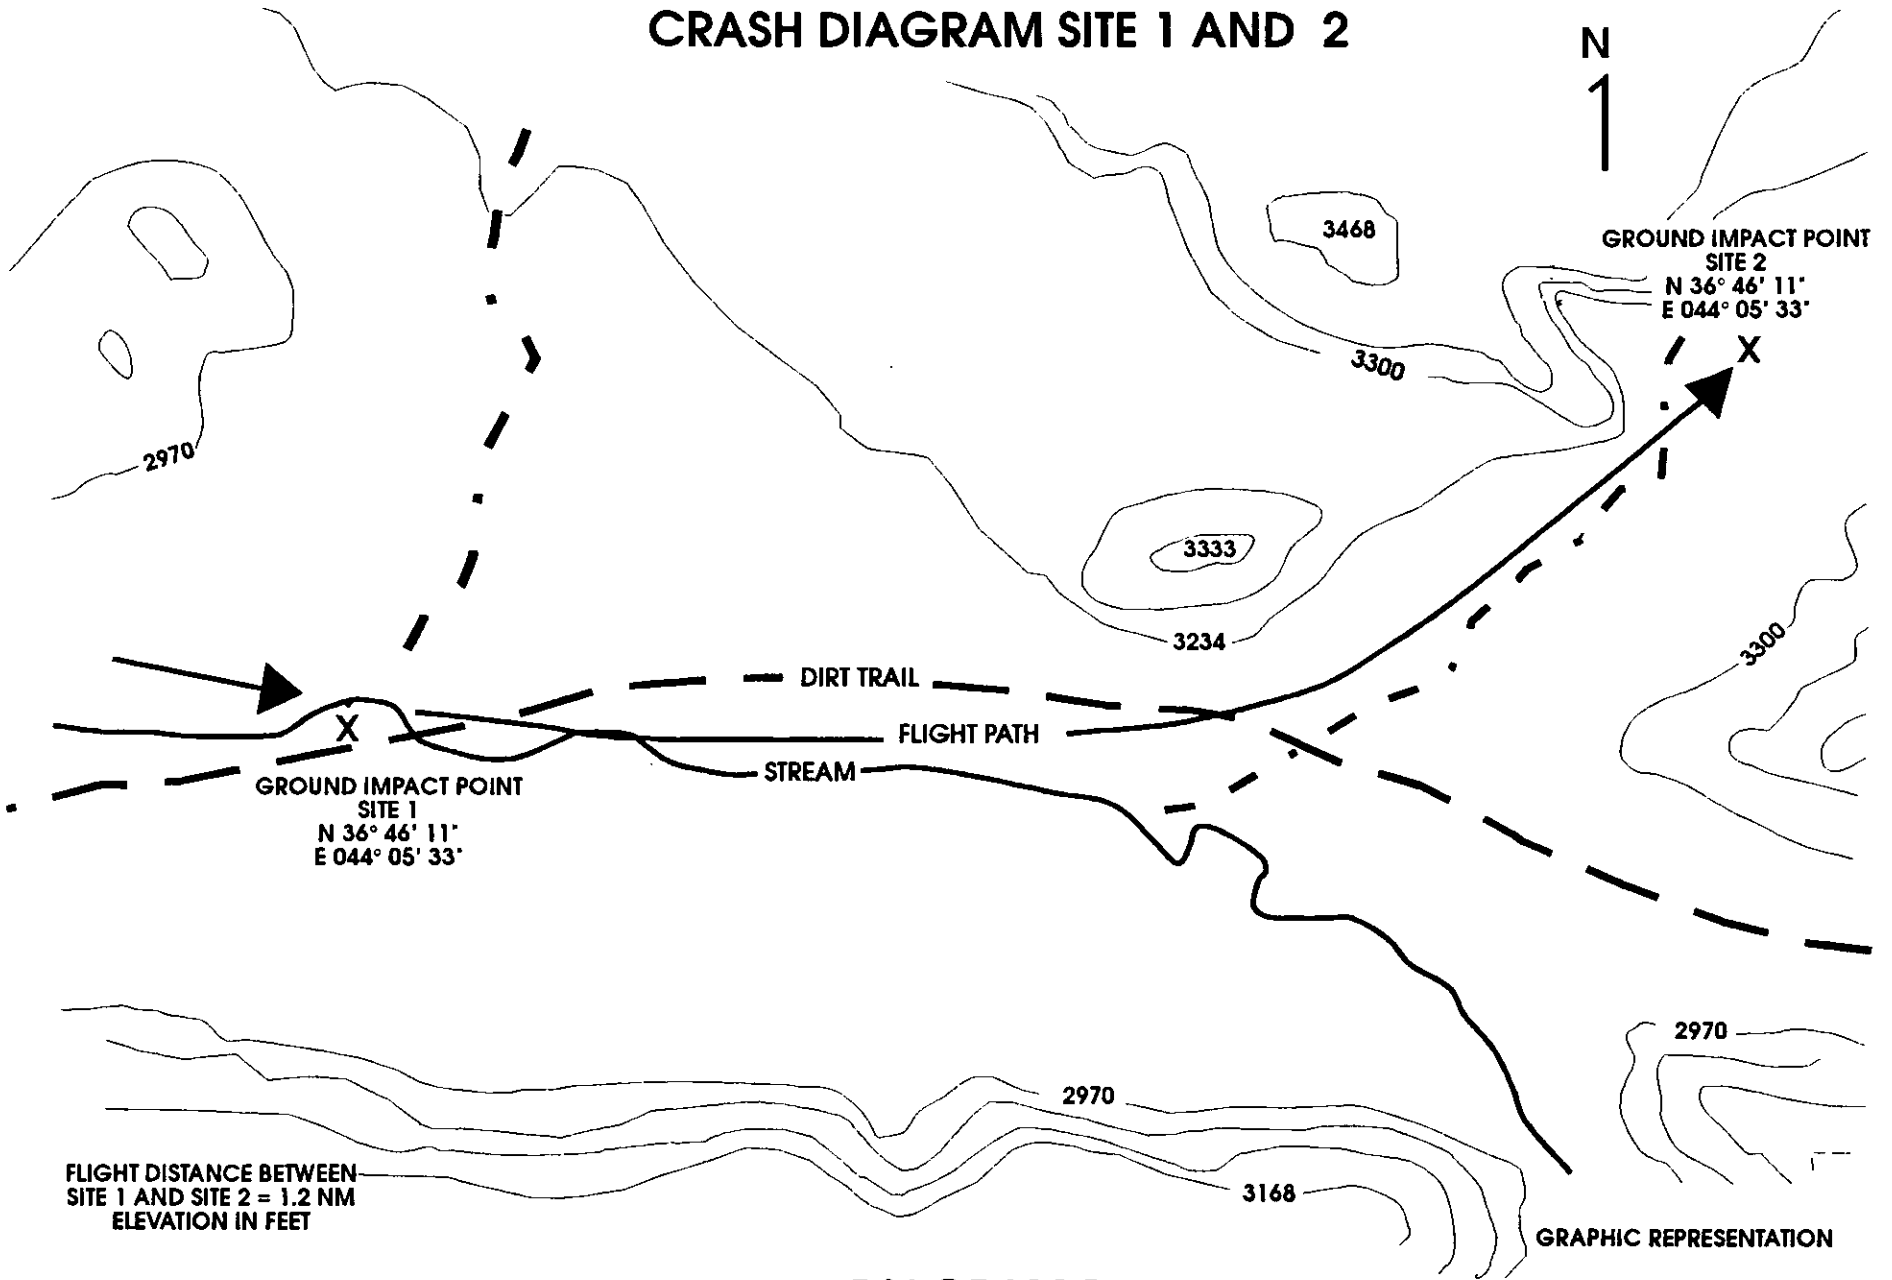
CRASH DIAGRAM SITE 1 AND 2

FLIGHT DISTANCE BETWEEN
SITE 1 AND SITE 2 = 1.2 NM
ELEVATION IN FEET
