**AIRCRAFT
ACCIDENT INVESTIGATION BOARD
REPORT**

**US ARMY UH-60
BLACK HAWK HELICOPTERS
87-26000 AND 88-26060**

TECHNICAL OR ENGINEERING EVALUATIONS

AMSEL-RD-NV-SE-EWD (SFAE-AV-AEC/25 Apr 1994) (70-1r) 1st End
Mr. R. Paolella and Ms. P. Lum/x44697 and x43211
SUBJECT: Failure Analysis on Crash Damaged Electronic Equipment

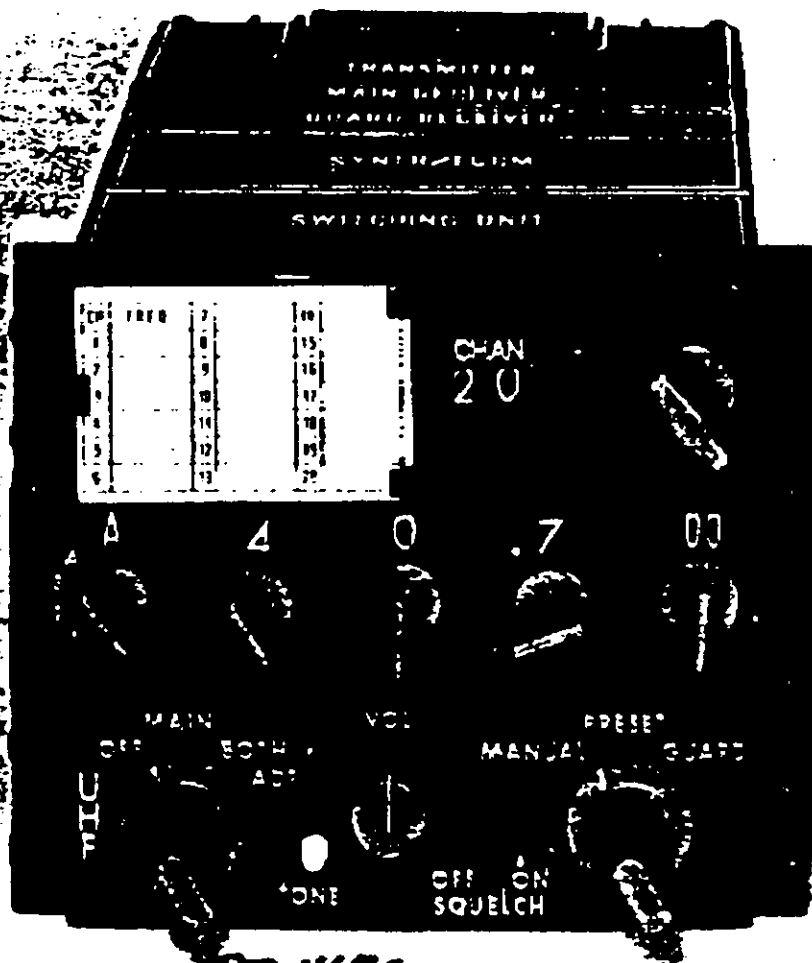
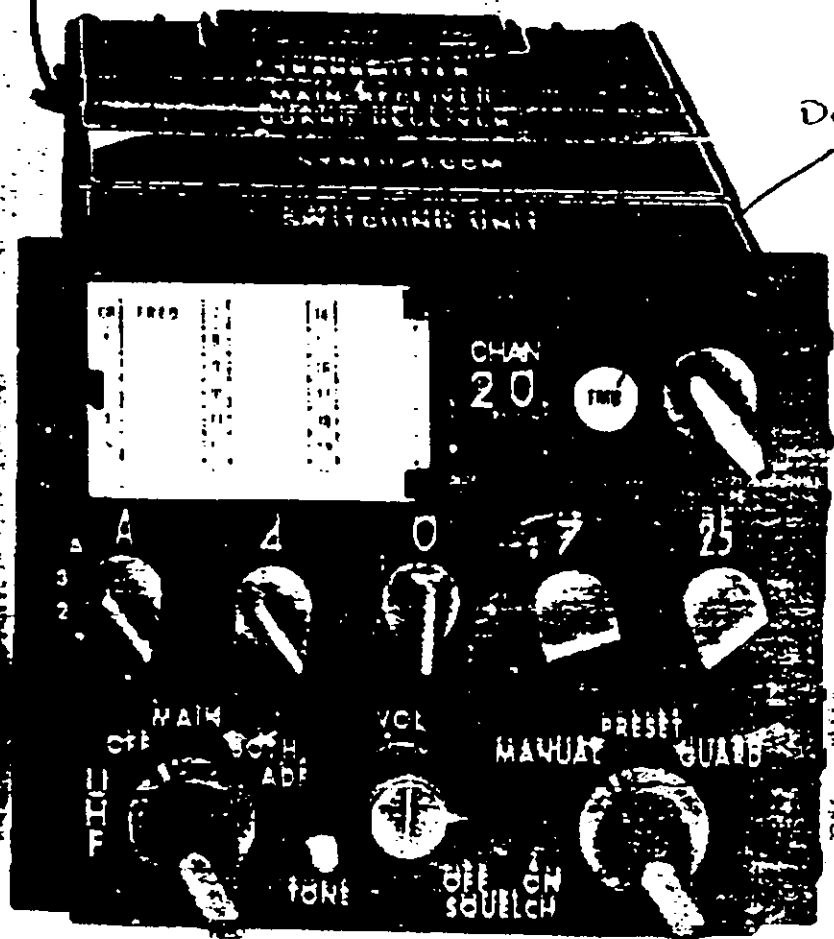
ARC-164 Comparison *White Triangle*

a. The RT-1167 faceplate is of different construction than the RT-1168 faceplate. The RT-1167 faceplate has grommets and a different channel selector switch which enables it to be rain-proof. The RT-1167 actually gets a rain test in the factory. The RT-1168 gets humidity testing only, no rain.
