**AIRCRAFT
ACCIDENT INVESTIGATION BOARD
REPORT**

**US ARMY UH-60
BLACK HAWK HELICOPTERS
87-26000 AND 88-26060**

TECHNICAL REPORT F-15 MAINTENANCE

Aircraft Evaluated: F-15C, Tail Number 79-0025

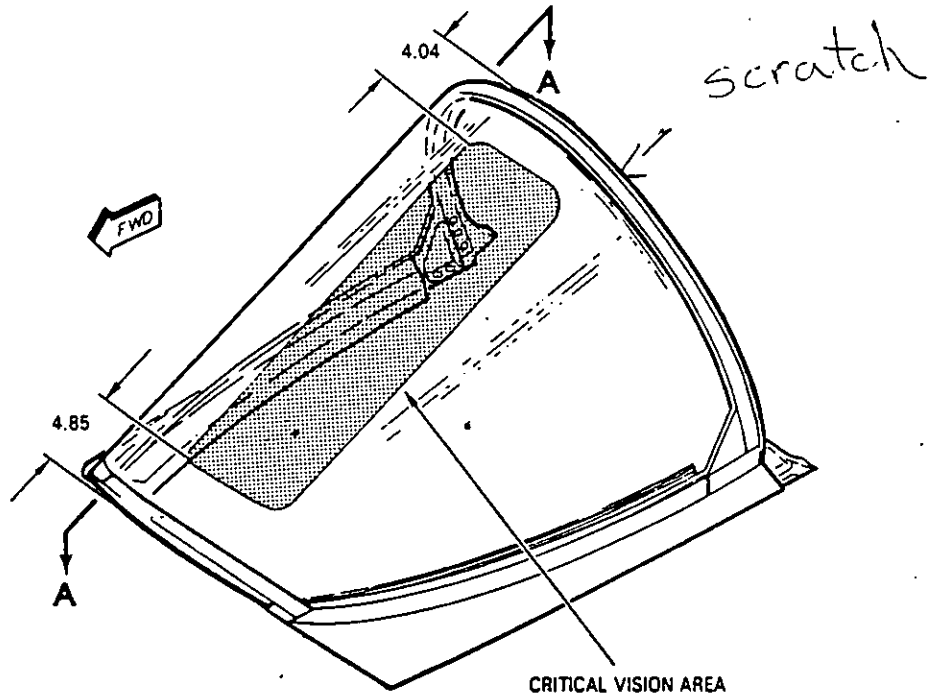
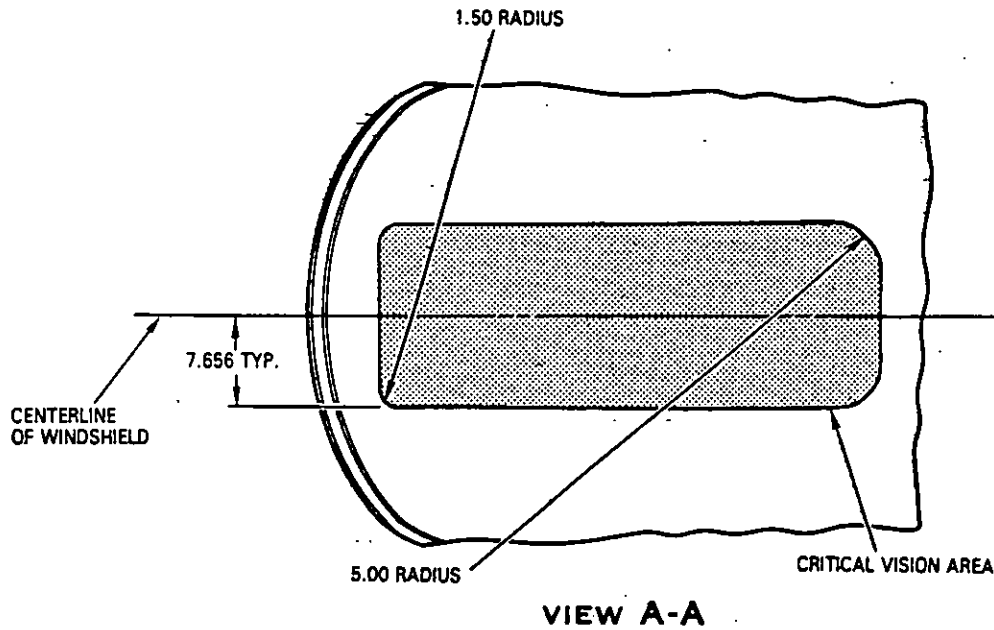
On my evaluation of A/C 9025 I found a scratch approximately 4 inches long at the 11 o'clock position on the windshield, near the windshield arch (Atch 3). Through visual inspection I found no distortion, and therefore there is no visual distortions. I then inspected the canopy, I found a few scratches that look like they may have come from a pilots helmet, but determined that they would be out of the pilots view area, and there was not any distortion.

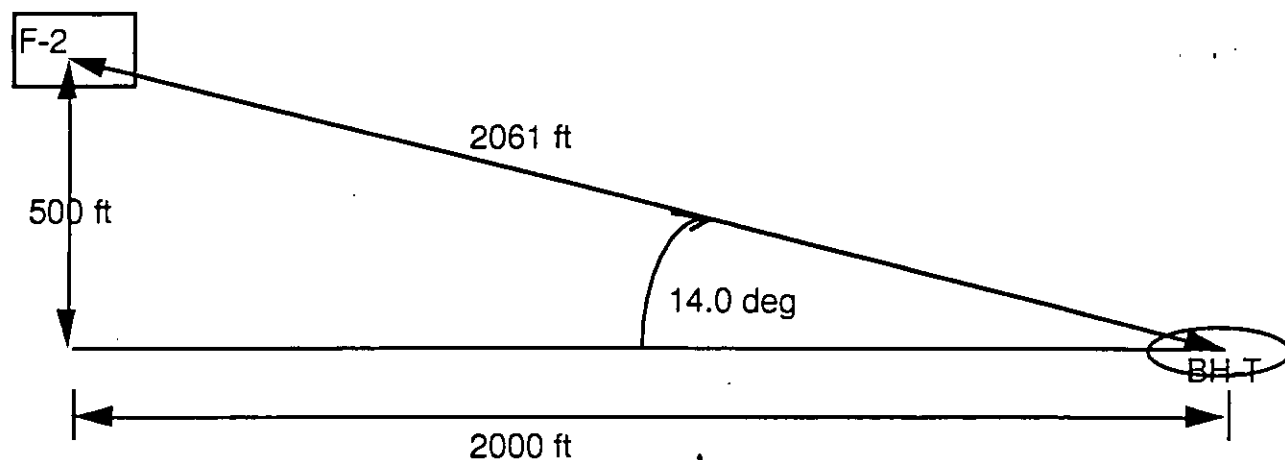
Figure 3. F-2 is at a slant range of 2061 feet from BH-T, and the look down angle is 14.0 degrees.

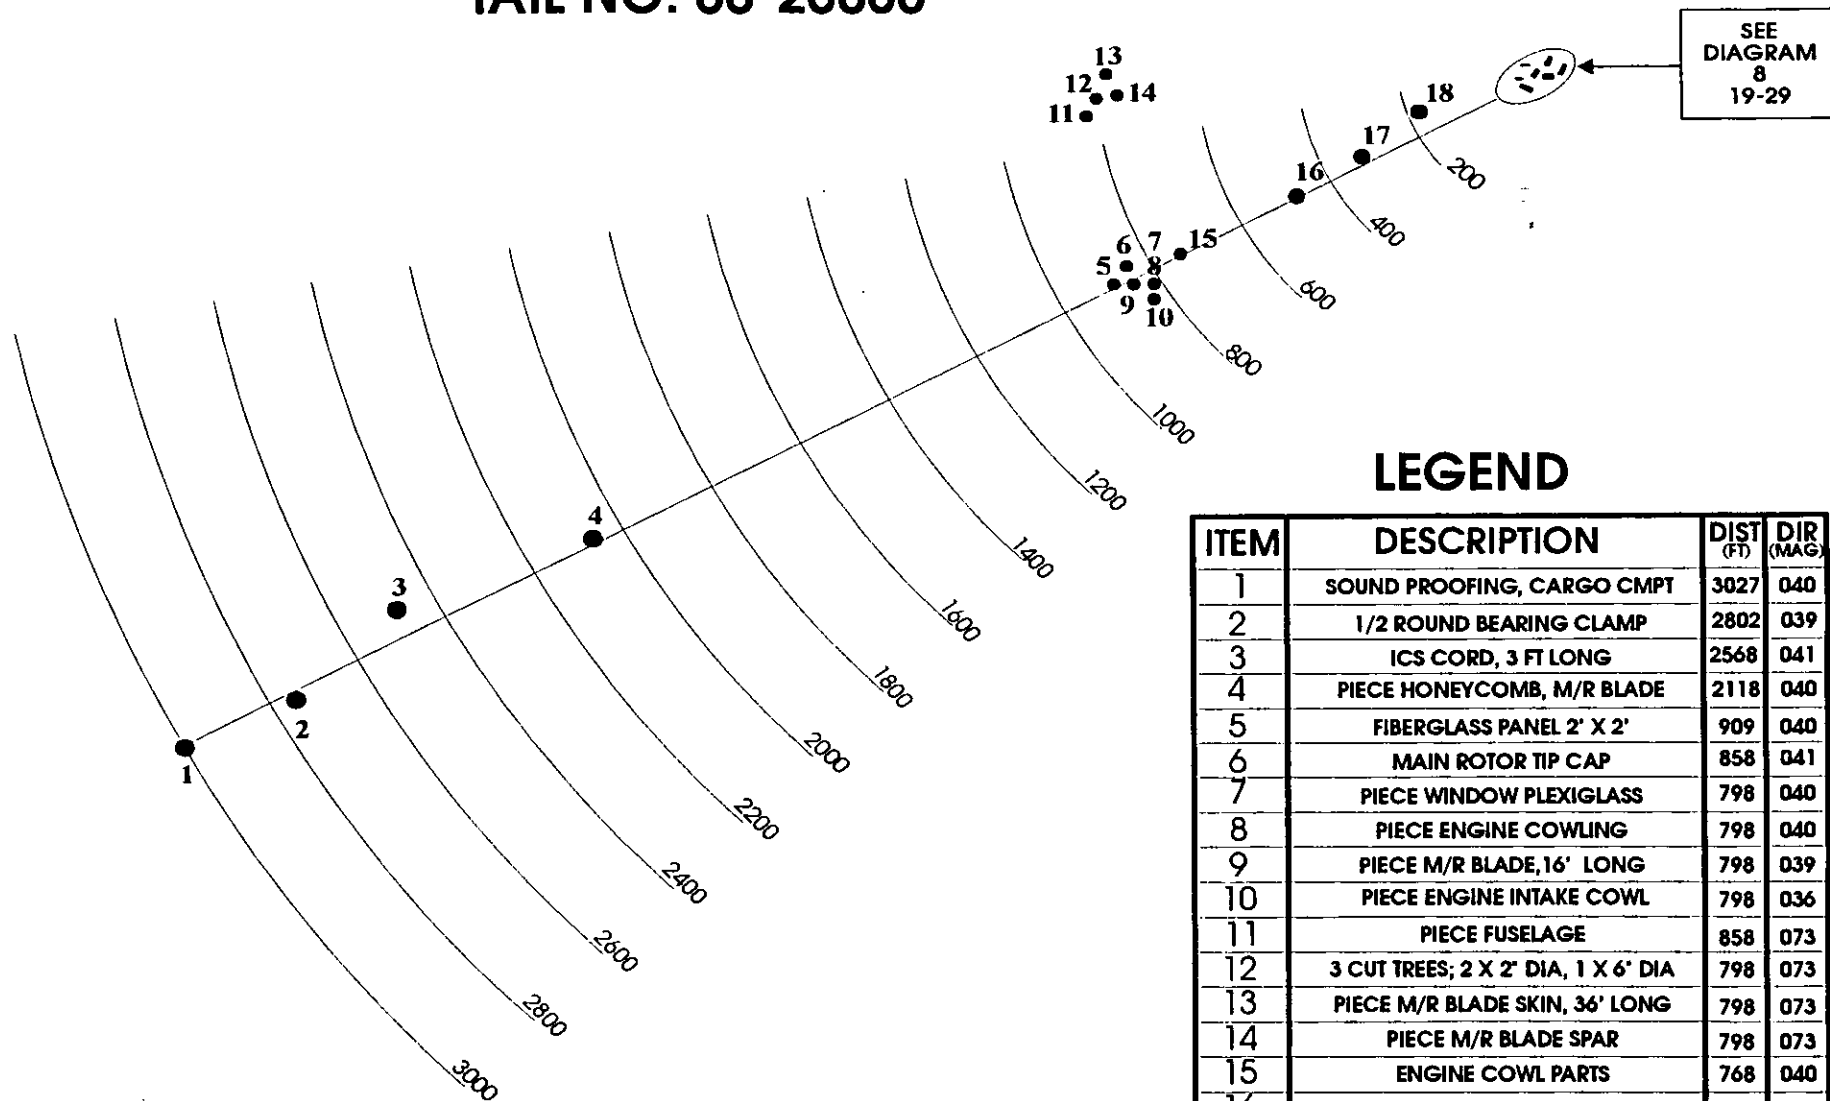
FLIGHT PATH WRECKAGE DISTRIBUTION SITE 2 TAIL NO. 88-26060
