**Serious Accident Investigation
Factual Report**

**Freeman Reservoir Fatality
Bureau of Land Management
Northwest Colorado Fire Management Unit
Little Snake Field Office
Craig, Colorado
June 26, 2009**

ACCIDENT INVESTIGATION FACTUAL REPORT

Accident: Freeman Reservoir Tree Falling Fatality
Location: Little Snake Field Office, Craig, Colorado
Date: June 26, 2009

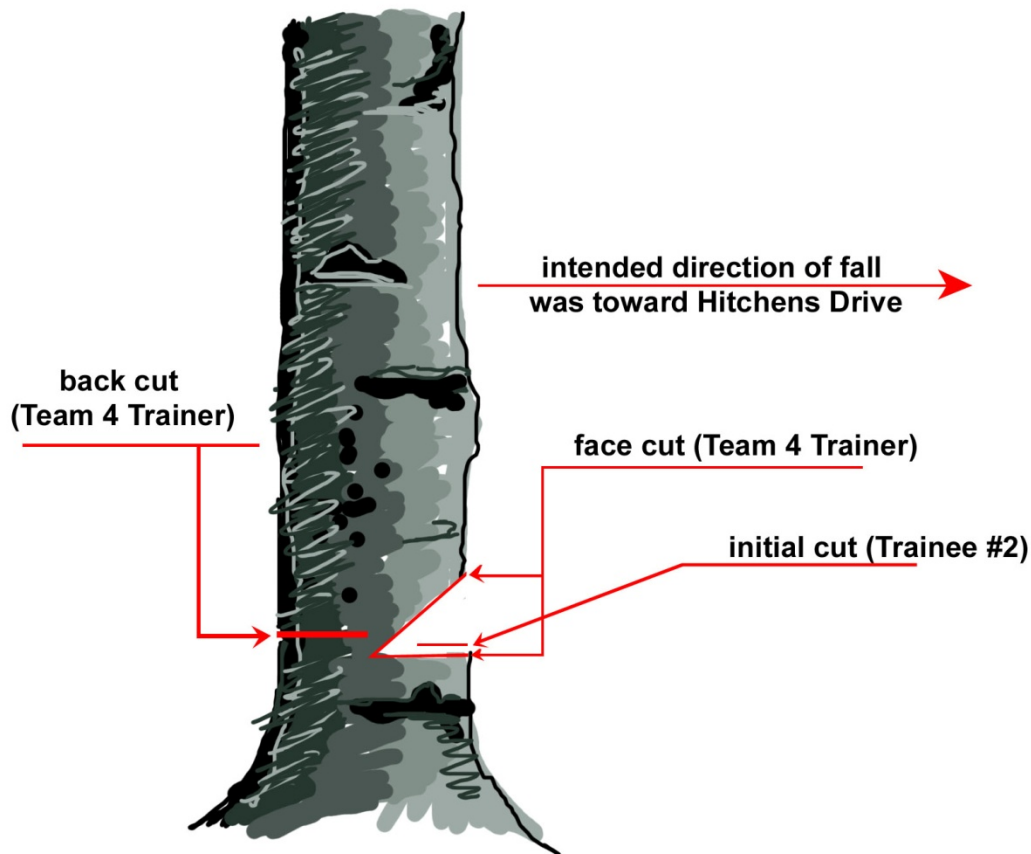
Figure 1: Initial cut made by Team 4 Trainee #2 and subsequent face cut and back cut made by Team 4 Trainer.

The dead tree was the first tree of the day that Team 4 Trainer cut. Team 4 Trainer started the saw and cut the horizontal portion of the pie cut approximately ½ inch below the horizontal cut that Team 4 Trainee #2 had started (see Figure 1).

The SAIT was unable to determine why Team 4 Trainer dropped ½ inch below the initial horizontal cut. Team 4 Trainer finished the face cut which was well-aligned and had good matching points. Team 4 Trainer removed the cut out and realized that the 23-inch diameter tree was rotted inside and only had approximately 3 inches of solid wood around the outside of the tree (see Figure 2).

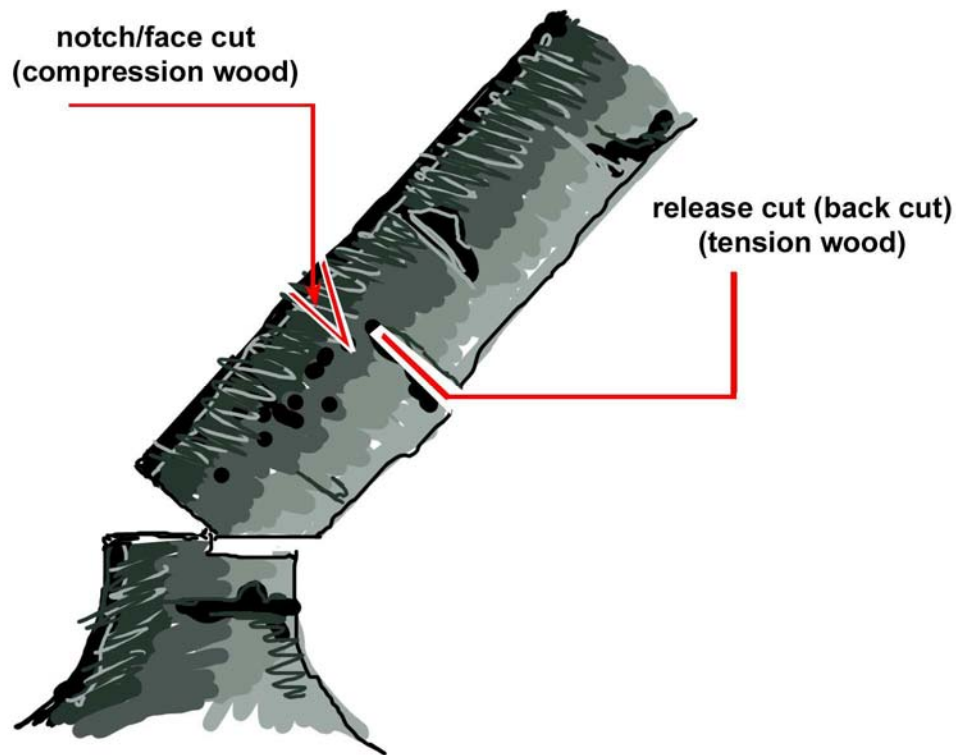
Figure 3: Close-up of Team 4 Trainer's second set of cuts after the tree got hung-up

along the tree trunk toward Hitchens Drive and initiated a second cut to free the tree from the stump and put the tree on the ground. Team 4 Trainer cut a pie-shaped notch approximately 18 inches above the original back cut to make space for the compression wood on the top side of the tree (see Figure 3).

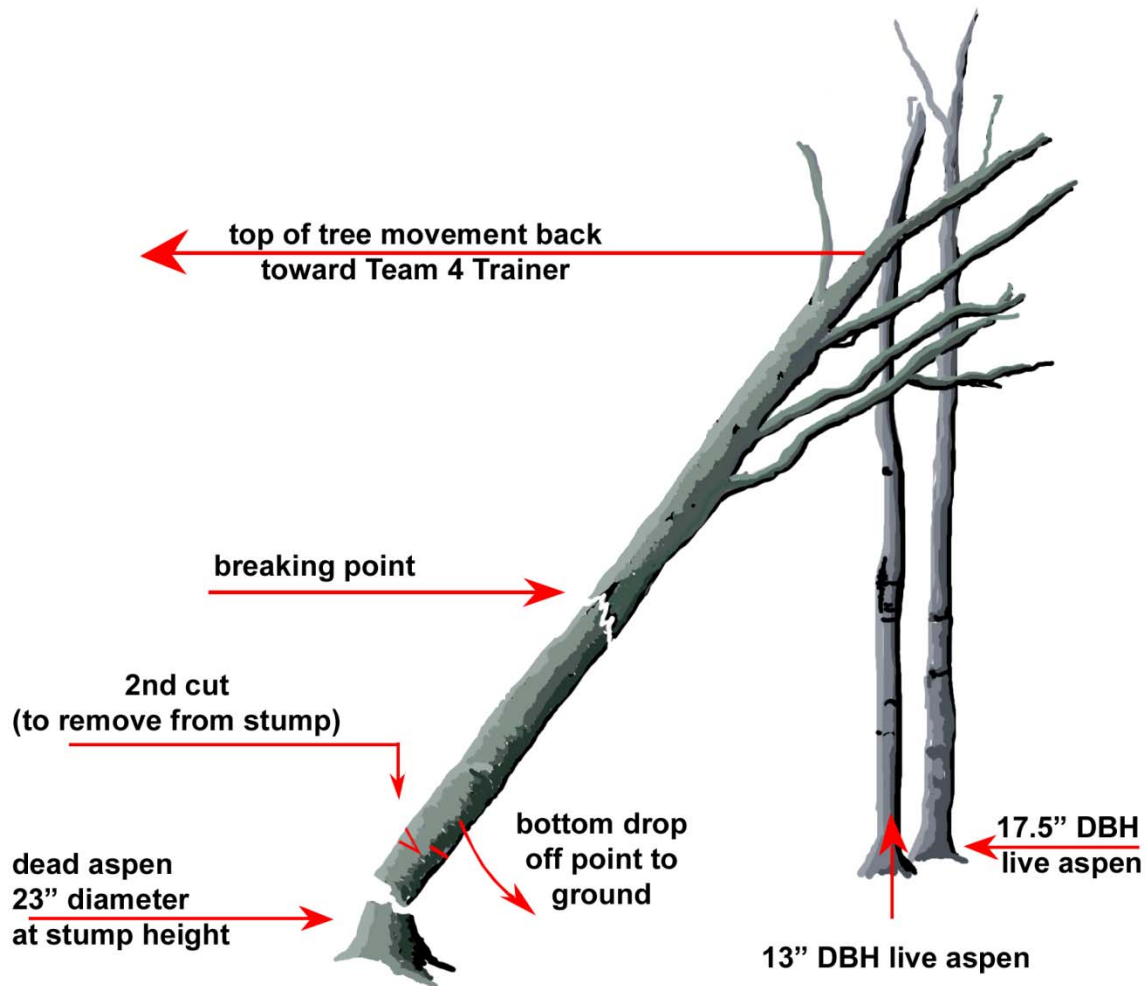
Figure 4: Profile of cutting area showing action of broken top during second cut by Team 4 Trainer

After the notch face cut was completed, Team 4 Trainer initiated a tension release cut by utilizing the top of the saw bar and coming up from the bottom towards the previous cut. The tension release cut was approximately 3 inches above the flat cut on the notch face cut (see Figure 3). This action caused the tree to fall off the stump and simultaneously caused the portion between the original cut and the tension release cuts to split in two and be pushed out to the cutter side. When the tree fell off the stump and came into contact with the ground, the force was great enough to cause the tree trunk to break into two pieces approximately 20 feet up from the second cut (see Figure 4).

The lower portion of the dead aspen measured 20 feet, 4 inches long; and the upper portion measured 37 feet, 8 inches long. The remaining length of the tree consisted of broken limbs and the stump.

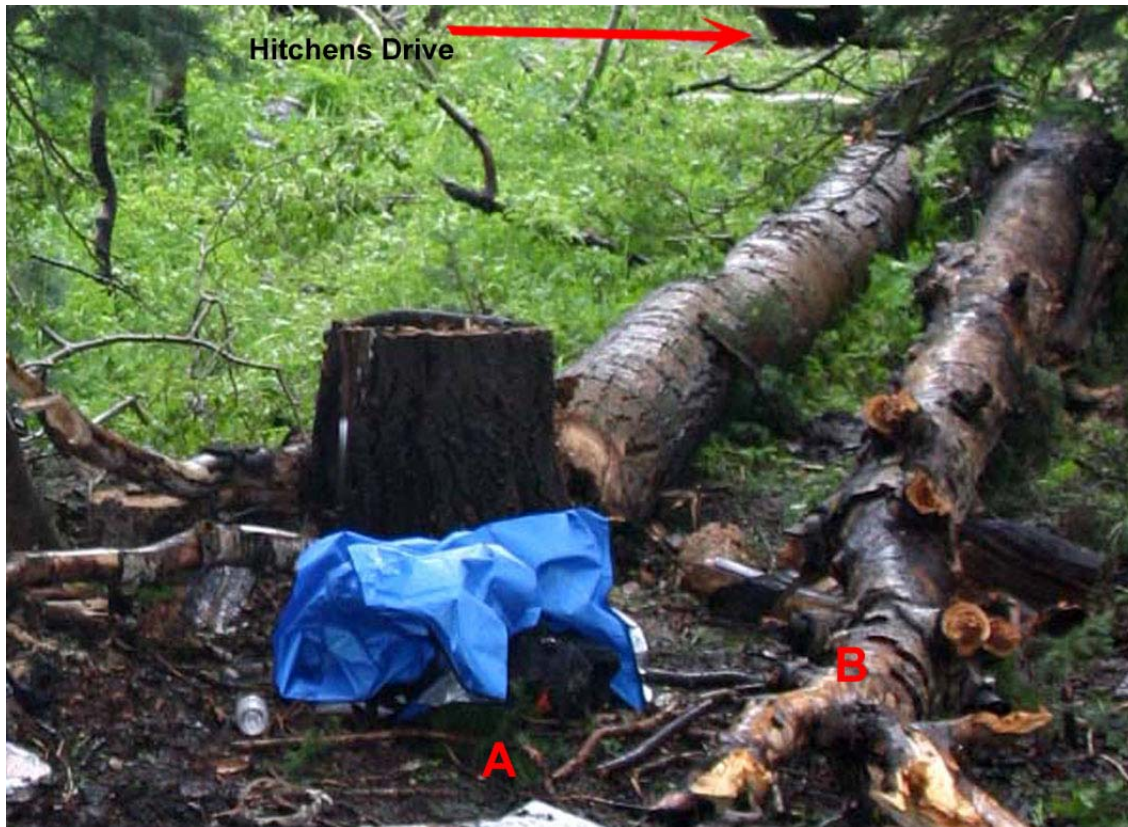
Photo A1: This photo shows the location of Team 4 Trainer and the top portion of the tree.

Point A indicates the location of Team 4 Trainer when he was struck.
Point B indicates top portion of the tree (7 ½ - 8 inches diameter) that struck Team 4 Trainer. The tree was moved to this location in order to provide medical assistance to the victim.

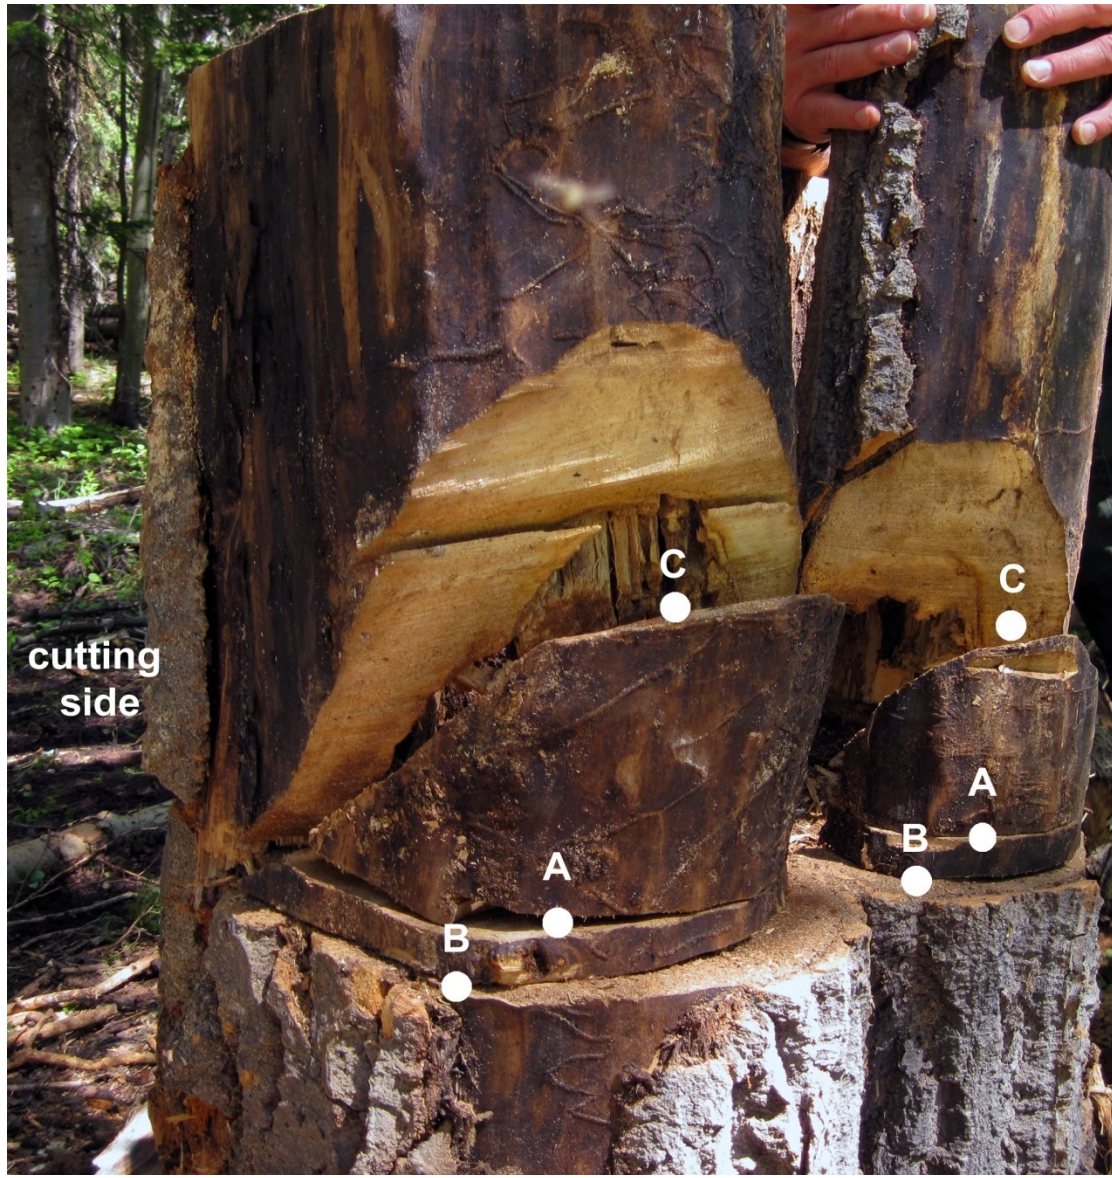
Photo B1: This photo is a reconstruction of cuts performed in the felling operation.

Point A shows the original horizontal cut made by Team 4 Trainee #2.

Point B shows the horizontal cut made by Team 4 Trainer.

Point C shows the downward diagonal cut made by Team 4 Trainer.

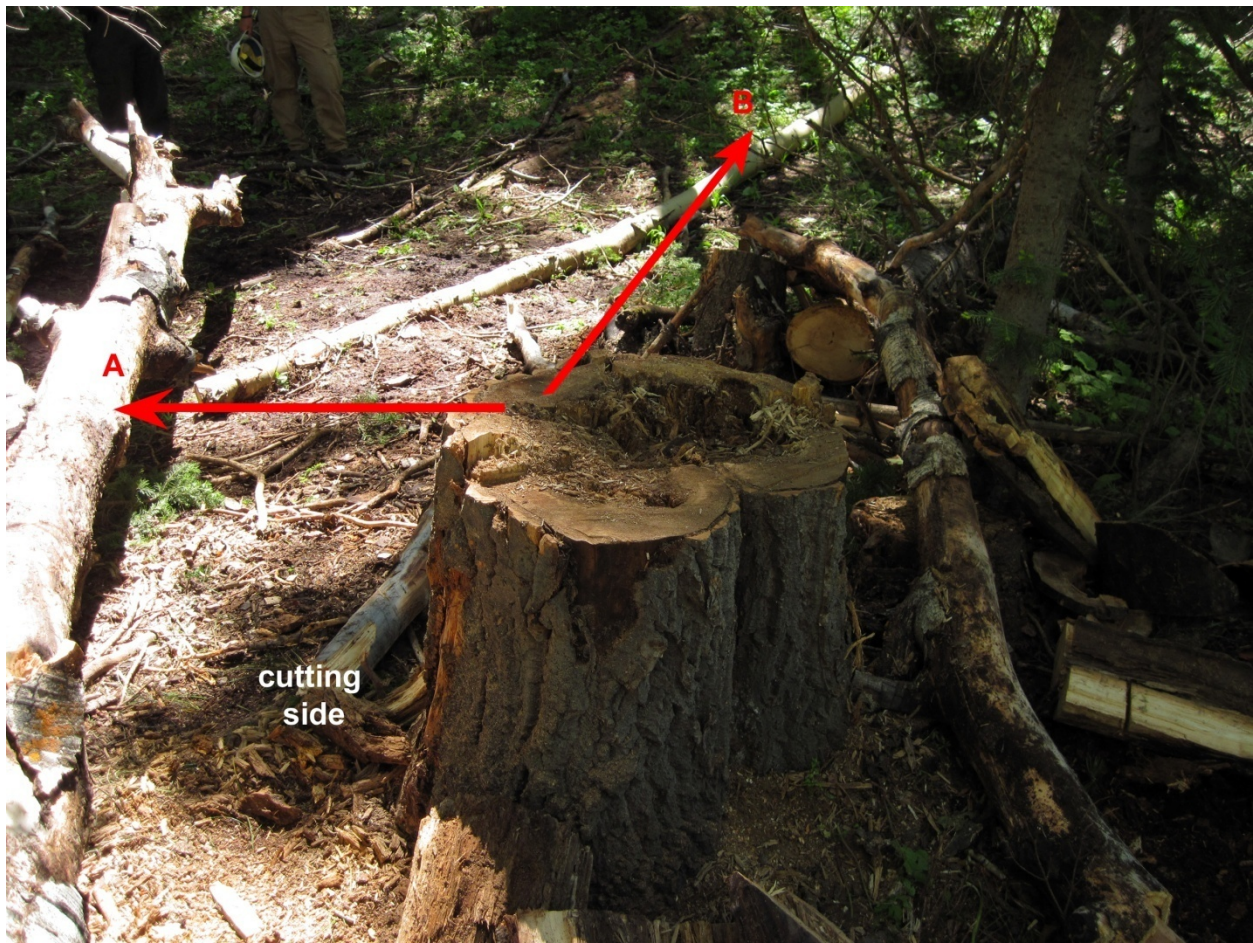
Photo B2: This photo illustrates the designated escape routes established at the start of the felling operations. Point A shows route on the cutter's side and B shows the route established on the offside.

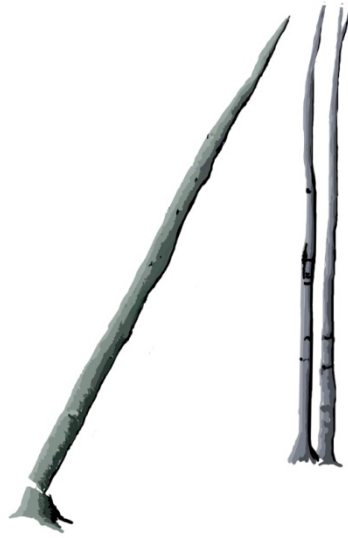
Part One:

Team 4 Trainer finished the back cut and the tree began to fall in the intended direction.

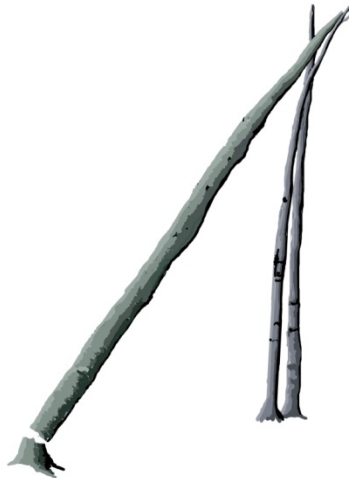
Part Two:

While falling, the tree hung up in a live aspen. The live aspen was pushed and bent approximately 5 to 6 feet by the weight and pressure until it came into contact with another live tree of the same approximate size. Team 4 Trainer cut through the remaining holding wood on the off side in an attempt to free the tree. The attempt was unsuccessful.

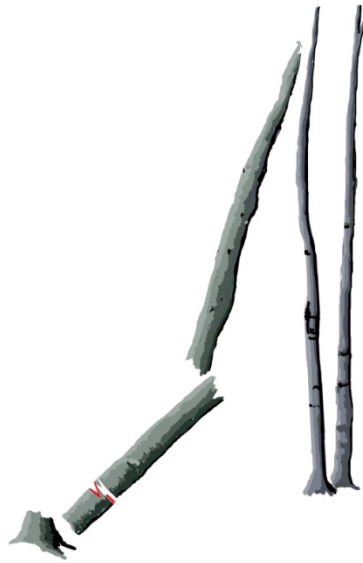
Part Three:

Team 4 Trainer moved 2 to 3 feet forward of the stump and began a second cut with the intent to relieve the pressure on the leaning tree and bring it to the ground. As he completed the second cut, the tree came off the stump and the trunk broke into two separate pieces in addition to the butt piece.

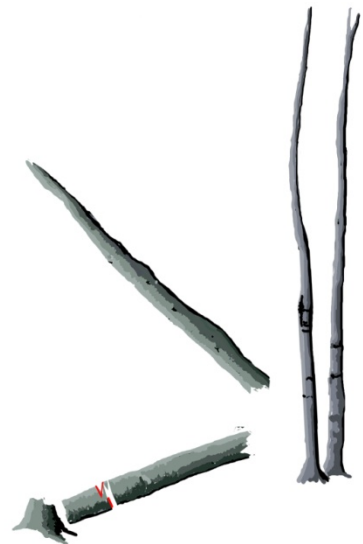
Part Four:

The butt section broke and was forced out the cutter side. The lower or bottom part of the tree fell to the ground in the expected direction. The upper piece, however, was catapulted by the pressure of the bent live aspen, back toward where Team 4 Trainer was located.

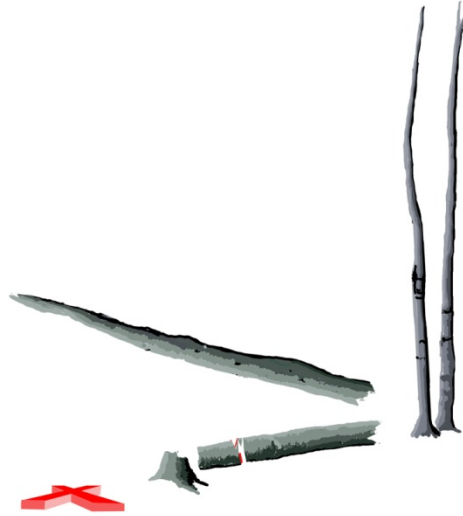
Part Five:

The top section of the tree fell at an angle towards the cutter. The bottom of this piece hit the ground and impaled itself with the upper part continuing to fall toward the Team 4 Trainer's location.

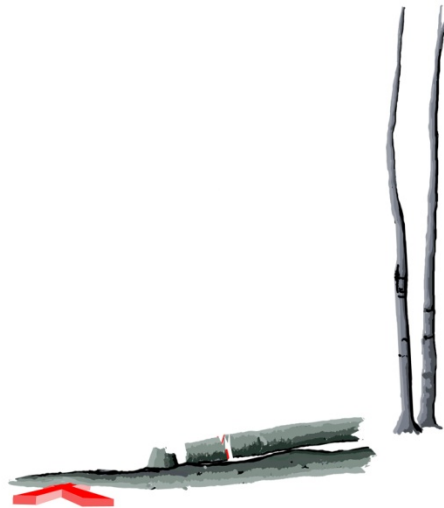
Part Six:

The upper portion of the tree strikes Team 4 Trainer in the back of the head and back, driving him to the ground, and coming to rest on top of him.

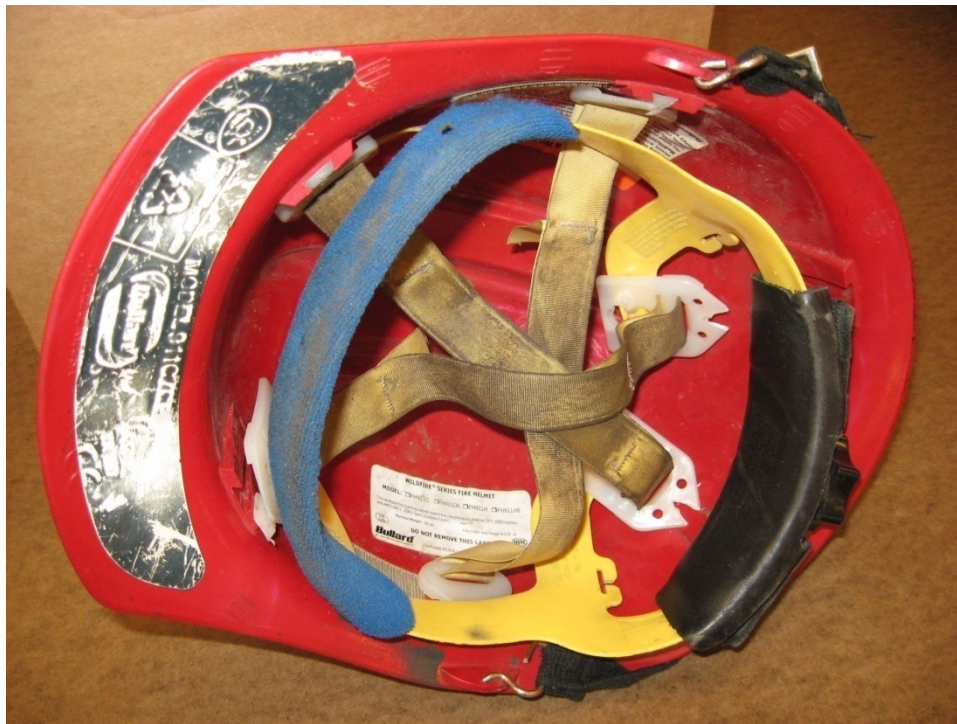
The only observed damage to the suspension system was to both of the rear attachment keys which were broken off of the suspension (Figure 2). The four remaining attachment keys appeared undamaged and functioned properly to attach the suspension to the shell.

Figure 2 – Condition of inside of hardhat

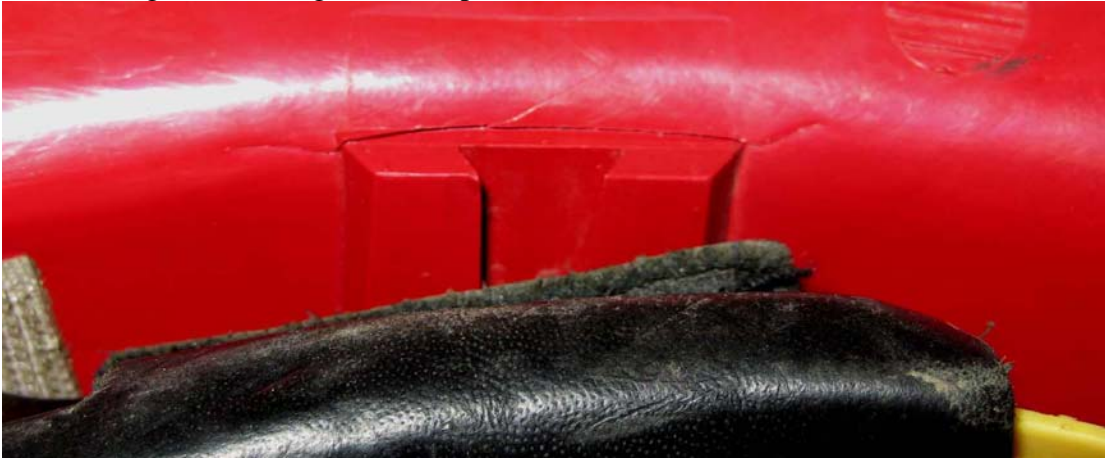
A visual inspection of the hardhat shell revealed only one area of damage. There was a 1-1/2 inch long crack in the shell in the area of the right rear suspension key slot (Figure 3). This crack went through the full thickness of the shell material. Aside from this crack, the shell showed no visual effect of the impact sustained. In overall appearance the hardhat was in good condition with a normal amount of light scuffing and scratching as expected with use. There were no obvious misshapen or deformed areas.

Figure 3 – Damage to shell, right rear suspension attachment area
