## 7F/9F EXHAUST FRAME AND DIFFUSER ASSEMBLY

g  
F/FA INSPECTION LIMITS MANUAL

Exhaust Diffuser

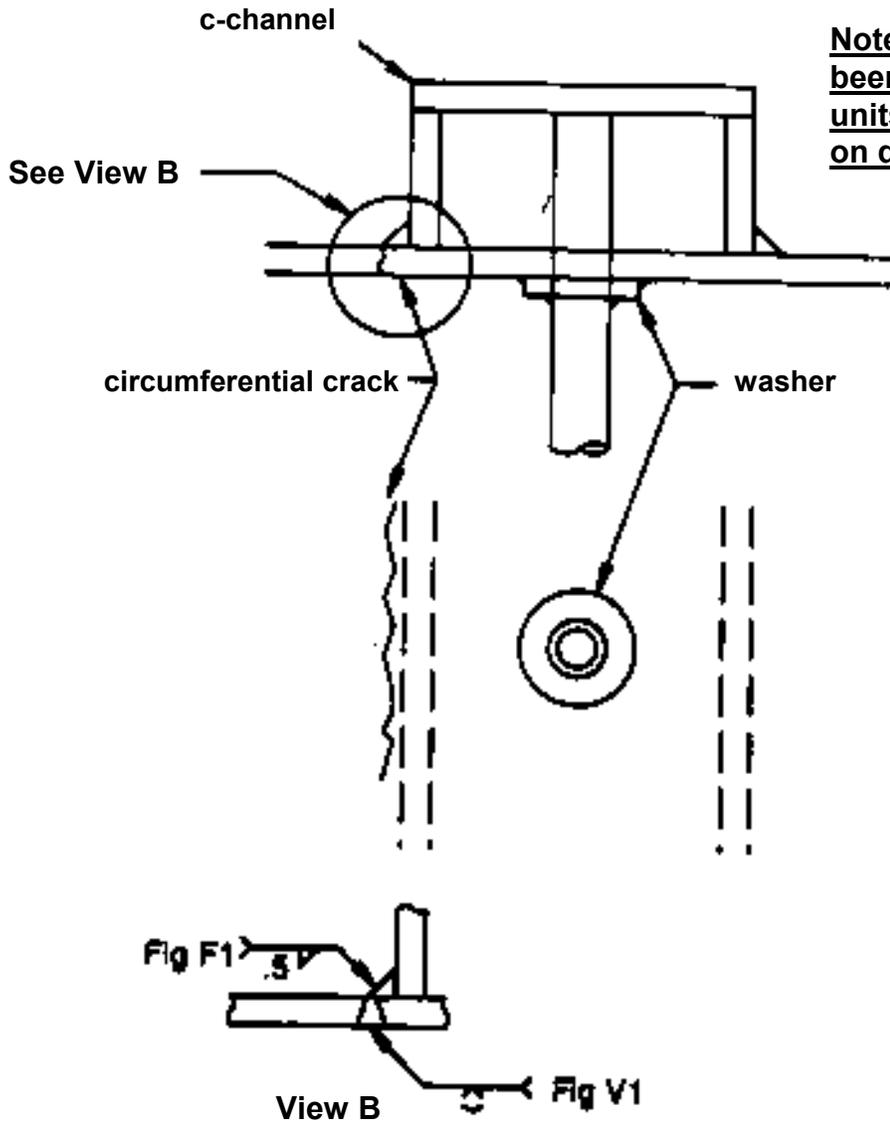
**Circumferential Cracking at Stiffening Rings or Flanges**

**Note: C-channel has been removed on some units to alleviate stress on diffuser.**

Weld repair can be performed at any outage opportunity regardless of crack length.

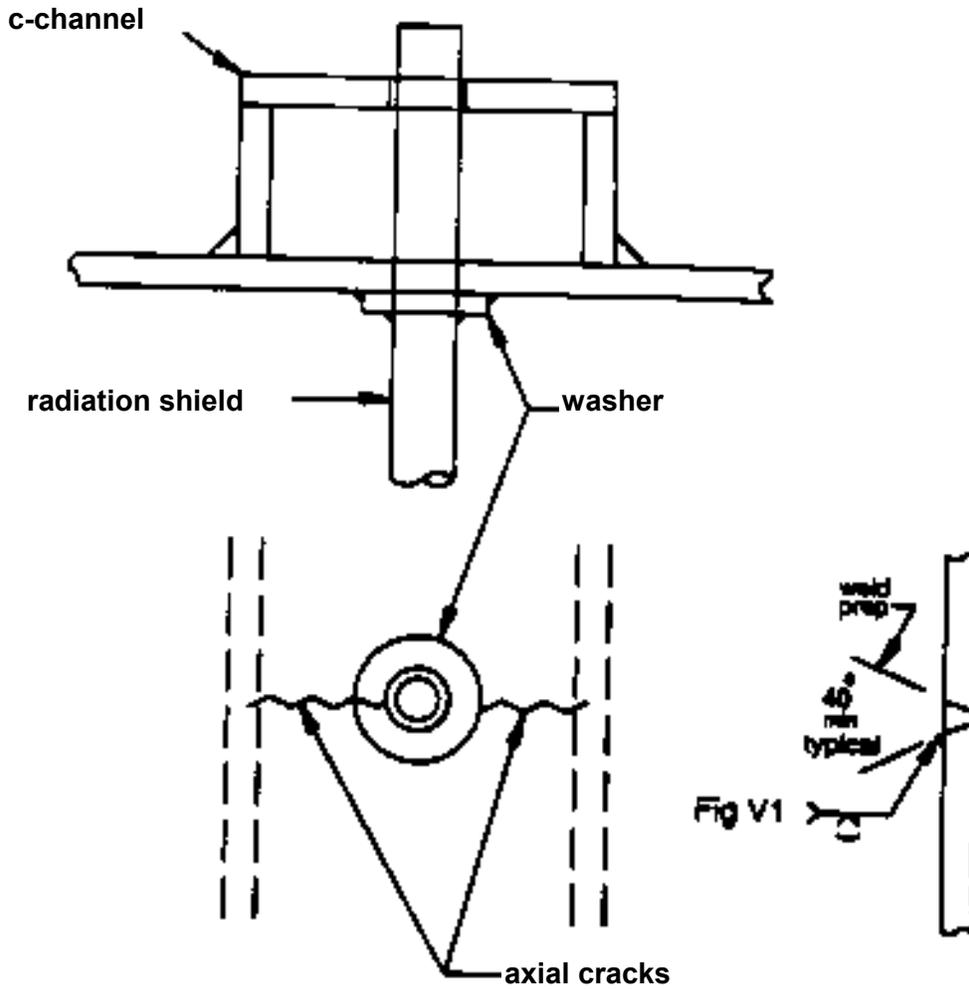
**Radiation Shield Weld Cracks**

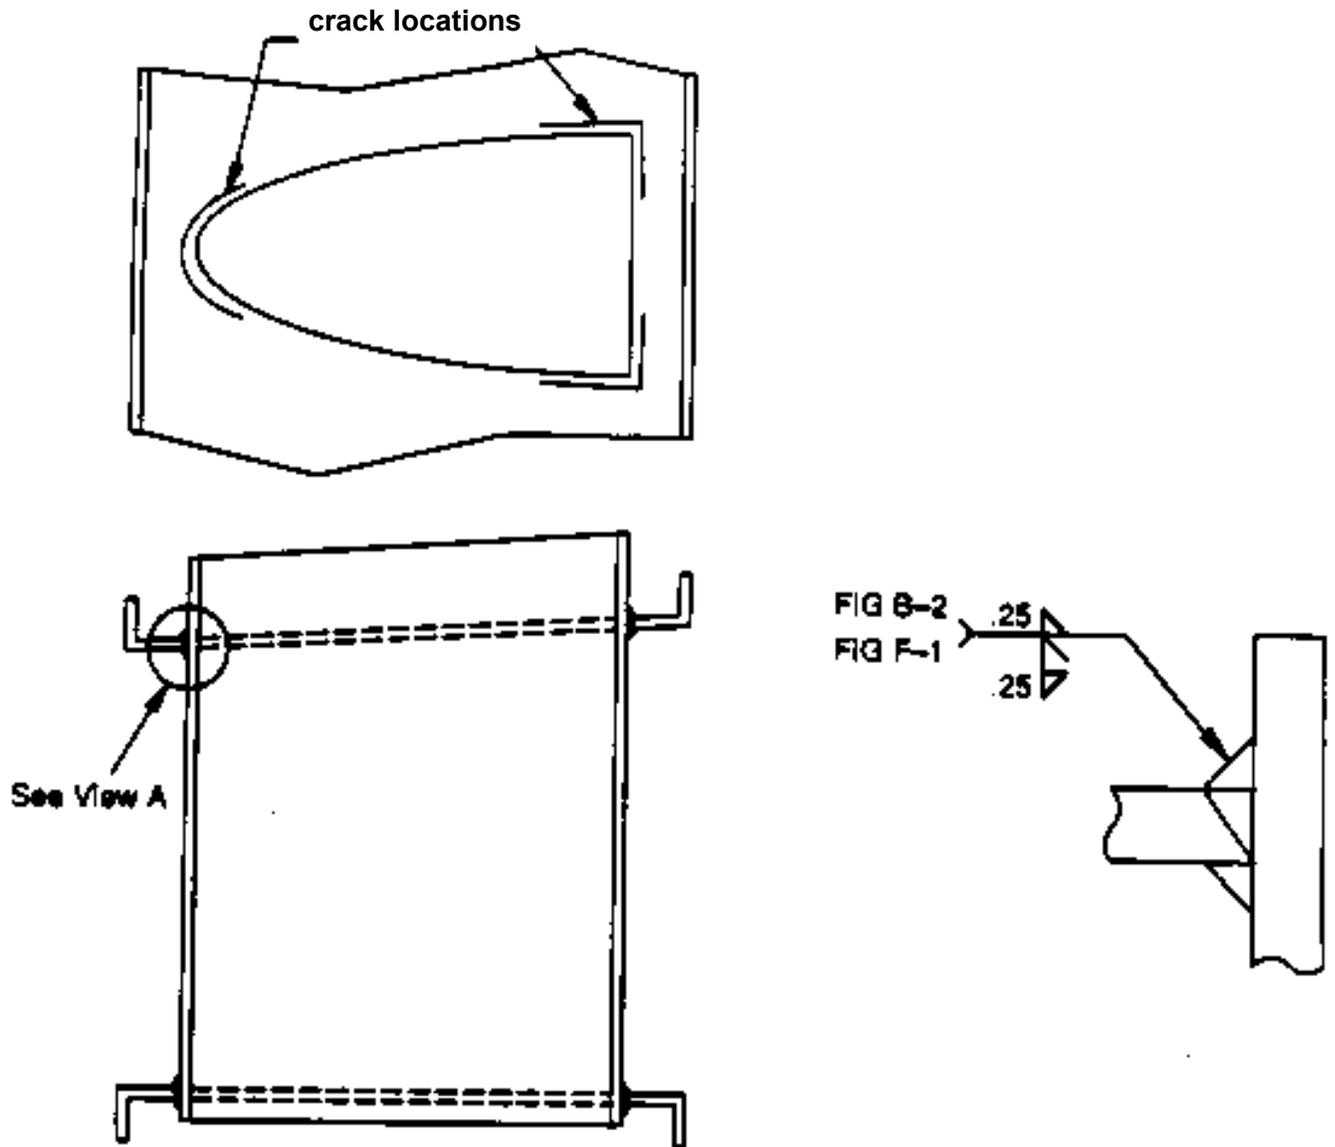
Manway Weld Crack

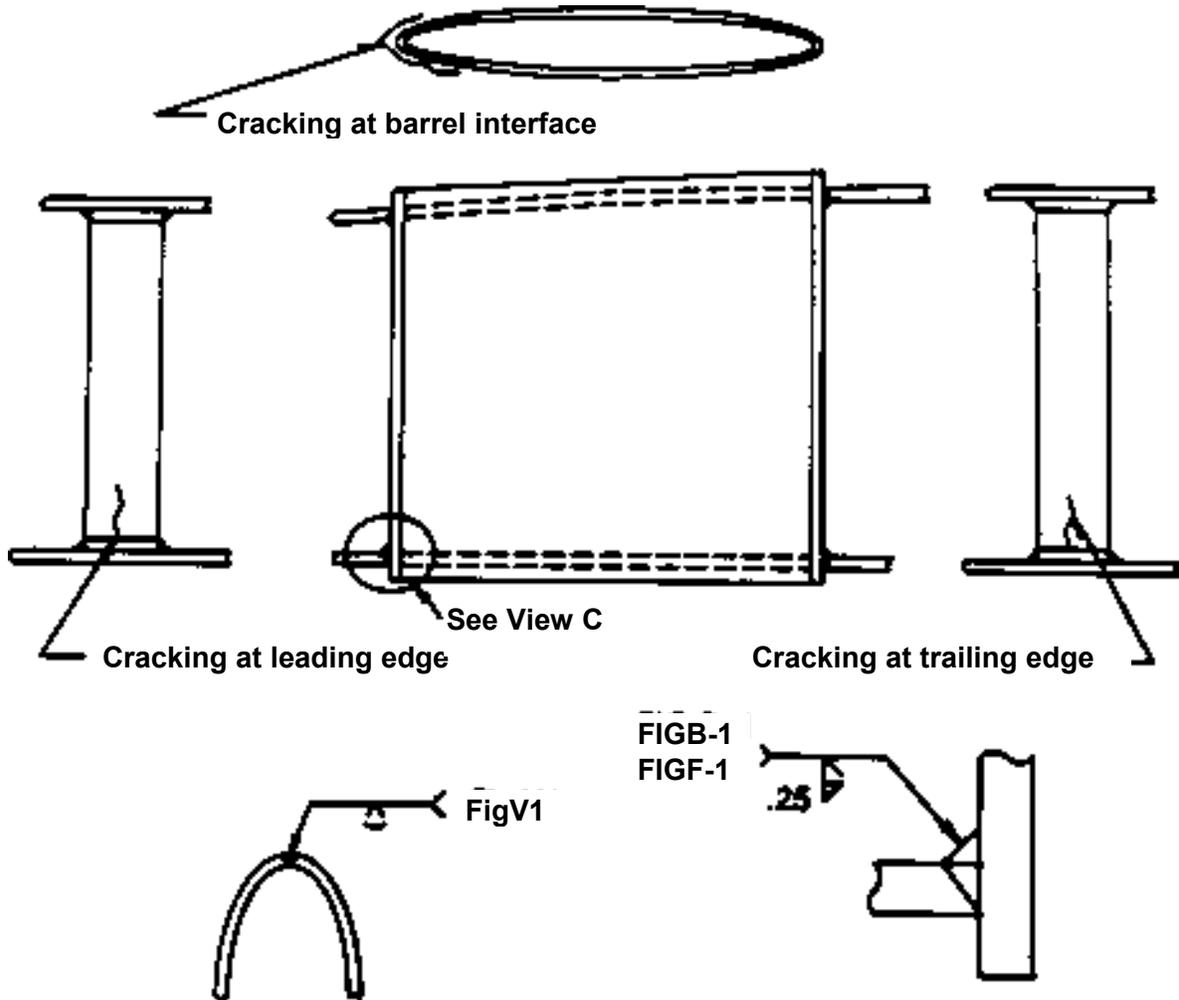
**Fwd Diffuser Airfoil Cracking**

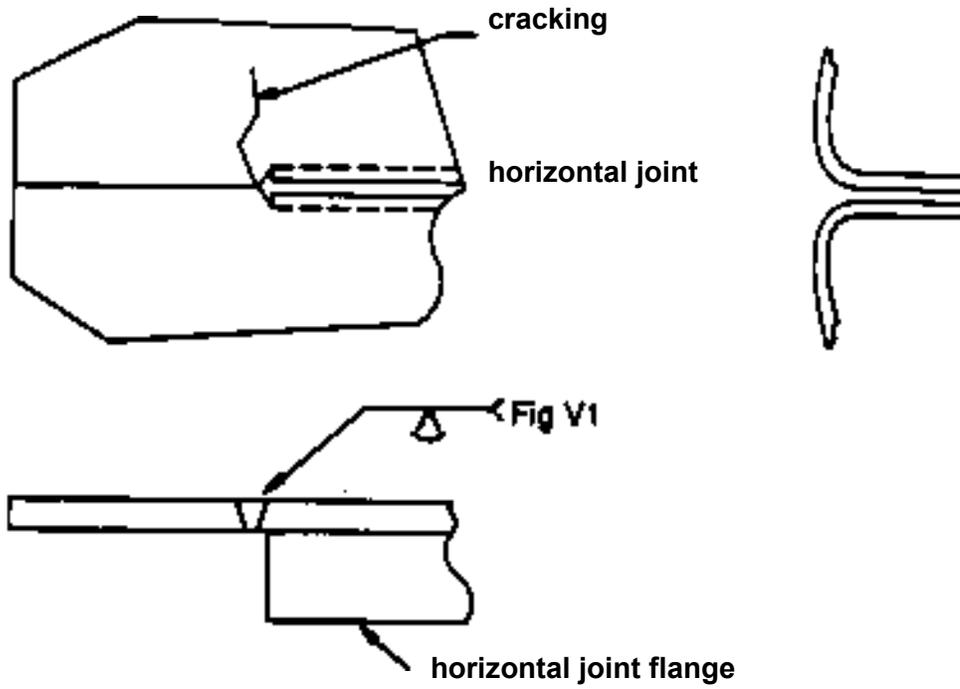
**Fwd Diffuser Horizontal Joint Cracking**

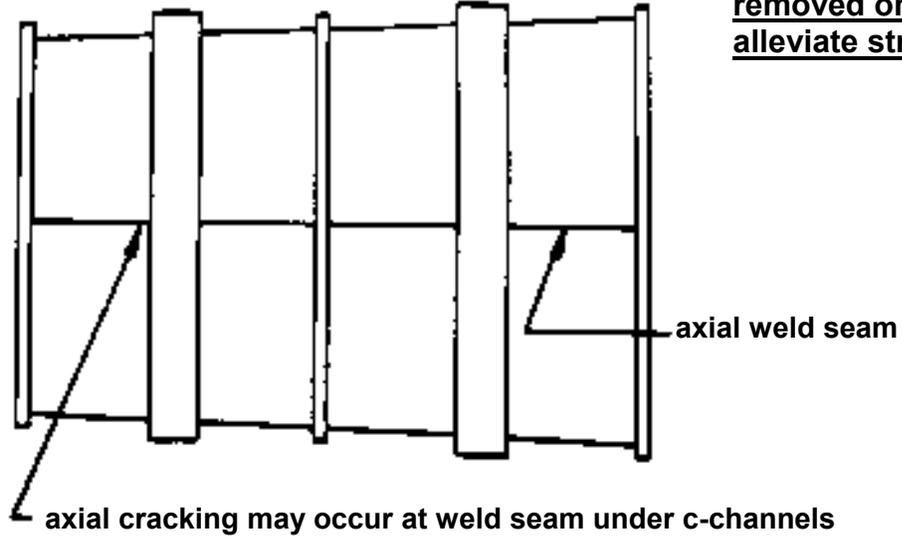
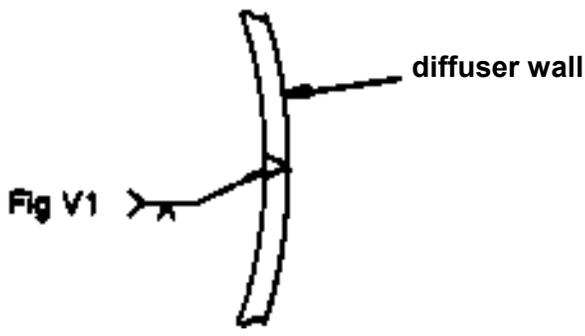
**Aft Diffuser Axial Cracking in Outer Barrel**

**Note: CChannels have been removed on some units to alleviate stress on diffuser**

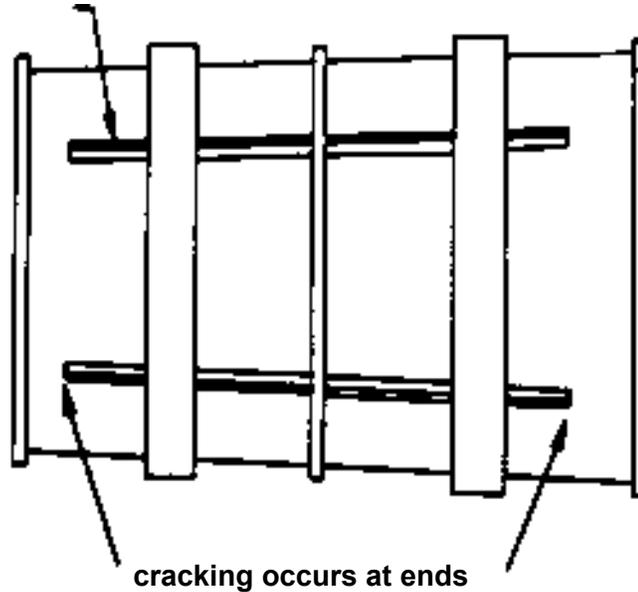
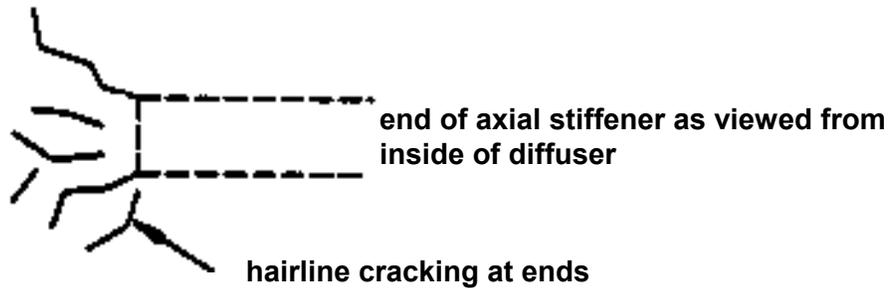
**Aft Diffuser Cracking at Axial Stiffener Ends**

**Note** Axial stiffeners have been removed on some units to alleviate stress on diffuser.

These cracks tend to stop growing and may not require repair. If any crack exceeds 4 inches in length or if several cracks appear to be connecting in such a manner as to possibly allow a panel segment to come out, then the cracks should be ground out and welded with a full penetration groove weld.

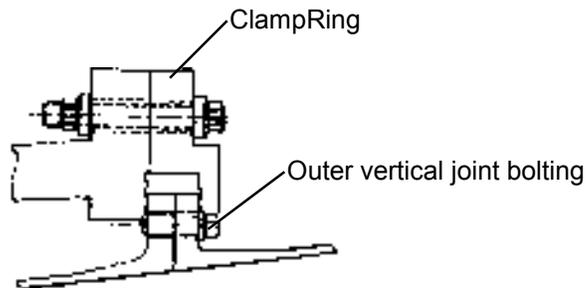
Units in the field have experienced a condition where the forward to aft outer vertical joint bolting loosen and back out. It is believed this condition resulted from the bolts losing tension due to effects of operational heat treatment and subsequent loss of tension. If this condition exists, a higher temperature bolt is currently used. In some cases washers have been added to increase the clamping force and anti-rotation locktabs have been used.

#### 1. Original Design

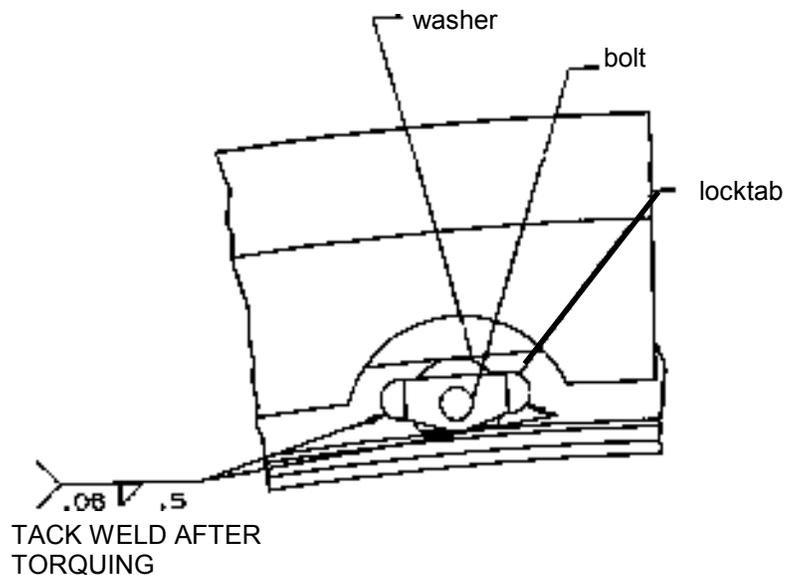
#### 2. With washer, longer bolt, and anti-rotation clip.

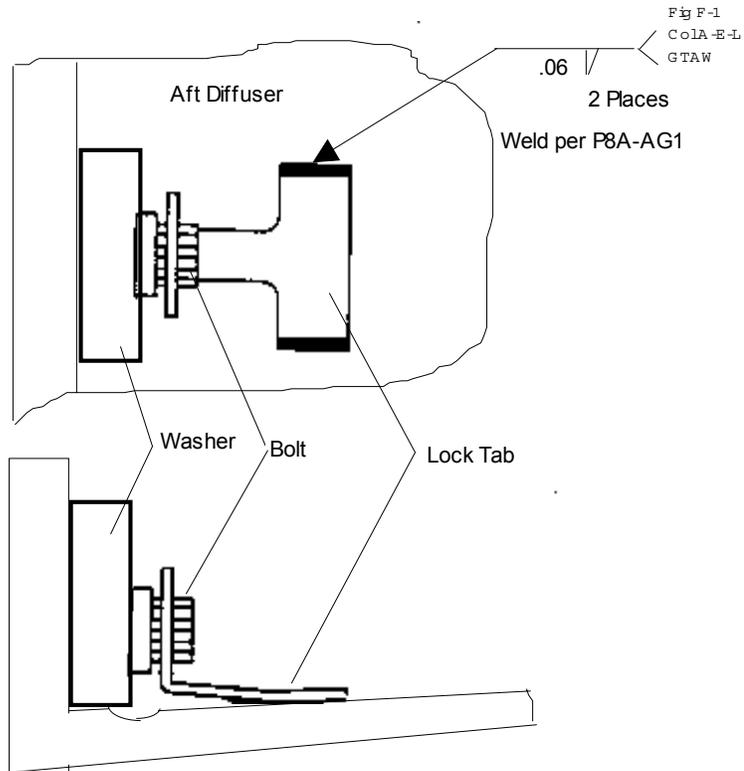
3. With washer, longer bolt, and redesign anti-rotation clip. (Current Design)

It should be realized that with the locktabs installed, during the scheduled major Inspection, new loacktabs will have to be installed and welded.

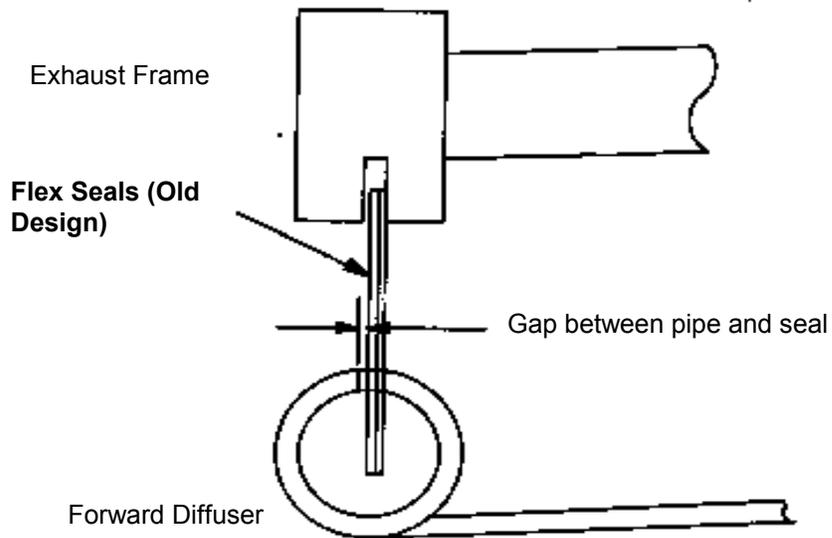
Figure 27-1. Original Flex Seal Design

A problem known as “shingling” has occurred on some units with original design flex seals as installed on early 7F/FA Units. “Shingling” is when the flex seal segments slide past each other and create openings to the cooling circuit. A new flex seal design is now used that has tabs at the end of each seal segment to prevent this “shingling” condition. The preferred field fix for “shingling” is to replace the old style flex seals with the new seal design. This requires removal of the upper half of the Exhaust Frame which would only be an option during a major outage. Two field fix options are also presently used. One which can be performed with the upper half of the turbine case removed and a second approach which is installed from the flow path of the exhaust frame with no unit disassembly. Contact your GE representative for information.

If “shingling” occurs on old design seals, the following are current recommended replacement parts:
