Air Extraction Valve (VA2) Seating Position Adjustment Procedure

VA2 valve assemblies may fail to open in 11 seconds, causing the turbine to trip. This procedure is a preventative measure to reduce the likelihood of this occurring, and should be performed on all four bleed valves, even if they have not caused a trip on the unit. If the travel stop has been previously adjusted from its original calibration point, or if the end of the bolt is stamped with a 2, this procedure may not be appropriate. You can visually check to see if the stop bolt has been previously adjusted as indicated in step 1 of the procedure below. If it appears that a previous adjustment has been made, please contact AC Controls' Chuck Andrews at (704) 545-4500 for recommendations on how to proceed. If the bolt is stamped with a "2", this procedure has already been completed and no action is needed.

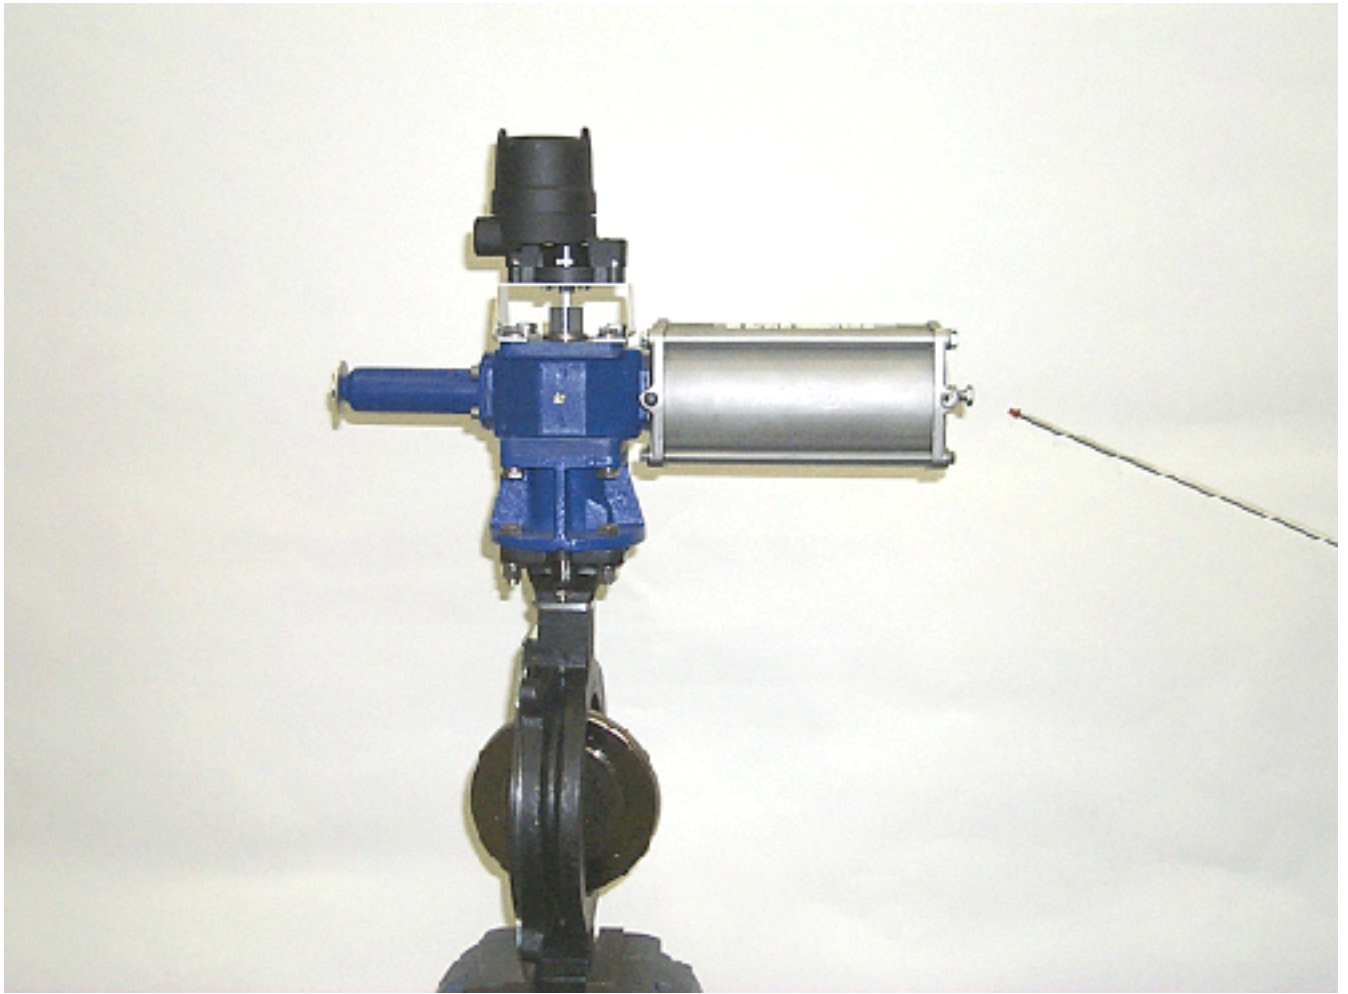
Figure 1.

2. Locate the "closed" travel stop bolt. (See Figure 1) The "closed" travel stop bolt was originally marked with either "anti-sabotage inspectors lacquer", as shown in Figure 2, or wired, as shown in Figure 3. Check to see whether these appear to still be at their factory setting or not. If not please contact AC Controls' Chuck Andrews at (704) 545-4500 for recommendations on how to proceed. Examples of previous adjustment would be a break in the Lacquer or twisting of the wire. If it appears the unit is still at its original setting and the unit was wired, cut the wire loose with a pair of wire cutters and discard. There is no need to replace this wire after completion of this procedure.
