General Electric LM2500 Gas Turbine

LM2500 SAC Borescope Inspection UNIT TM40

CUST – DOWANS

ENGINE SERIAL NUMBER:
481-364

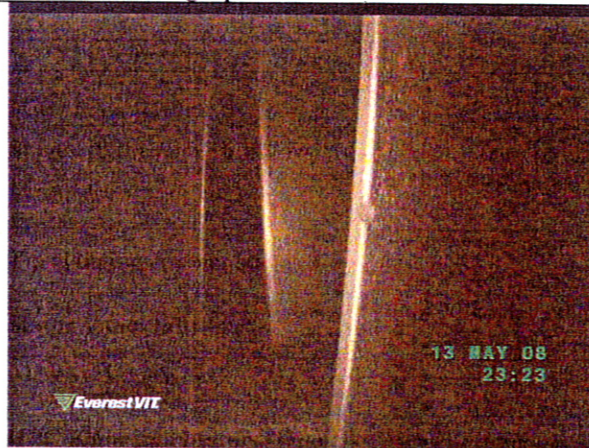
Component	Condition
Stages 1 through 9 Blades	<ul style="list-style-type: none"> Stage 3 blades minor FOD/nicks x 3 blades-acceptable Stage 4 blades minor FOD/nicks x 3 blades-acceptable Stage 9 blades minor FOD/nicks x 2 blades-acceptable Acceptable in accordance with GEK 97310 Vol. 1 table 5-4.

Stg 4 blade damage

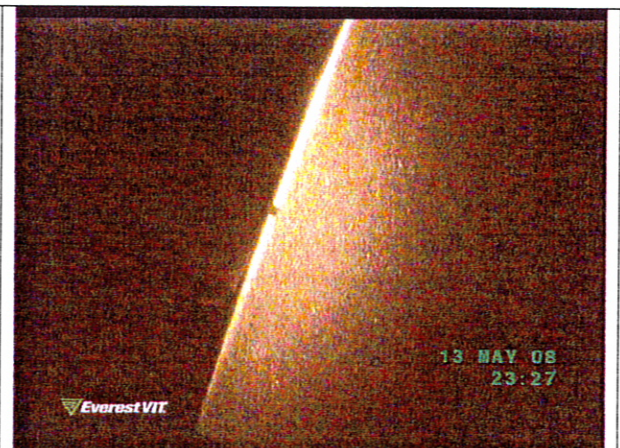
Stg 3 blade damage

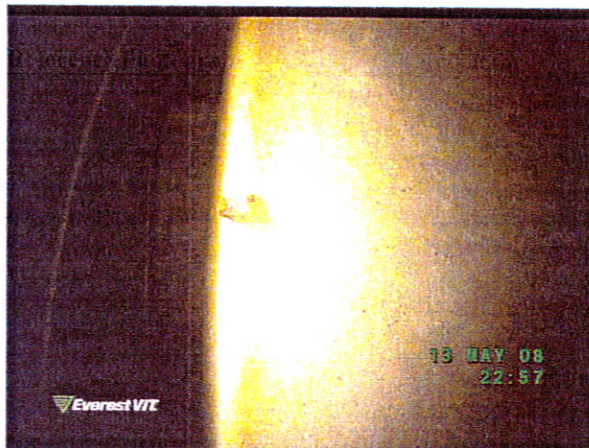
Stg 9 blade damage

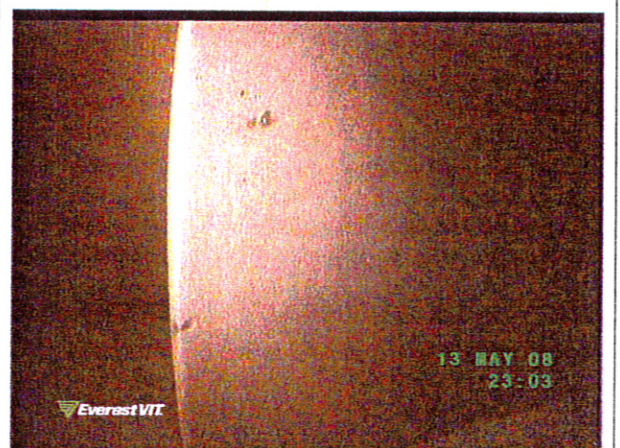
Stg 9 blade damage

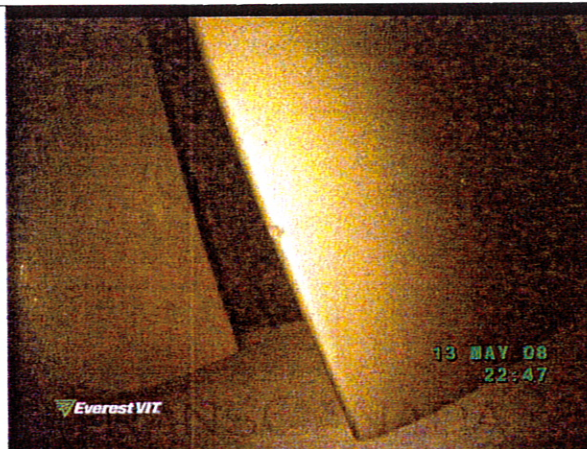
Stages 10 through 16 Blades	<ul style="list-style-type: none"> • Stage 10 blades minor FOD/nicks x 6 blades-acceptable • Stage 15 blades minor FOD/nicks x 2 blades-acceptable • Stage 16 blades, no defects found • Acceptable in accordance with GEK 97310 Vol. 1 table 5-4
Tip clanging contact stages 3-6	<ul style="list-style-type: none"> • No defects found • Acceptable
Stator Vanes (all)	<ul style="list-style-type: none"> • No defects found • Acceptable
All VSV Vanes	<ul style="list-style-type: none"> • No defects found • Acceptable
HPC Rotor and Stator Airflow Path Surfaces	<ul style="list-style-type: none"> • Normal levels of dirt/corrosion present. • Acceptable

Stg 10 blade damage

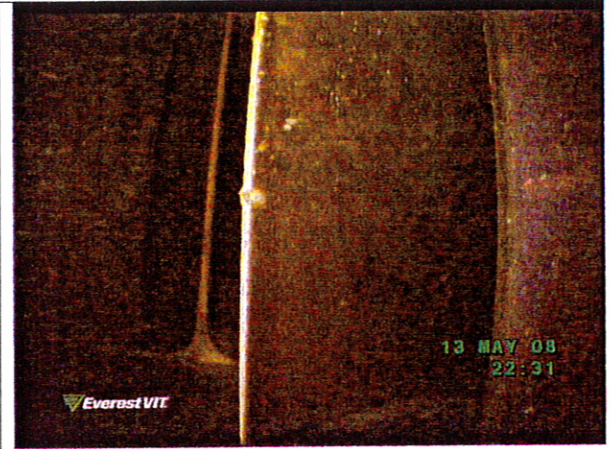
Stg 15 blade damage

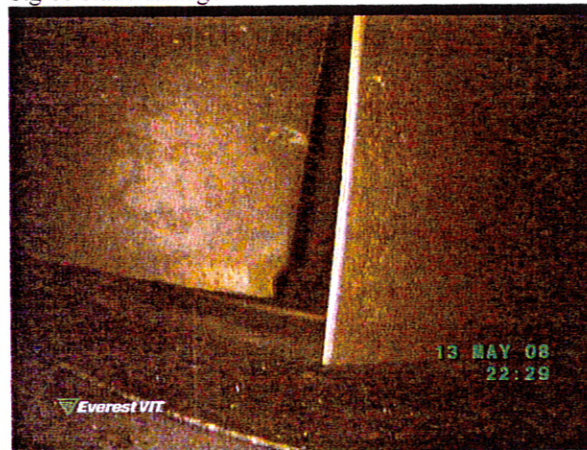
Stg 15 blade damage

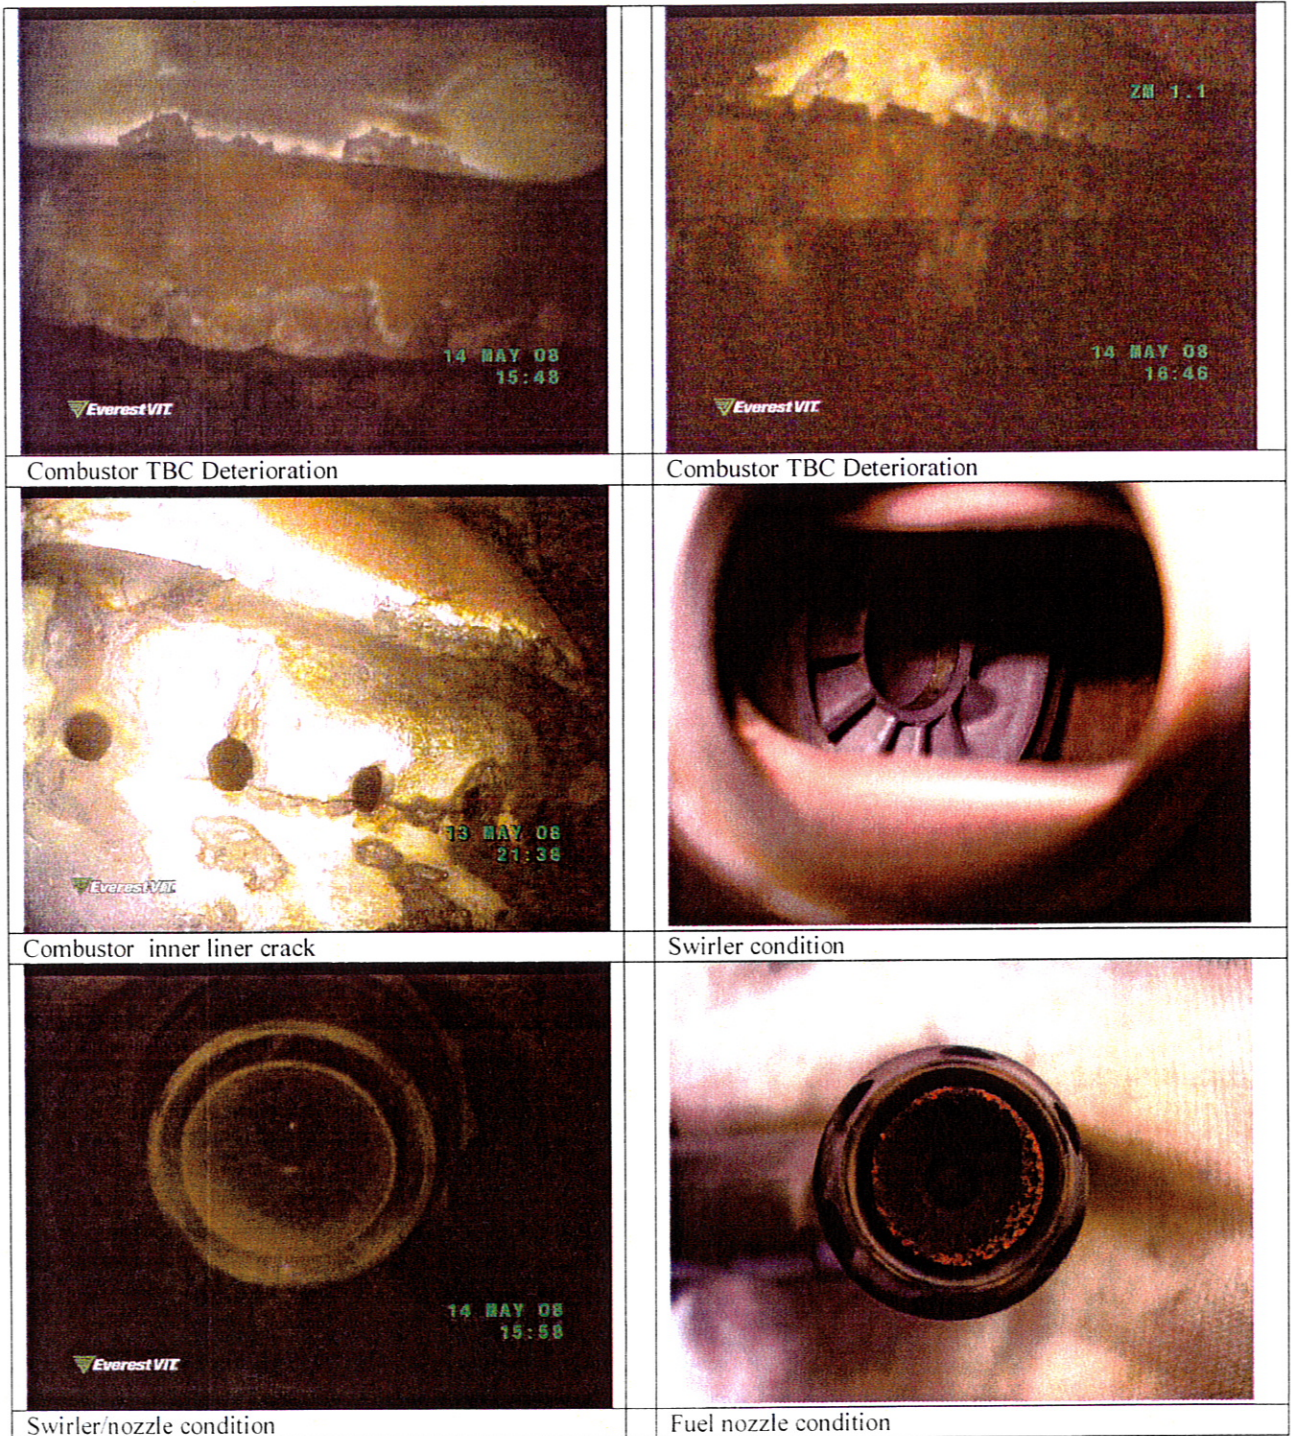
Reference Photographs – Combustor, Pre-mixers

Component	Condition
All Combustor Surfaces	<ul style="list-style-type: none"> General condition acceptable.
Dome Band/Dome Plate	<ul style="list-style-type: none"> Minor thermal barrier coating loss/degradation-acceptable
Riveted Joints	<ul style="list-style-type: none"> No defects found
Trumpet and swirler cups	<ul style="list-style-type: none"> Minor thermal barrier coating loss/degradation-acceptable.
Dome Assembly	<ul style="list-style-type: none"> No defects found
Igniter Ferrule	<ul style="list-style-type: none"> No defects found
Combustor Cowl	<ul style="list-style-type: none"> No defect found
Inner and Outer Liner	<ul style="list-style-type: none"> Circumferential crack found at inner liner (approx 1"), acceptable in accordance with GEK 97310 Vol. 1 Table 5-5 inspection 7.
Fuel nozzle	<ul style="list-style-type: none"> 3 fuel nozzles removed for visual inspection and re - installed, S/N PHCGP878, S/N PHCGP770, S/N PHCGP889. Spray orifices unacceptable for liquid fuel use.

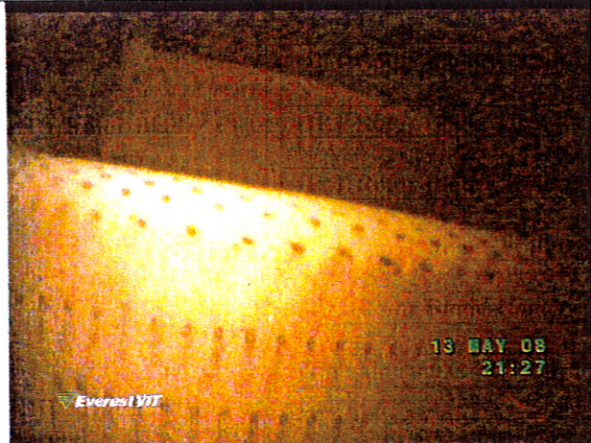
Component	Condition		
	Defect	Location	Findings/GEK limits
HPT Stage 1 Nozzle Assembly	Nozzle airfoil		
	N/A	N/A	No defects found in areas inspected
	Inner and Outer Platform		
	N/A	N/A	No defects found in areas inspected
	General remarks		Condition satisfactory for continued use.
HPT Rotor Blade-Stage 1	Defect	Location	Findings/GEK limits
	HPT Rotor Blades-Leading Edge Area A		
	N/A	N/A	No defects found
	HPT Rotor Blades-Leading Edge Area B

Stg 1 Nozzle condition

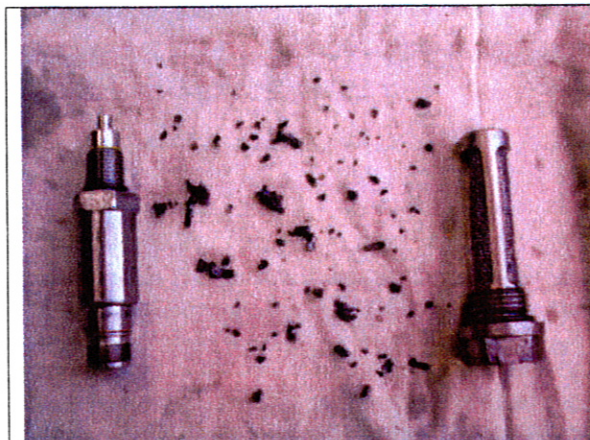
Component	Condition
Lube and Scavenge Pump Inlet Screens Inspection.	<ul style="list-style-type: none"> Plastic type debris found in AGB filter screen Minor plastic debris contamination in A,C and D filter screens B sump screen clear
Gas Turbine External Inspection	<ul style="list-style-type: none"> IGV clevis nut/barrel loose and out of rig – requires calibration to ensure operation within VSV scheduling requirements. Fuel hose, deterioration of outer protective sheath on several hoses – replace at with spares at next outage

L&S filter screen contamination

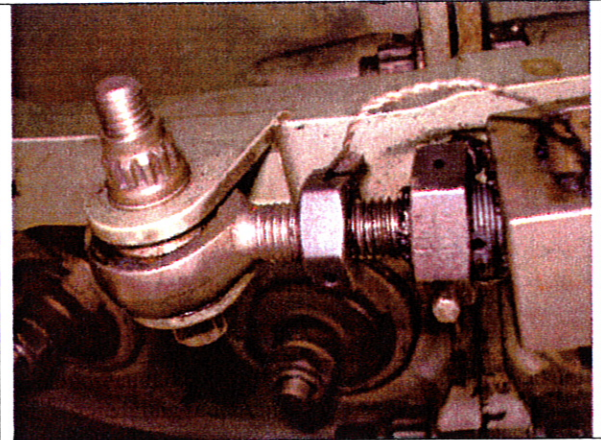
IGV clevis assy loose

- Adjust IGV clevis assy and check rigging IAW GEK 97310 Vol. 2 WP118 00 and WP 206 00 – recommend full system (VIGV – HP6)
- Monitor and replace damaged fuel supply hoses as required to minimize potential leakages
