General Electric LM2500 Gas Turbine

LM2500 SAC Borescope Inspection UNIT TM42

CUST – DOWANS

ENGINE SERIAL NUMBER:
481-757

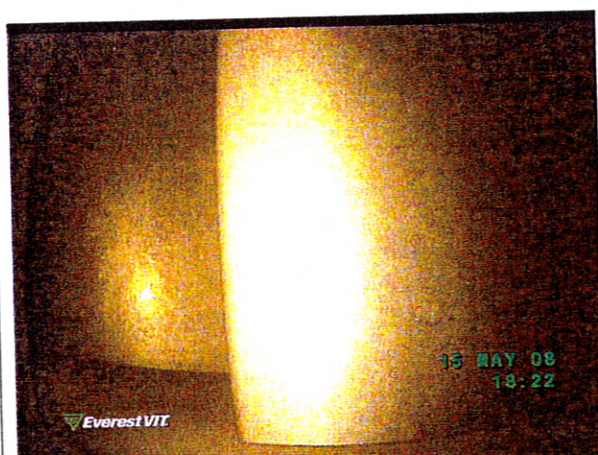
Stg 10 blade condition.

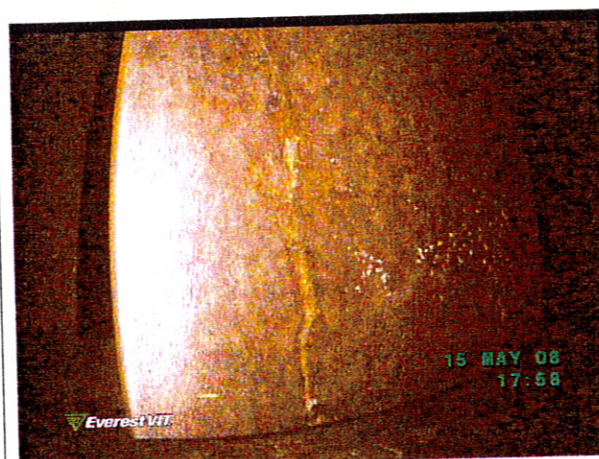
Stg 16 blade condition.

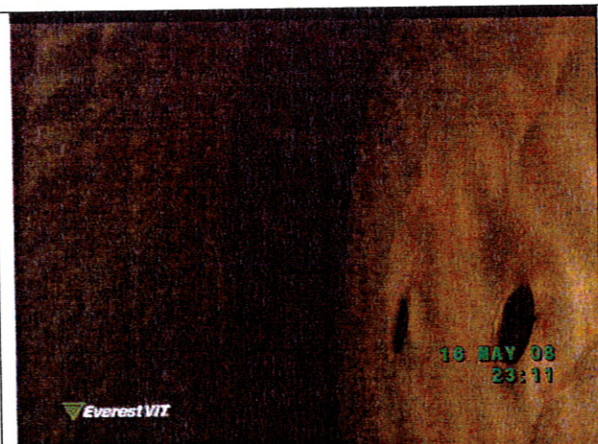
Combustor TBC condition satisfactory.

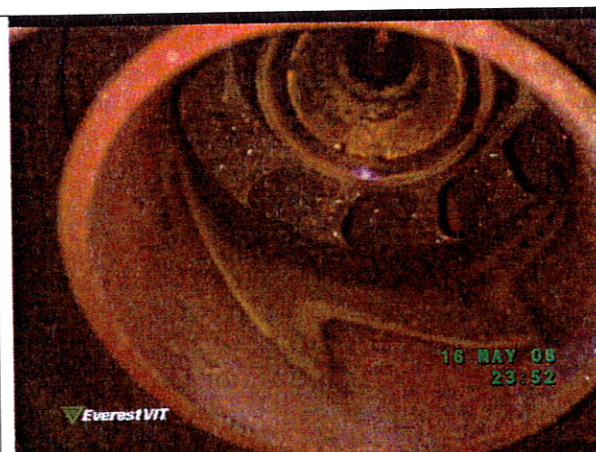
Swirler/nozzle condition.

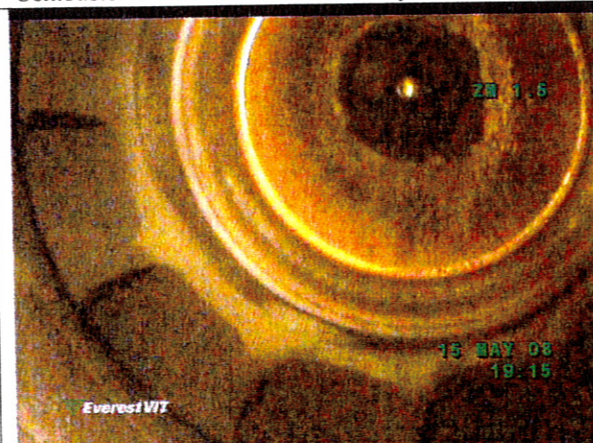
Swirler/nozzle condition.

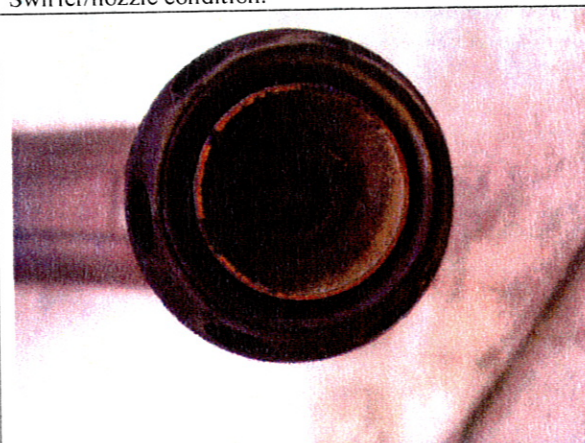
Fuel nozzle condition.

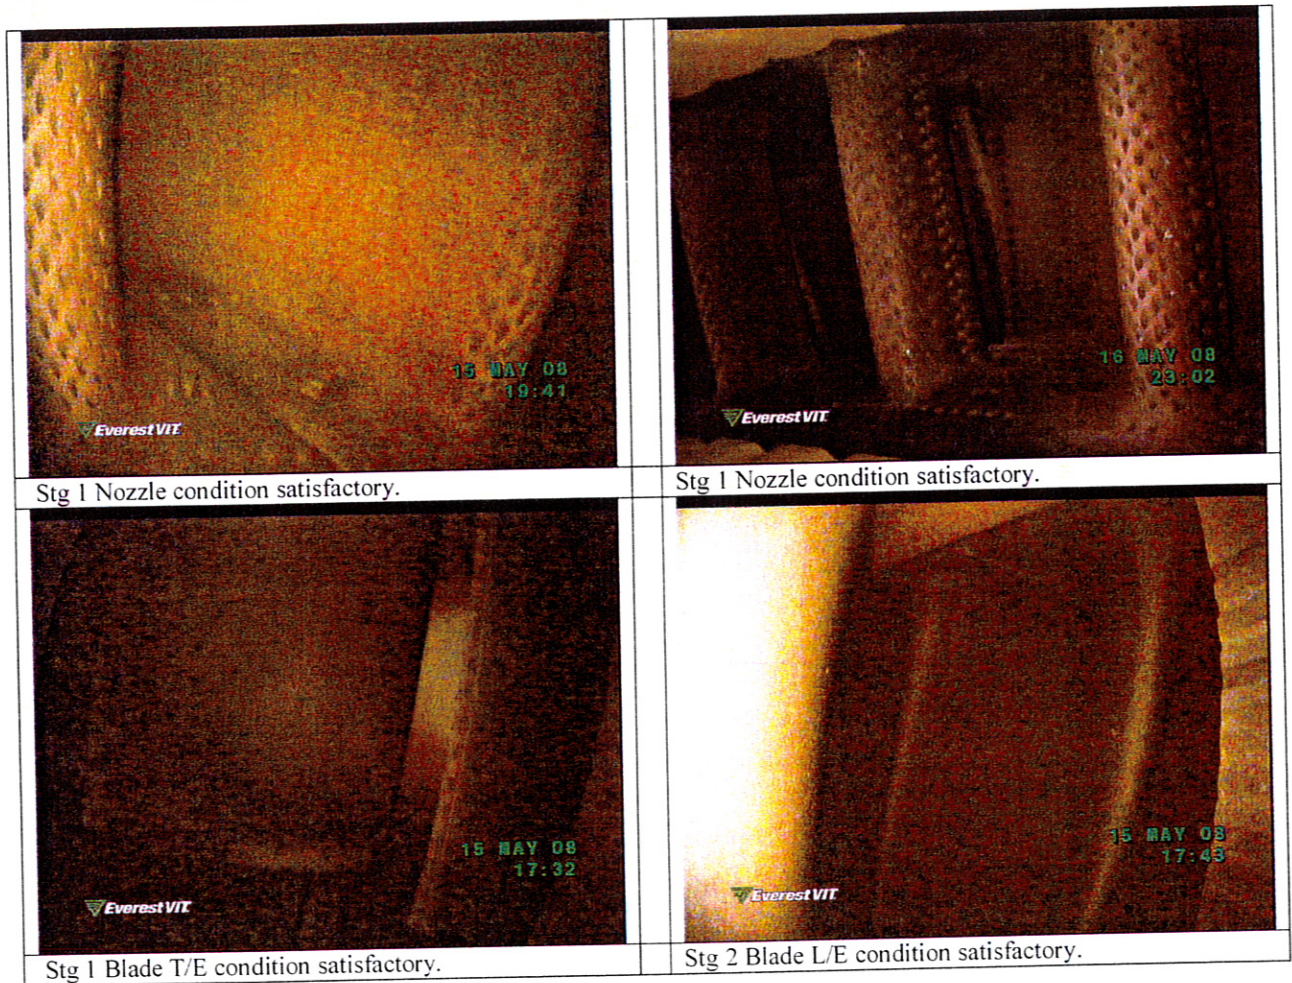
Reference Photographs – HPT assembly

Component	Condition		
HPT Stage 1 Nozzle Assembly	Defect	Location	Findings/GEK limits
	Nozzle airfoil		
	N/A	N/A	No defects found in areas inspected
	Inner and Outer Platform		
	N/A	N/A	No defects found in areas inspected
	General remarks		Condition satisfactory for continued use.
HPT Rotor Blade-Stage 1	Defect	Location	Findings/GEK limits
	HPT Rotor Blades-Leading Edge Area A		
	N/A	N/A	No defects found
	HPT Rotor Blades-Leading Edge Area B		
	N/A	N/A	No defects found
	HPT Rotor Blade Tips		
	N/A	N/A	No defects found
	HPT Rotor Blade-Trailing Edge Area A		
	N/A	N/A	No defects found
	HPT Rotor Blade-Trailing Edge Area B		
	N/A	N/A	No defects found
	HPT Rotor Blade-Concave Surface Area A		
HPT Stages 1 and 2 Nozzle Shroud	N/A	N/A	No defects found
	General remarks		Condition satisfactory for continued use
	Defect	Location	Findings/GEK limits
	N/A	N/A	No defects found in areas inspected
HPT Stage 2 Nozzle Assembly	General remarks		Condition satisfactory for continued use

Defect	Location	Findings/GEK limits
	N/A	N/A	No defects found in areas inspected
	General remarks		Condition satisfactory for continued use
HPT Rotor Blade-Stage 2	Defect	Location	Findings/GEK limits
	HPT Rotor Blades-Leading Edge Area A		
	N/A	N/A	No defects found
	HPT Rotor Blades-Leading Edge Area B		
	N/A	N/A	No defects found
	HPT Rotor Blade Tips		
	N/A	N/A	No defects found
	HPT Rotor Blade-Trailing Edge Area A		
	N/A	N/A	No defects found
	HPT Rotor Blade-Trailing Edge Area B		
	N/A	N/A	No defects found
	HPT Rotor Blade-Concave Surface Area A		
HPT Stage 2 Nozzle Shroud	N/A	N/A	No defects found
	General remarks		Condition satisfactory for continued use.
	Defect	Location	Findings/GEK limits
	N/A	N/A	No defects found in areas inspected
	General remarks		Condition satisfactory for continued use

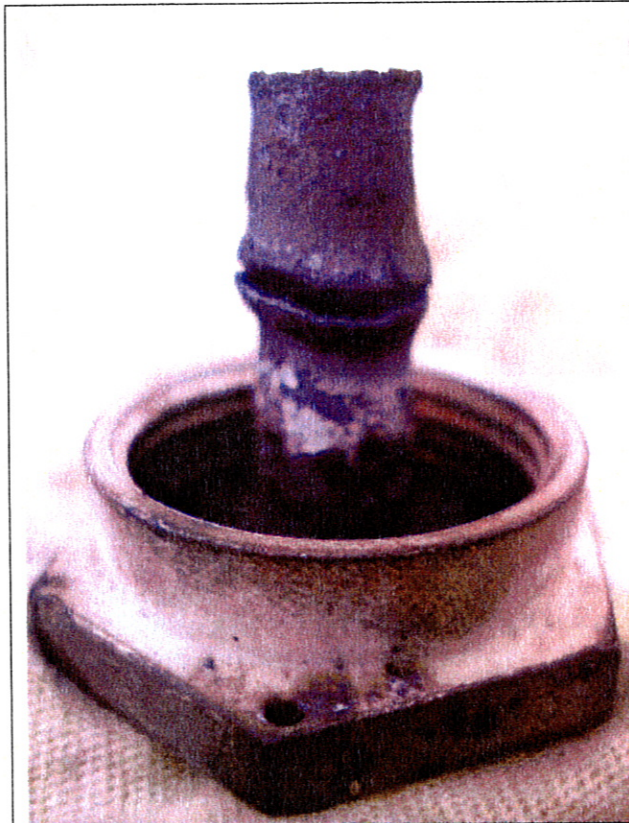
Component	Condition
Lube and Scavenge Pump Inlet Screens Inspection.	<ul style="list-style-type: none"> B sump screen, minor contamination not metallic. AGB screen, minor contamination x 1 metallic shard. Acceptable
Gas Turbine External Inspection.	<ul style="list-style-type: none"> Stud loose x 2 on power turbine stator case. Unable to tighten without risk of damage/shearing stud. Monitor for continued security, acceptable for continued use. Thermocouple found U/S at position 10R. PT54 probe port plug found U/S at position 10M.

U/S PT54 probe port plug.

- Engine condition satisfactory for continued use
- Replace U/S plug, P/N 9103M46P01, Ref GEK50336 Fig 51 item 5 (quote to follow)
- Dowans to replace U/S thermocouple with own stock.

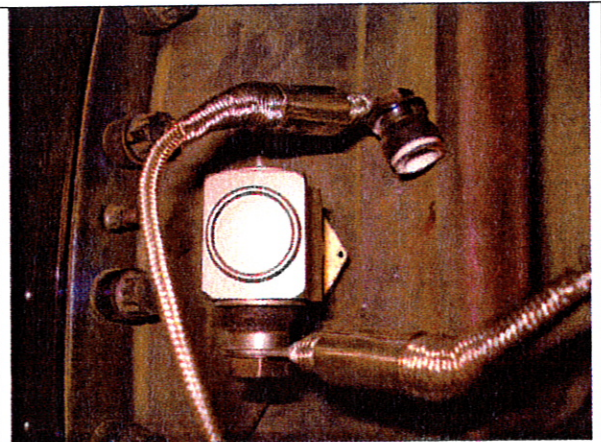
U/S thermocouple.
