LA-13638

A Review of Criticality Accidents

2000 Revision

Issued: May 2000

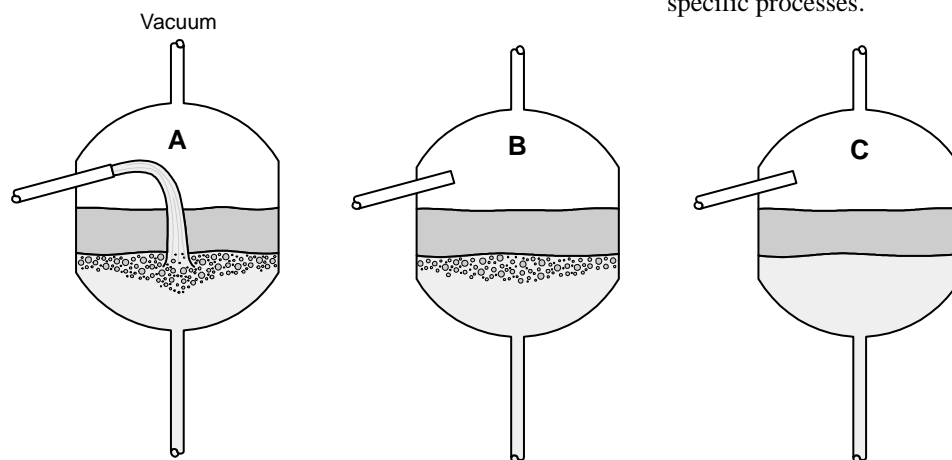
This excursion illustrates the subtle ways in which accidents can occur during solution processing. Although the deep trap was considered a safety feature for the control of contamination, it contributed directly to the criticality accident. The difficulty of understanding what had happened, even after it was known in which vessel the excursion occurred, is an excellent example of the impracticability inherent in attempting to calculate criticality accident probabilities for specific processes.

Figure 26. Solution transfer as reconstructed from the transparent plastic mockup of the transfer vessel. Configuration (B) is the postulated state at the time of the accident.

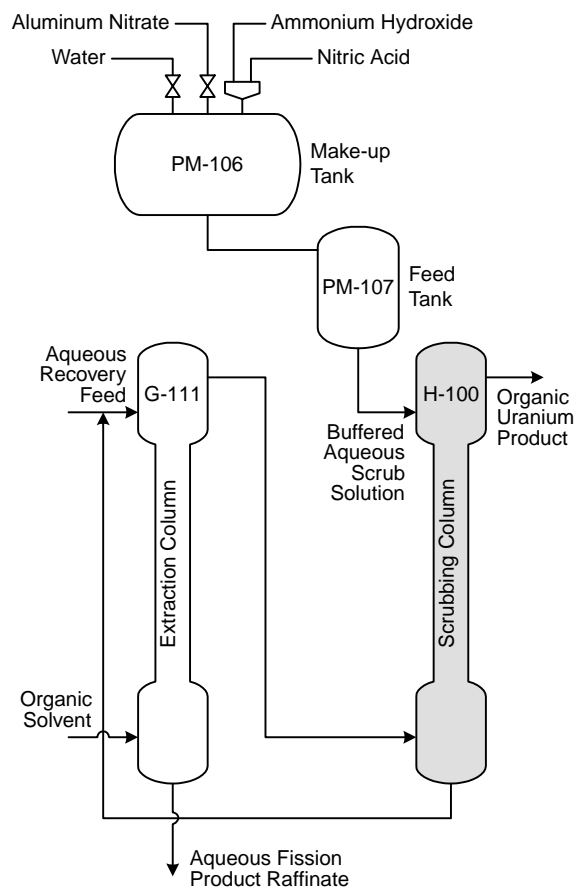
for the scrubbing column, H-100, had been leaking for about a month prior to the accident. Over time, this leak caused a dilution of the feed solution from 0.75 M to 0.08 M. The 13,400 ℓ make-up tank was equipped with a density alarm that would have indicated the discrepancy, but the alarm was inoperable. A density alarm was scheduled to be installed on the 3,000 ℓ process feed tank (PM-107) that was filled, as necessary, from the make-up tank, but this had not been done. The make-up tank was instrumented with a strip-chart recorder showing the solution level in the tank. However, the leak into the tank was so slow that the change in level would have not have been discernible unless several days worth of the chart was analyzed. To complicate matters, the chart recorder had run out of paper on 29 September and it was not replaced until after the accident. Furthermore, procedures that required the taking of samples from the feed tank, PM-107, to confirm the density, were not being followed.

Figure 27. First cycle extraction line equipment. The accident occurred in the lower disengagement section of the H-100 column.
