investigation report

Plutonium Contamination

Incident

Wednesday, October 14, 1981

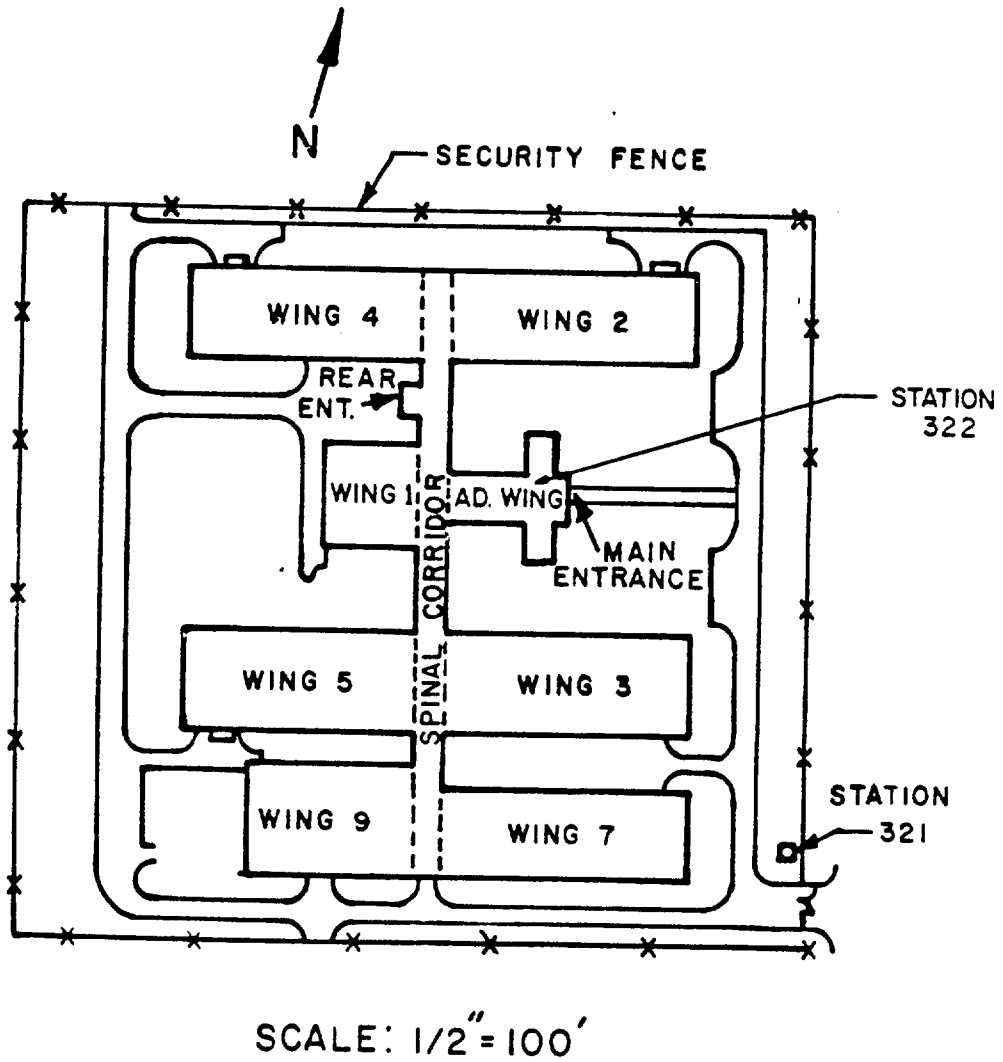
FIGURE 4. Site plan for the CMR building. The contaminated samples originated in Wing 2 and were opened in Wing 3.

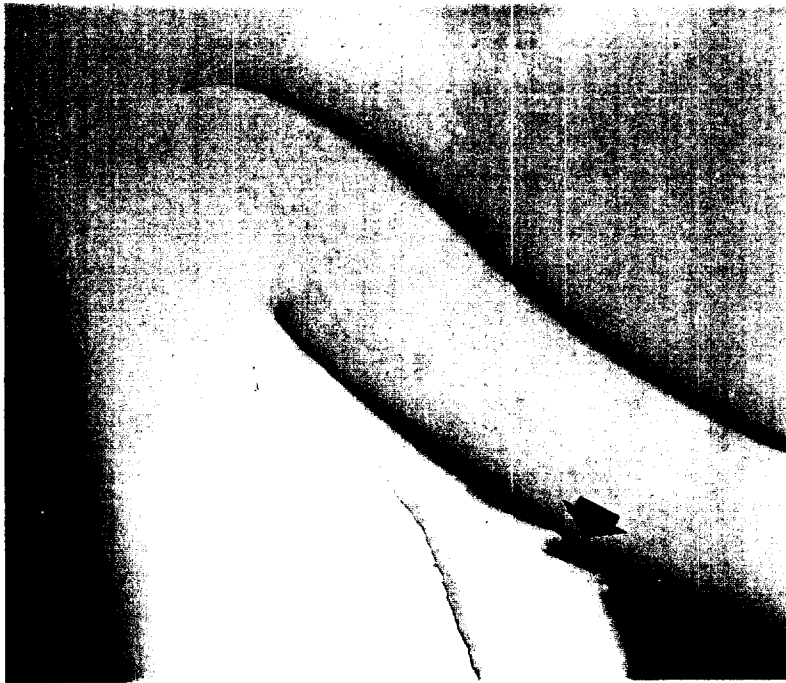
Fig 9 Photomicrograph of a corner of an impacted heat source capsule, showing some entrapped PuO_2 .

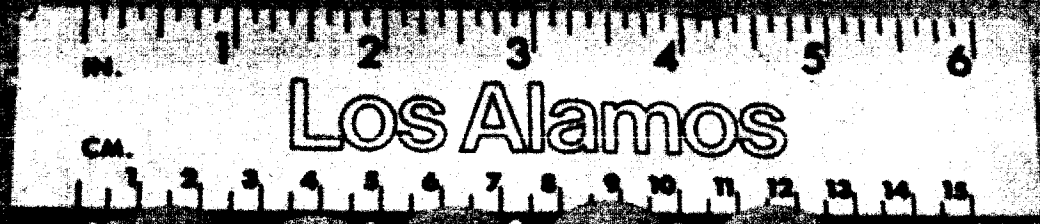
10 vials containing metallic fragments. The vials were individually labeled with only the sample numbers and the plastic lids were taped on. The analyst later recalled that the vials were not in a plastic bag. However, when Room 3110 was inspected after the incident an unmarked plastic bag, very similar to one that should have been used in packaging the samples, was found. Photographs of the can, the sample vials , and one of the Travelers are shown in Figures 11, 12 and 13. Contaminated alloy may be seen in some of the vials.

FIGURE 12. The ten contaminated sample vials.

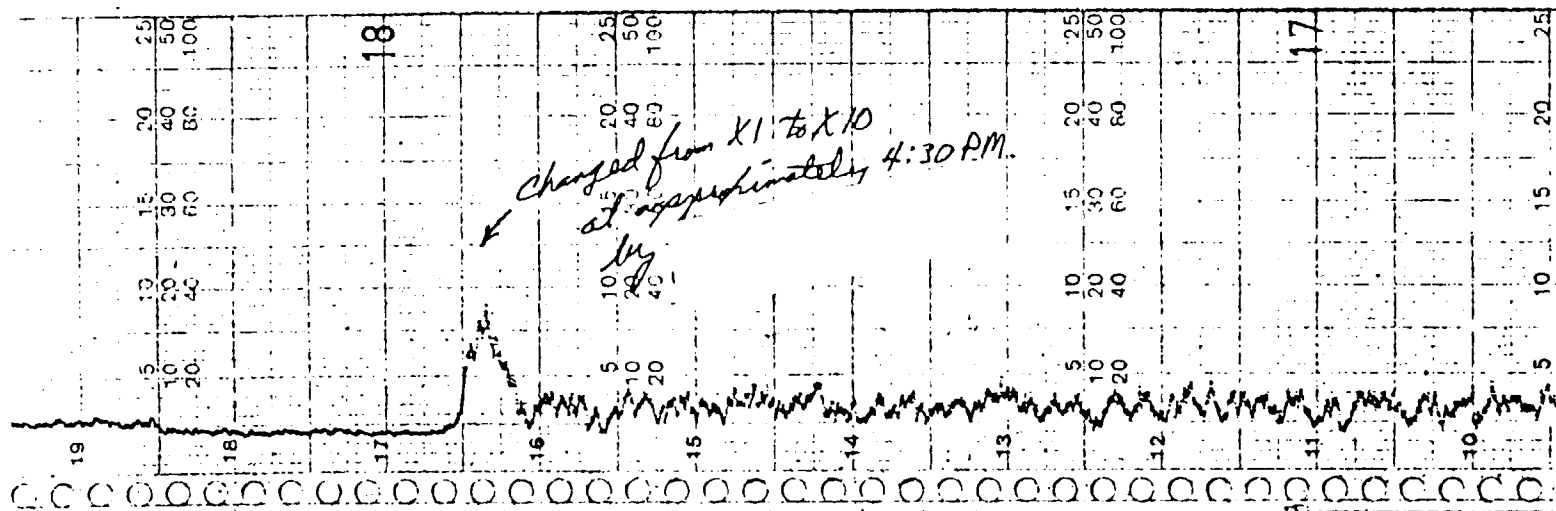
4. The Wing 3 HPT failed to detect the rise above background on the CAM in Room 3111 at about 4:30 to 4:40 p.m. when he switched the scale setting (Figure 14). However, the room lights were turned off, with only the emergency service light on, and the HPT stated that he had a migraine headache. Because of the design of the CAM, it is difficult to see the most recent portion (about the last 15 minutes) of the strip chart. Had the HPT noticed the most recent portion of the strip chart, or the CAM meter reading, he should have been suspicious and taken steps to investigate what was occurring.

The probable result is that he would have monitored and the contamination would have been found before 5:00 p.m. Then the incident would have been less complex.

FIGURE 14. Strip chart from the CAM in Room 3111, showing a rise at about 4:20pm.

The sensitivity was switched to the x10 scale at about 4:40pm.

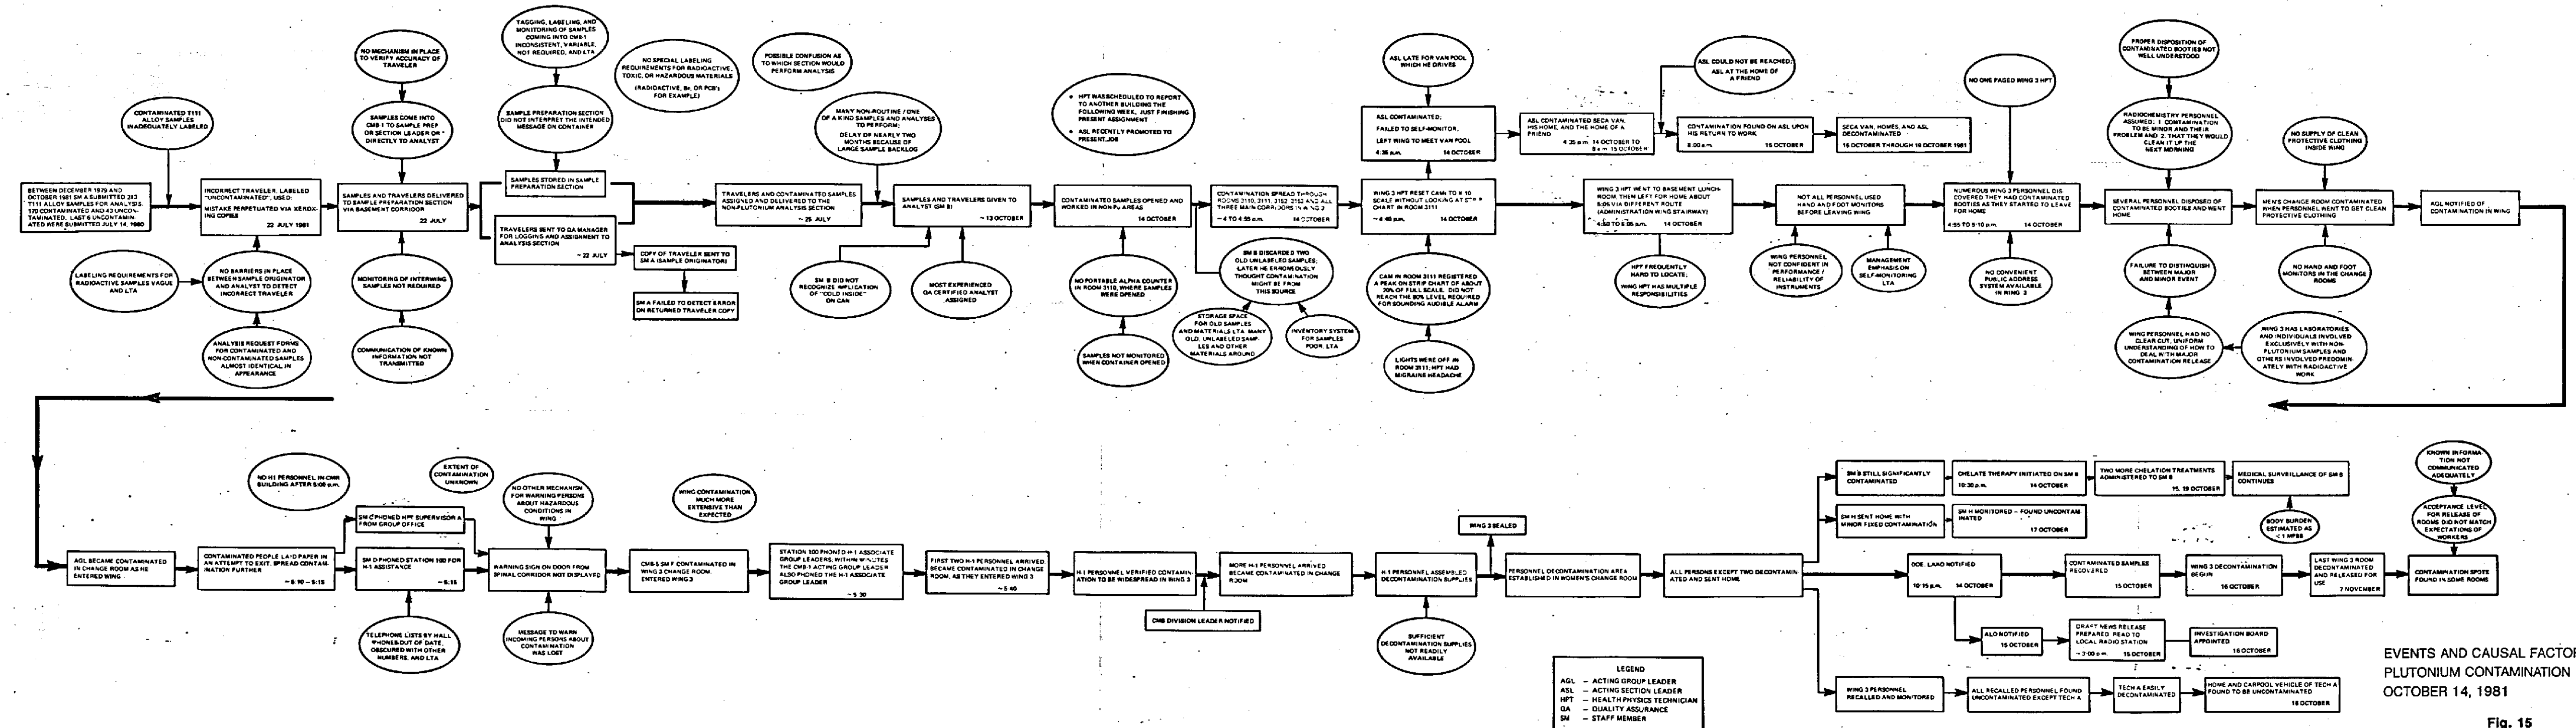
The Investigation Board identified a number of causal and contributing factors which caused and contributed to the October 14 plutonium contamination incident. The more direct and significant of these are summarized diagrammatically in the Events and Causal Factors Chart, Figure 15. The Board identified several items as deficient and others where it is believed that improvements could be made.

EVENTS AND CAUSAL FACTORS OF PLUTONIUM CONTAMINATION INCIDENT - OCTOBER 14, 1981
 Fig. 15
