LESSONS LEARNED FROM EARLY CRITICALITY ACCIDENTS

Richard E. Malenfant
Los Alamos National Laboratory

Nuclear Criticality Technology Safety Project Workshop
Gaithersburg, Maryland
May 14-15, 1996

EXCESSIVE RADIATION EXPOSURE AT PAJARITO LABORATORY

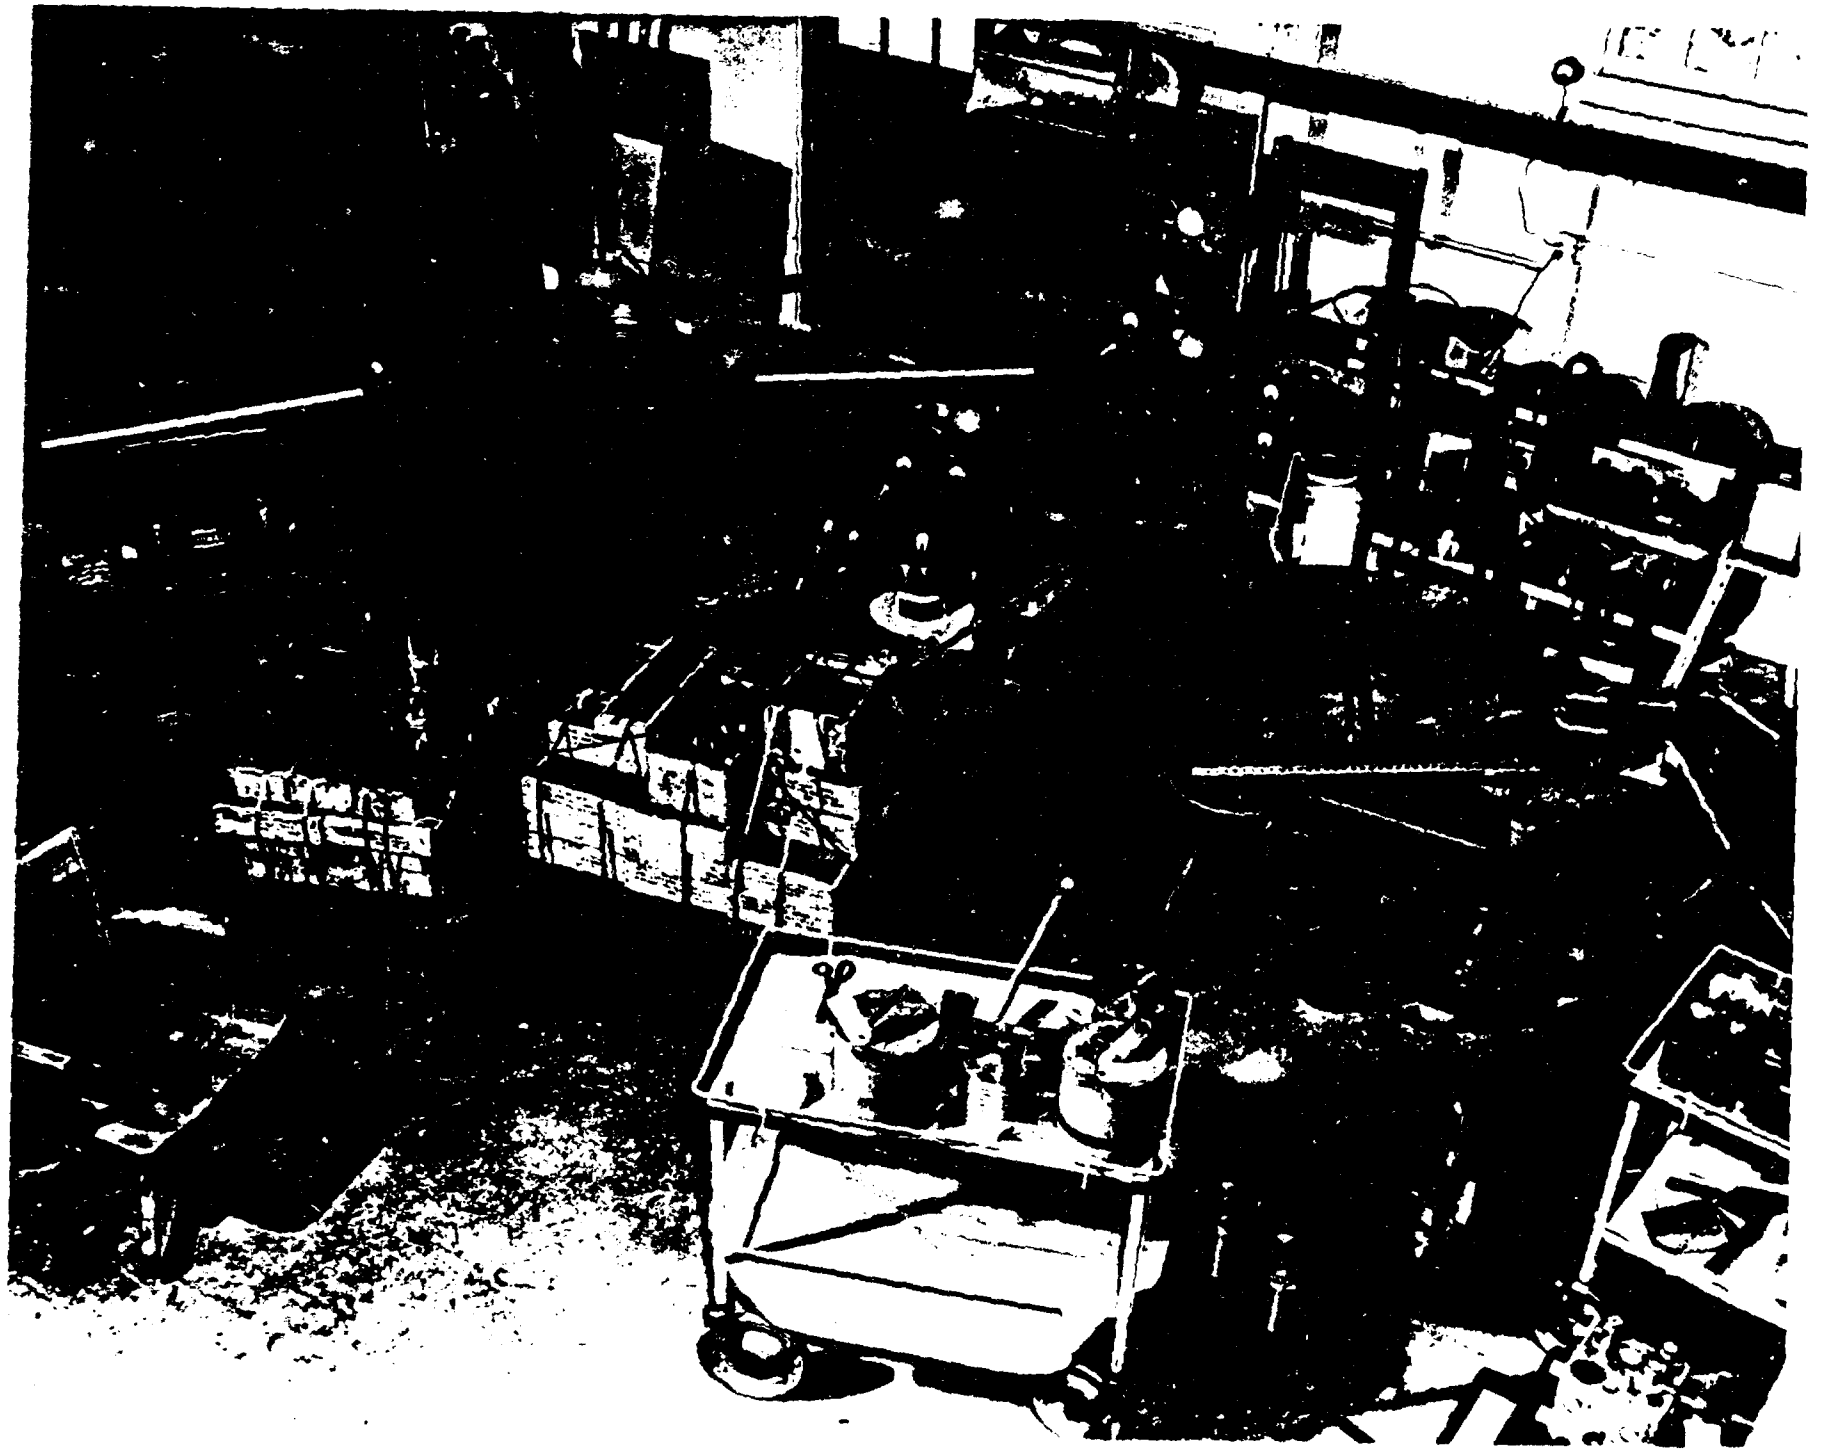
The area in which the experiment was conducted was cluttered and non essential equipment and personnel hampered the operation (Fig. 1).

Although it is argued (see attachment) that the experiment was not done carelessly, the condition of the experimental area and presence of non participants indicate a cavalier disregard for all but the most rudimentary safety features.

3. Only those persons actually concerned with the assembly should have remained in the room.
