App Note 3479: DS2154 – Migrating from Revision A2 to D1

This application note describes the procedures for replacing the A2 revision of the DS2154 with the D1 revision of the DS2154. The D1 revision of the DS2154 is a drop-in replacement for the A2 revision of the DS2154. However, it is possible that the user may experience a timing-related issue while replacing the parts. This application note will describe what to do to correct this problem.

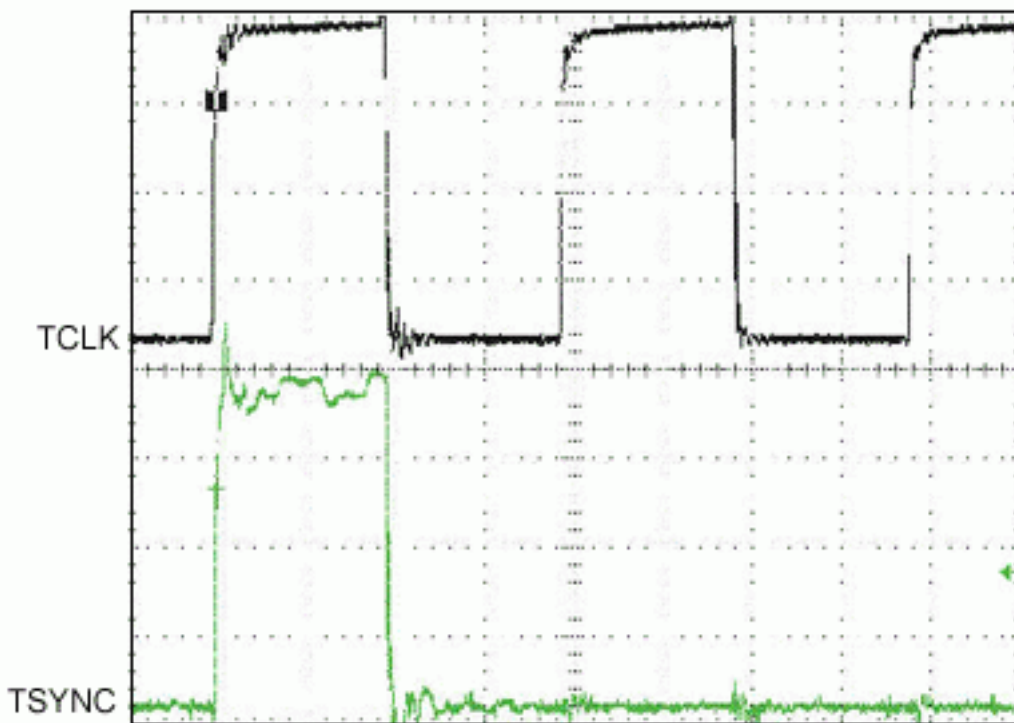
In the DS2154 D1 revision, when TSYNC is configured as an input by setting $TCR1.0 = 0$ ($TSIO = 0$), the E1 SYNC signal sometimes does not synchronize correctly with the MSB of time slot 0 (TS0). **Figure 4** is the scope image of a possible valid timing diagram between TSYNC and TCLK for the DS2154 A2 revision. However, this is not valid for the DS2154 D1 revision.

Figure 4. Transmit-Side Timing Between TSYNC and TCLK Taken from an Oscilloscope

Figure 4 shows the falling edge of TCLK and TSYNC as being nearly simultaneous. In the D1 revision, the incoming TSYNC is sampled at the falling edge of TCLK. In order to get the correct sampling, the user needs to add 25ns or more delay onto TSYNC. The user can also make the clock pulse of TSYNC wider. This way, the user can solve the sampling problem. The A2 revision of the DS2154 has a rising edge detector to aid in aligning TSYNC with TS0. The D1 revision of the DS2154 simply samples TSYNC with the falling edge of TCLK. **Figure 5** shows the timing diagram between TCLK and TSYNC after making the TSYNC pulse wider.

When replacing the A2 revision of the DS2154 with the D1 revision, most applications will never experience this timing issue. However, if the application experiences this problem, it is recommended to increase the TSYNC delay by 25ns or to widen the TSYNC pulse. For further questions about the operation of the DS2154, please contact the Dallas Semiconductor Telecommunications Applications support team through email: telecom.support@dalsemi.com, or phone: 972-371-6555.

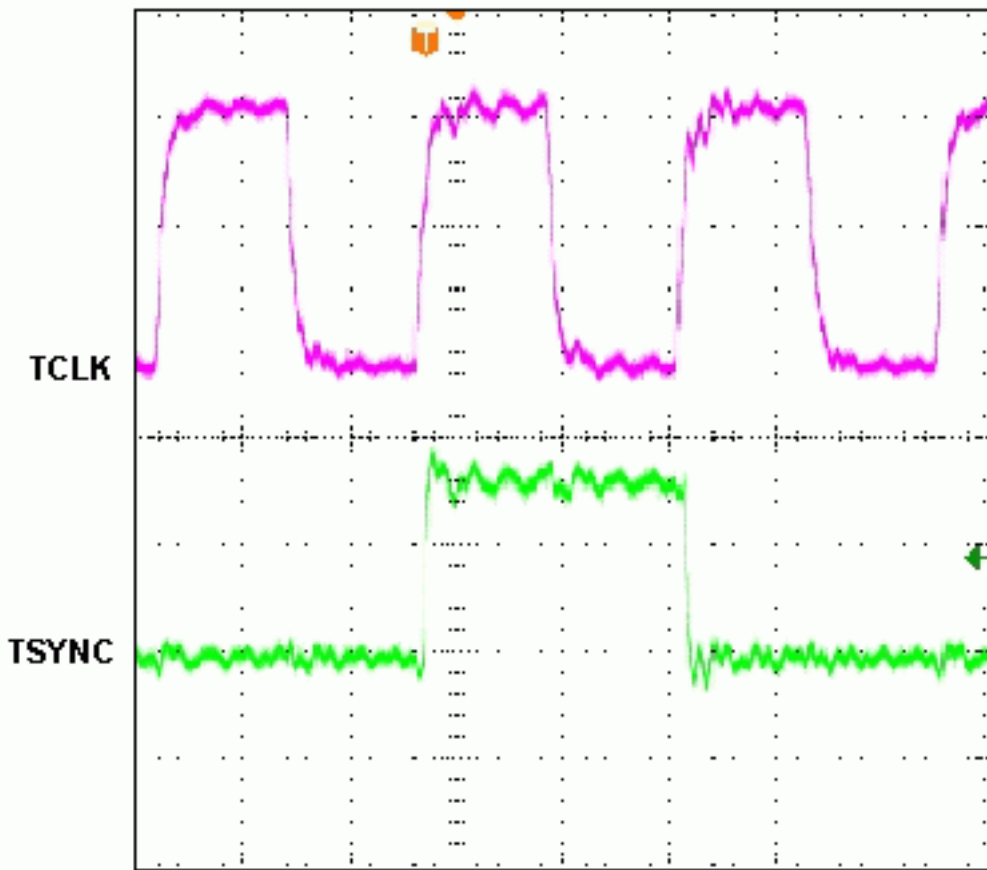
Figure 5. Transmit-Side Timing Between TSYNC and TCLK Taken from an Oscilloscope After Widening the TSYNC Pulse
