CORROSION PREVENTION MANUAL

GENERAL INFORMATION
(VOLUME 1)
SPECIFIC INFORMATION
(VOLUME 2)
MODELS 707 AND 727 THROUGH 777

BOEING DOCUMENT D6-82560
PUBLISHED BY THE BOEING COMPANY, SEATTLE, WASHINGTON, U.S.A.

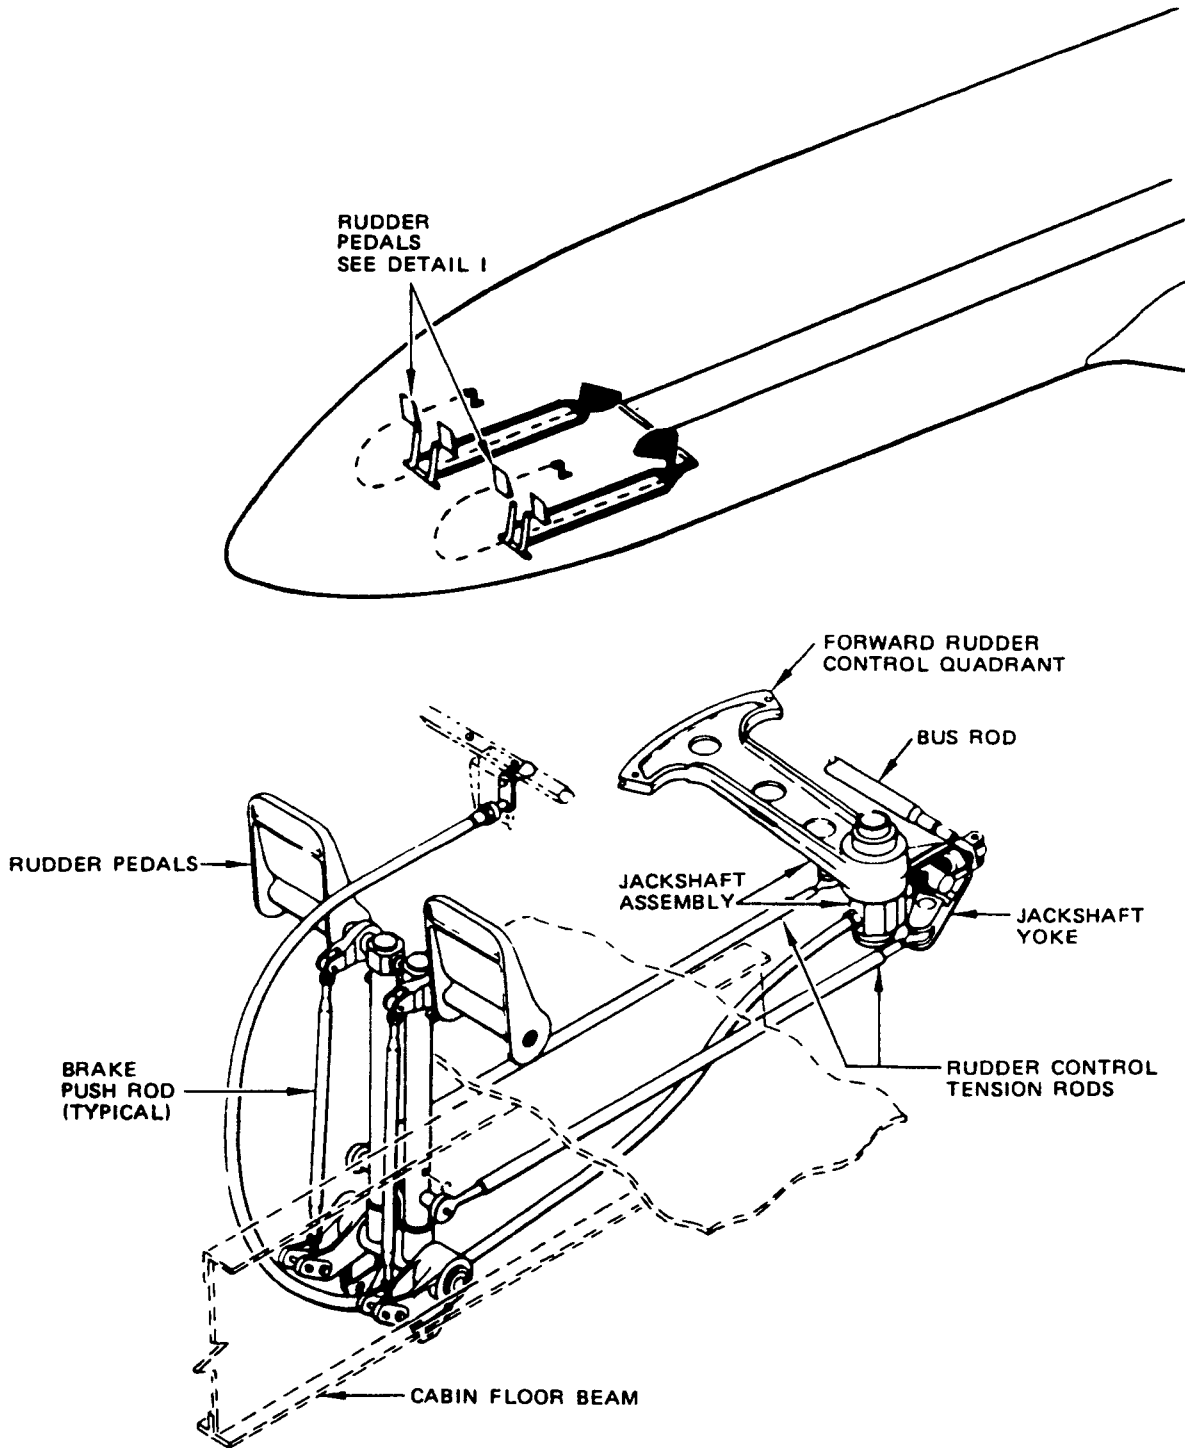
Rudder Control Tension Rods
Figure 1

- A. Corrosion has been reported on the rudder control tension rods located between the rudder pedals and the forward cable quadrants. Corrosion may reduce the fatigue life of these rod assemblies.

- A. Periodically examine the rudder control tension rods for evidence of corrosion.
- B. Where corrosion has already started, refer to Structural Repair Manual for details of corrosion removal.

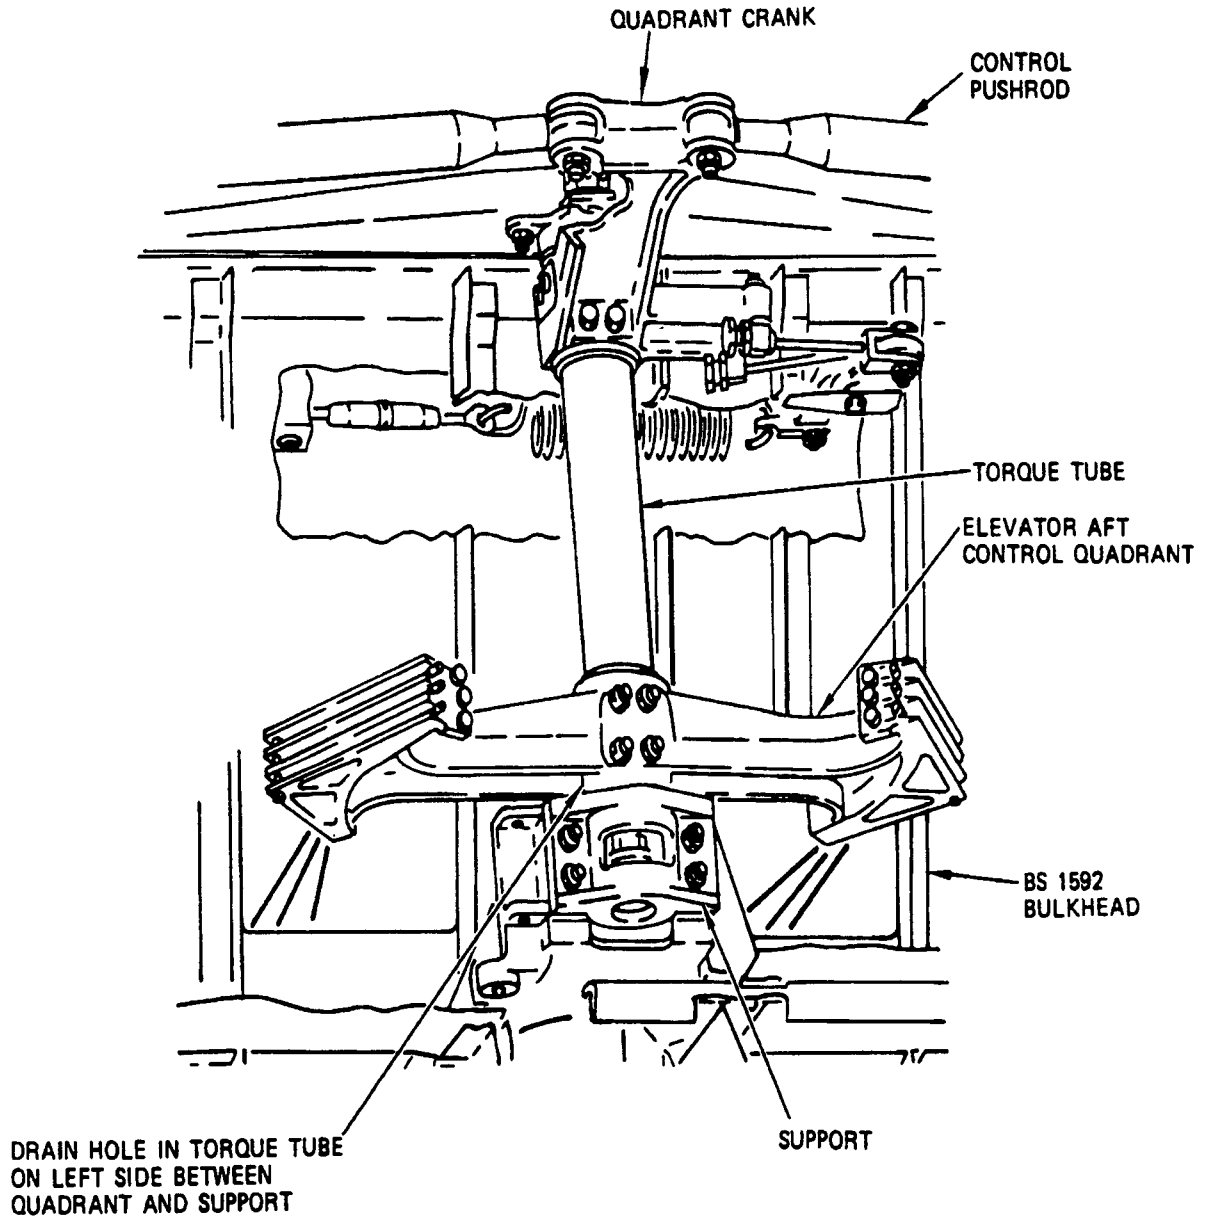
AFT CONTROL QUADRANT INSTALLATION

- A. Corrosion can occur on the elevator control quadrant support located at BS 1592. Corrosion can cause high elevator control forces. Corrosion deposits, caused by a clogged drain hole in the torque tube, did not let the quadrant assembly move freely. To make better the corrosion resistance of the support, we replaced the dry film lubricant in the bore with two coats of primer and protective paint finish, from line number 922.
- B. Corrosion can occur at the attachment holes, around bolt heads and at faying surfaces of the magnesium elevator control quadrant support.

- A. At regular times, examine the elevator control quadrant installation for corrosion. Make sure that the drain hole is not obstructed.
- B. Remove corrosion products, if you find them. Repair any damaged finishes to provide corrosion protection.

- C. Shield the control cables and apply water displacing corrosion inhibiting compound to the quadrant crank, torque tube, quadrant assembly and support bracket.

- D. For treatment of cables, refer to Volume 2, 27-00-07, Fig. 2.
- E. Lubricate the installation with MIL-G-23827 grease.
- F. Refer to Structural Repair Manual for corrosion removal procedures.

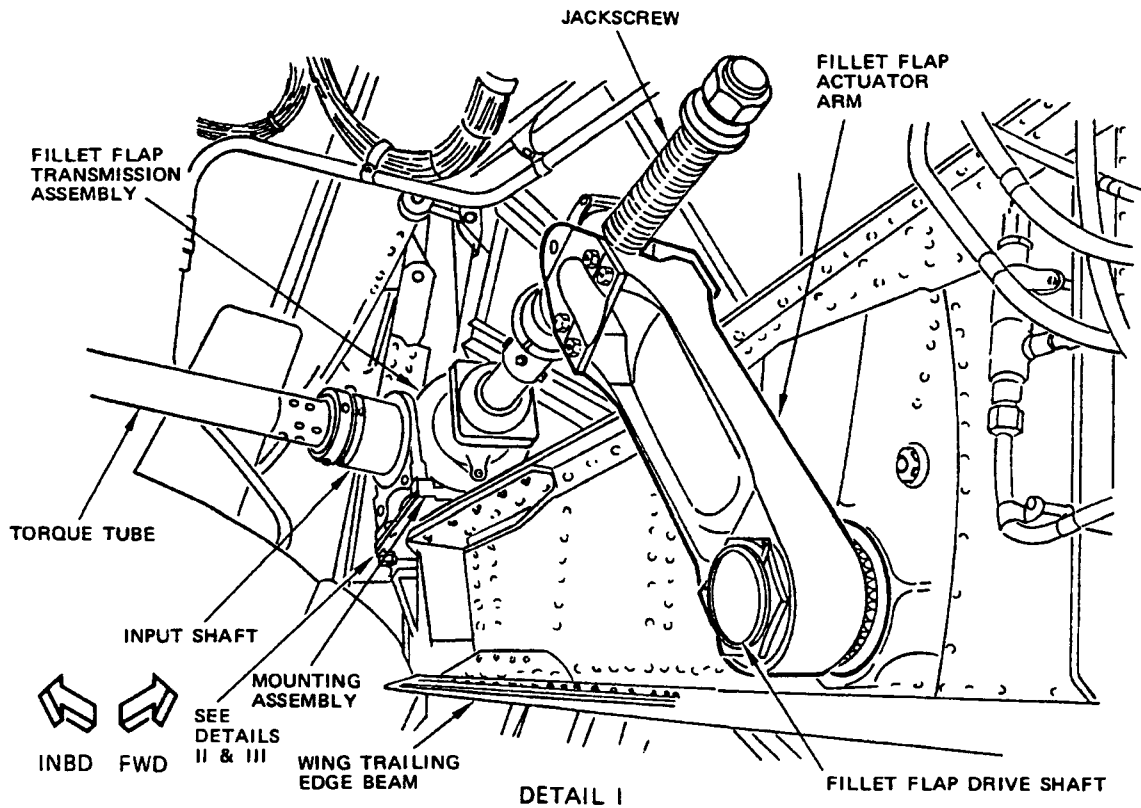
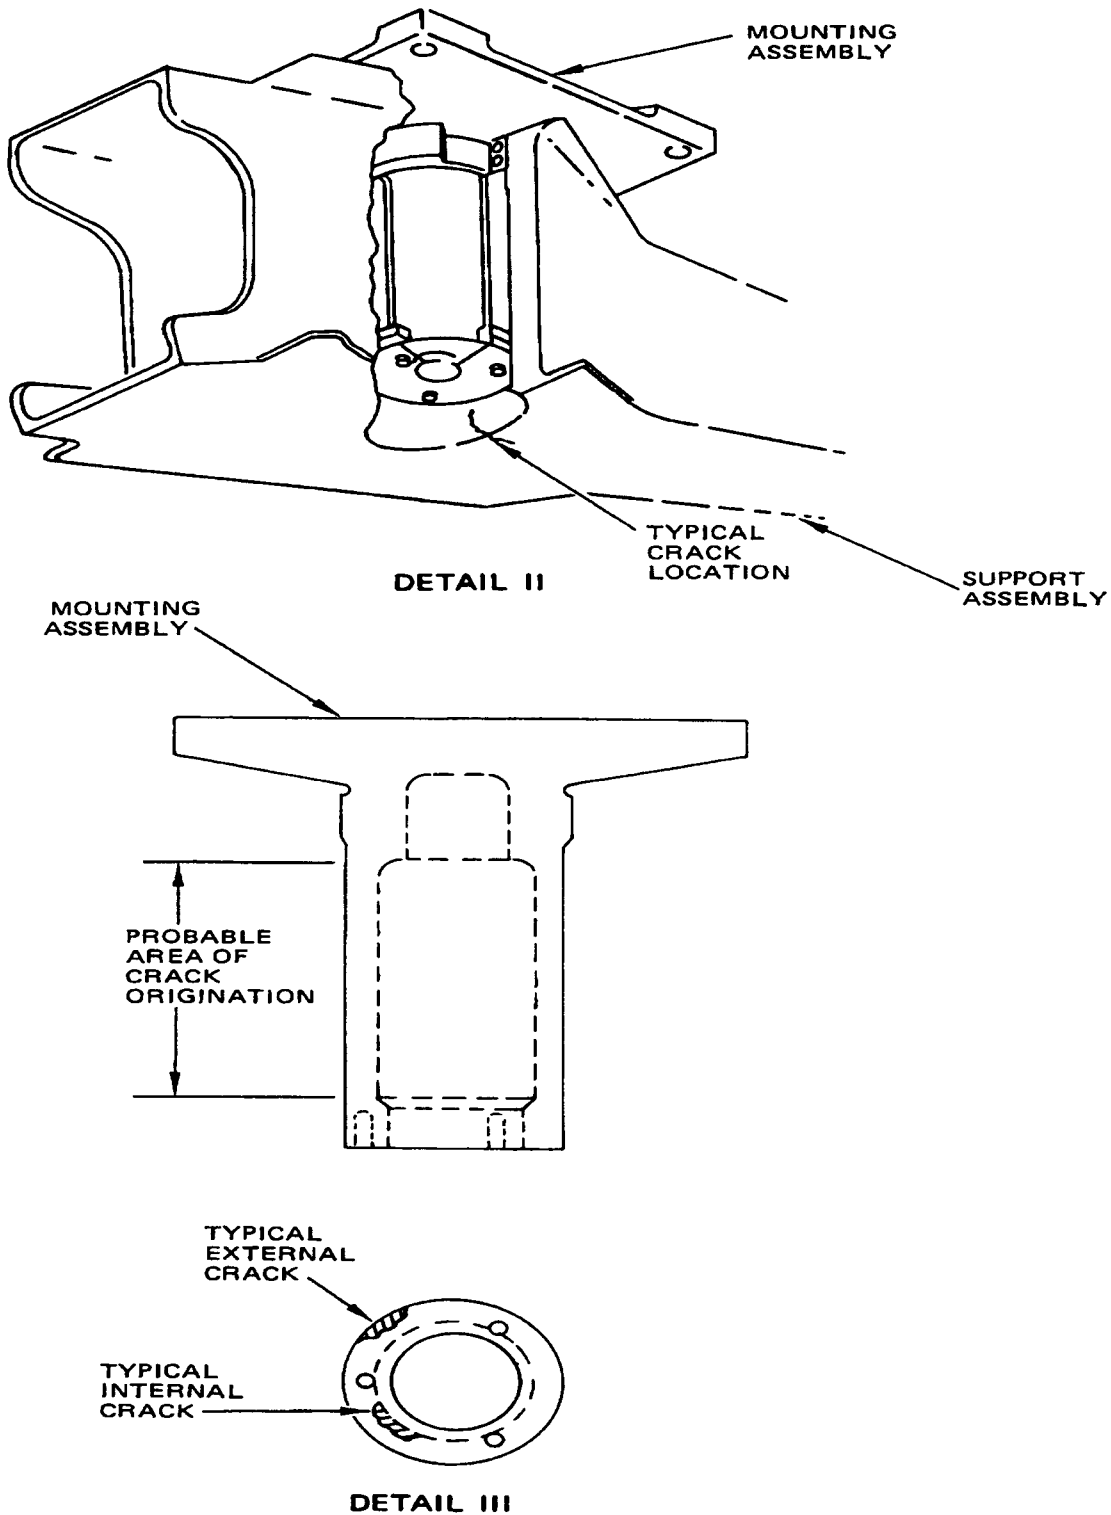
Fillet Flap
Figure 1 (Sheet 1)

- A. The fillet flap transmission assembly is mounted on the trailing edge beam in the main gear wheel bay. Corrosion problems have been associated with 707-300B and -300C airplanes. Stress corrosion cracks in the bearing bore of the flap drive screw support fitting have also been reported.

- B. Stress corrosion cracking of the transmission mount assemblies have been reported. A material change which is less susceptible to stress corrosion cracking was incorporated in production at cum line 856.

- C. Stress corrosion cracking of the transmission support assembly has been reported. This fitting, which supports the mount noted in par. 1.B., has been replaced by a new fitting made from an improved alloy from cum line 886. This replacement of existing fittings on earlier airplanes may be accomplished by SB 3251.

- D. On Intercontinental airplanes, corrosion has been reported on the mating splines at the fillet flap drive shaft, fillet flap actuator arm, and fillet flap inboard rib hinge fitting. Cracks in the splined end of the fillet flap actuator arm have been reported and are attributed to corrosion originating on the splines. Lubrication provisions were installed on the flap actuator arms on airplanes from cum line number 504 and can be provided retroactively by incorporating SB 27-2398. Lubrication provisions were installed on the fillet flap inboard rib hinge fittings on airplanes from cum line number 759 and can be provided retroactively per par. 2.1.

- D. For line numbers through 855, it is recommended that the transmission mounting be removed for inspection at the earliest opportunity maintenance schedule will allow. Inspection of the support fitting per SB 3251 is also suggested for airplanes up to line number 885.
- E. Inspect the flap transmission mounting for evidence of corrosion in the stem area. Refer to SB 3053 for details. Use one of the NDT methods per operator's standard procedure for evidence of stress corrosion cracking.

F. Refer to Structural Repair Manual for rework instructions.

G. Apply water displacing corrosion inhibiting compound to the structure in the area surrounding the flap transmission mounting installation.

H. On Intercontinental airplanes without lubrication provisions installed for the mating splines of the fillet flap drive shaft, actuator arm and inboard rib hinge fitting, inspect splines for evidence of corrosion. It is recommended that the inspection be performed at the first convenient opportunity consistent with scheduled maintenance activity. The inspection requires the disassembly of the drive shaft from the actuator arm and from the inboard rib hinge fitting. It is recommended that the lubrication provisions be incorporated at the time of inspection. If no corrosion is discovered, apply water displacing corrosion inhibiting compound to all surfaces and pack the spline cavities with corrosion preventive compound MIL-C-11796, Class 3, or MIL-G-23827 grease (preferred) or equivalent. If corrosion is discovered, refer to Structural Repair Manual for rework instructions.

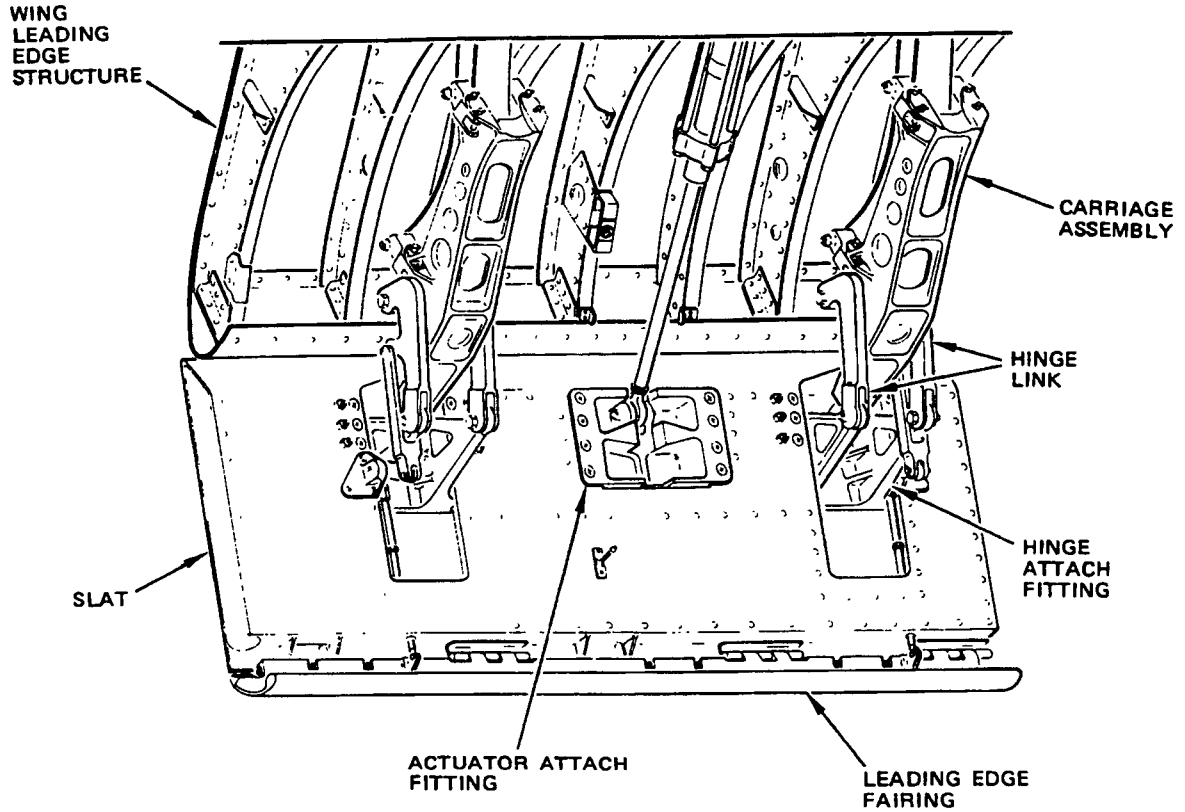
Leading Edge Slats and Flaps
Figure 1 (Sheet 1)

- A. The leading edge slats on Intercontinental airplanes are exposed to severe weather elements and corrosive atmosphere during its normal flight envelope.
- B. Corrosion has been reported in the wells for the actuator and carriage attachment fittings. Production changes were initiated to improve the paint system on all detail parts and to install fasteners attaching the fittings wet with BMS 5-95 sealant. Sealing in the wells was minimized to allow the parts to "breathe".
- C. Stress corrosion cracks on the lugs of the slat hinge support fittings and flap torque tube castings have been reported.
- D. Refer to the Introduction of this manual for a discussion of the Aging Airplane Corrosion Prevention and Control Program and related documentation. Structural items within this section are subject to the unique requirements of the mandatory Corrosion Prevention and Control Program.

- A. Make the periodic inspection described in Volume 1, 20-20-00 to ensure that the protective finishes provided at manufacture remain intact. White powdery deposits are evidence of the existence of corrosion which should alert operators that some corrective action is required. A corrosion prevention program should be initiated to prevent or minimize the occurrence of corrosion in these highly susceptible areas.

- B. At first opportunity when scheduled maintenance work allows access to the actuator or carriage fittings, corrosion prevention treatment should be accomplished. Refer to 27-16 of the Maintenance Manual for procedures to extend flap/slat system.

- C. Remove gap filling or fillet seals around the attachment fittings and visually inspect for evidence of corrosion.
- D. Where extensive corrosion exists (large amounts of white deposits) and evidence of stress corrosion cracks on the lugs of the hinge attach fittings, refer to Structural Repair Manual.

- E. For minor corrosion, to minimize the down time of the airplane, clean off corrosion and restore finish (Ref Volume 1, 20-50-00). Apply water displacing corrosion inhibiting compound.

- F. Apply corrosion inhibitor to lugs and lug faces of hinge and actuator fittings.
