CORROSION PREVENTION MANUAL

Volume 2-727

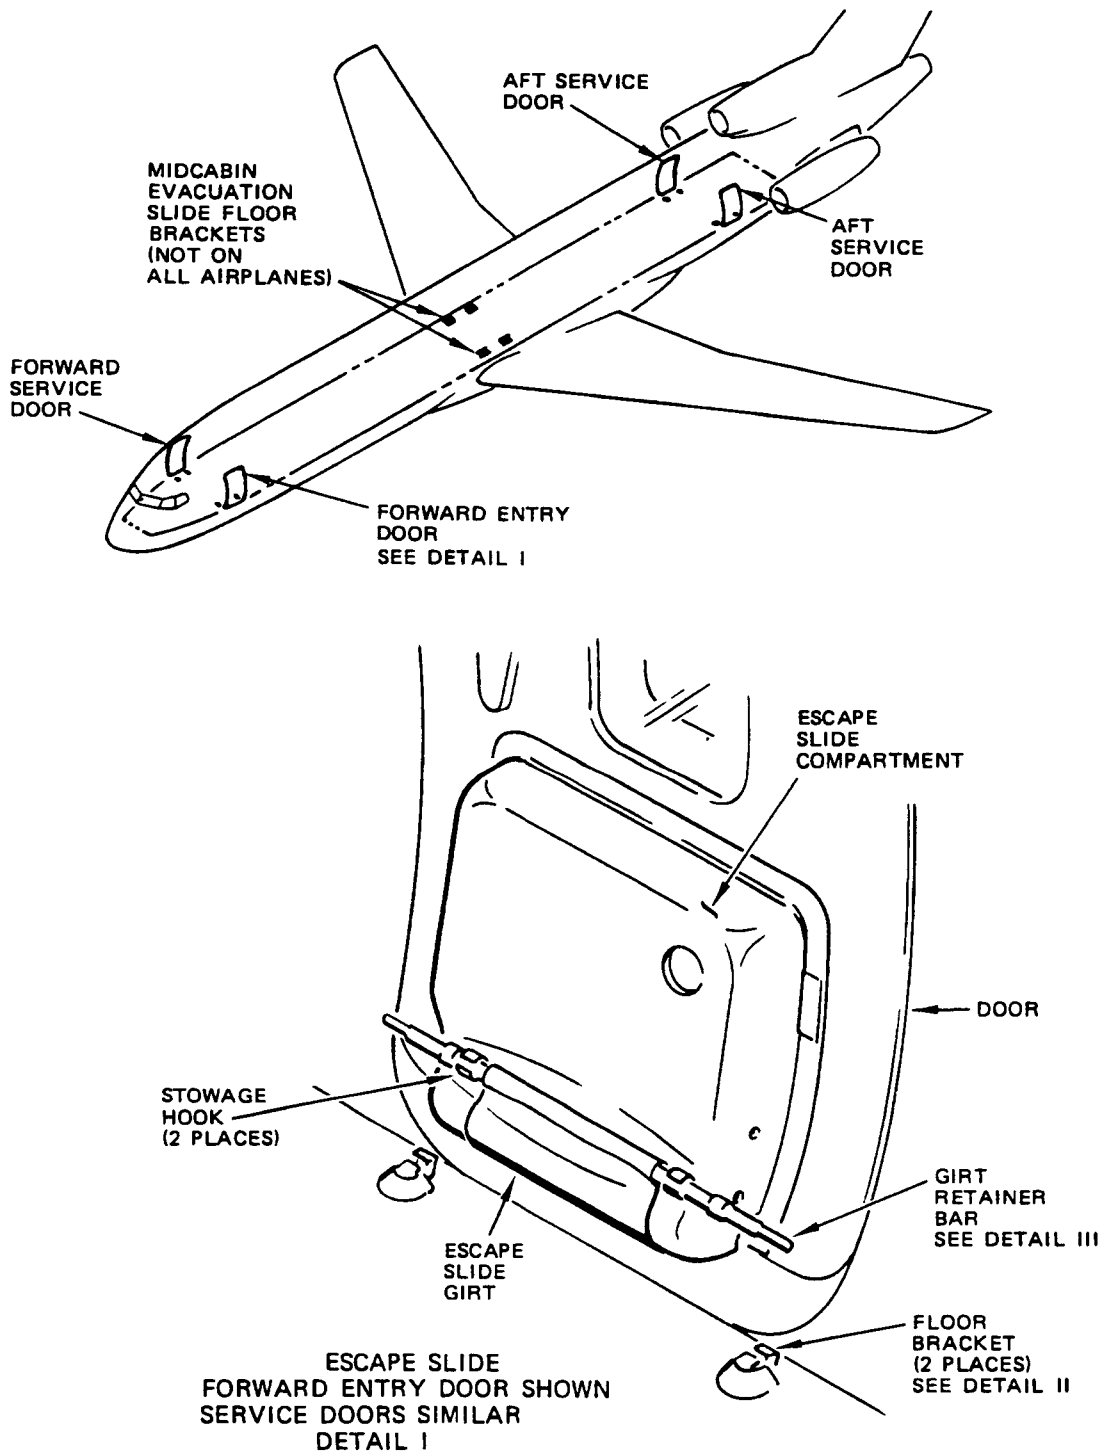
Door Mounted Escape Slide
Figure 1(Sheet 1)

- B. Floor-mounted brackets are provided so that a girt bar can be attached to arm the slide deployment system.
- C. Corrosion has been encountered on the floor plates at the entry and service doors and on structure at the mid cabin locations. Corrosion has been attributed to the use of dissimilar metals in these installations. The brackets are steel and other components are made of aluminum. Bracket fasteners may also be corrosion suspect areas.

- E. Corrosion has been reported under the nylon sleeve and in the bore of the girt retainer bar. Slide vendors have been notified to provide moisture barriers on new assemblies.

- F. On 727-100 and early 727-200, the escape slide latch cable assemblies were installed with carbon steel cables. Reports of corrosion on the subject cable assemblies have been received. Corrosion resistant steel cables have replaced the carbon steel cables in production at cum line number 1116 and can be installed retroactively by incorporating SB 25-223. Cum line numbers 1089, 1093, 1098, 1101, 1102, 1112 and 1115 have been retrofitted prior to delivery.

- A. On airplanes thru cum line 871 inspect the floor bracket assemblies at the first opportunity consistent with scheduled maintenance activity.
- B. Refer to SB 25-185 for preventive treatment of the floor bracket assemblies.
NOTE: It is recommended that SB 25-185 be incorporated on applicable airplanes because the work can be accomplished in a short time.

- C. For extensive corrosion damage to the floor bracket assembly, refer to SB 25-185 for rework or replacement instructions.
- D. Inspect girt retainer bar for corrosion as follows:
NOTE: Some nylon sleeves may be bonded to the girt bar. In this case no further inspection or action is considered necessary provided the adhesive forms a complete fillet at both ends of the sleeve. If a bonded sleeve is to be removed, it must be cut and replaced with a new one.

(2) As an interim measure pending full inspection, use an eye dropper or similar applicator to apply water displacing corrosion inhibiting compound to the sleeve ends of the assembled girt retainer bar. Capillary action will distribute it to the sleeve/bar faying surface, thereby expelling any moisture.

- E. Where pitting or evidence of corrosion exists on girt retainer bar, refer to Structural Repair Manual.
- F. For inspection and preventive treatment of the carbon steel latch cable assembly refer to SB 25-223.

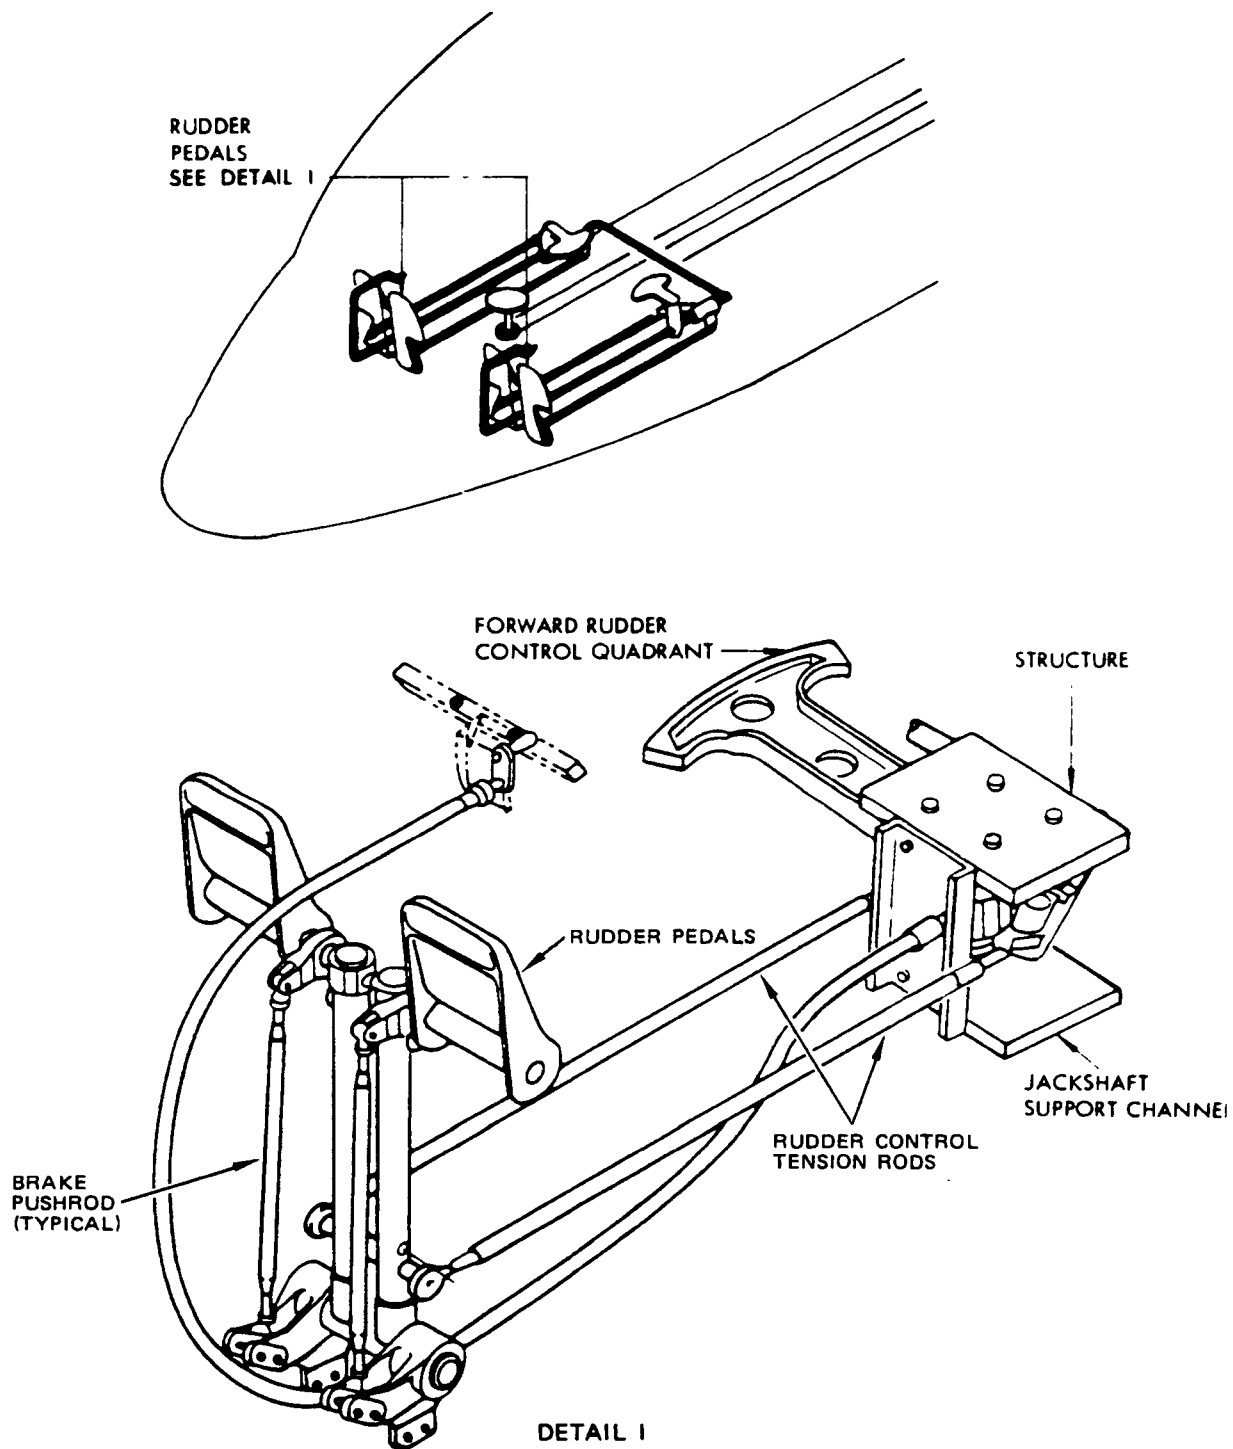
Rudder Control Tension Rods
Figure 1

- A. Corrosion has been reported on the rudder control tension rods located between the rudder pedals and the forward cable quadrants. Corrosion may reduce the fatigue life of these rod assemblies.

- A. Periodically examine the rudder control tension rods for evidence of corrosion.
- B. Where corrosion has already started, refer to Structural Repair Manual for details of corrosion removal.

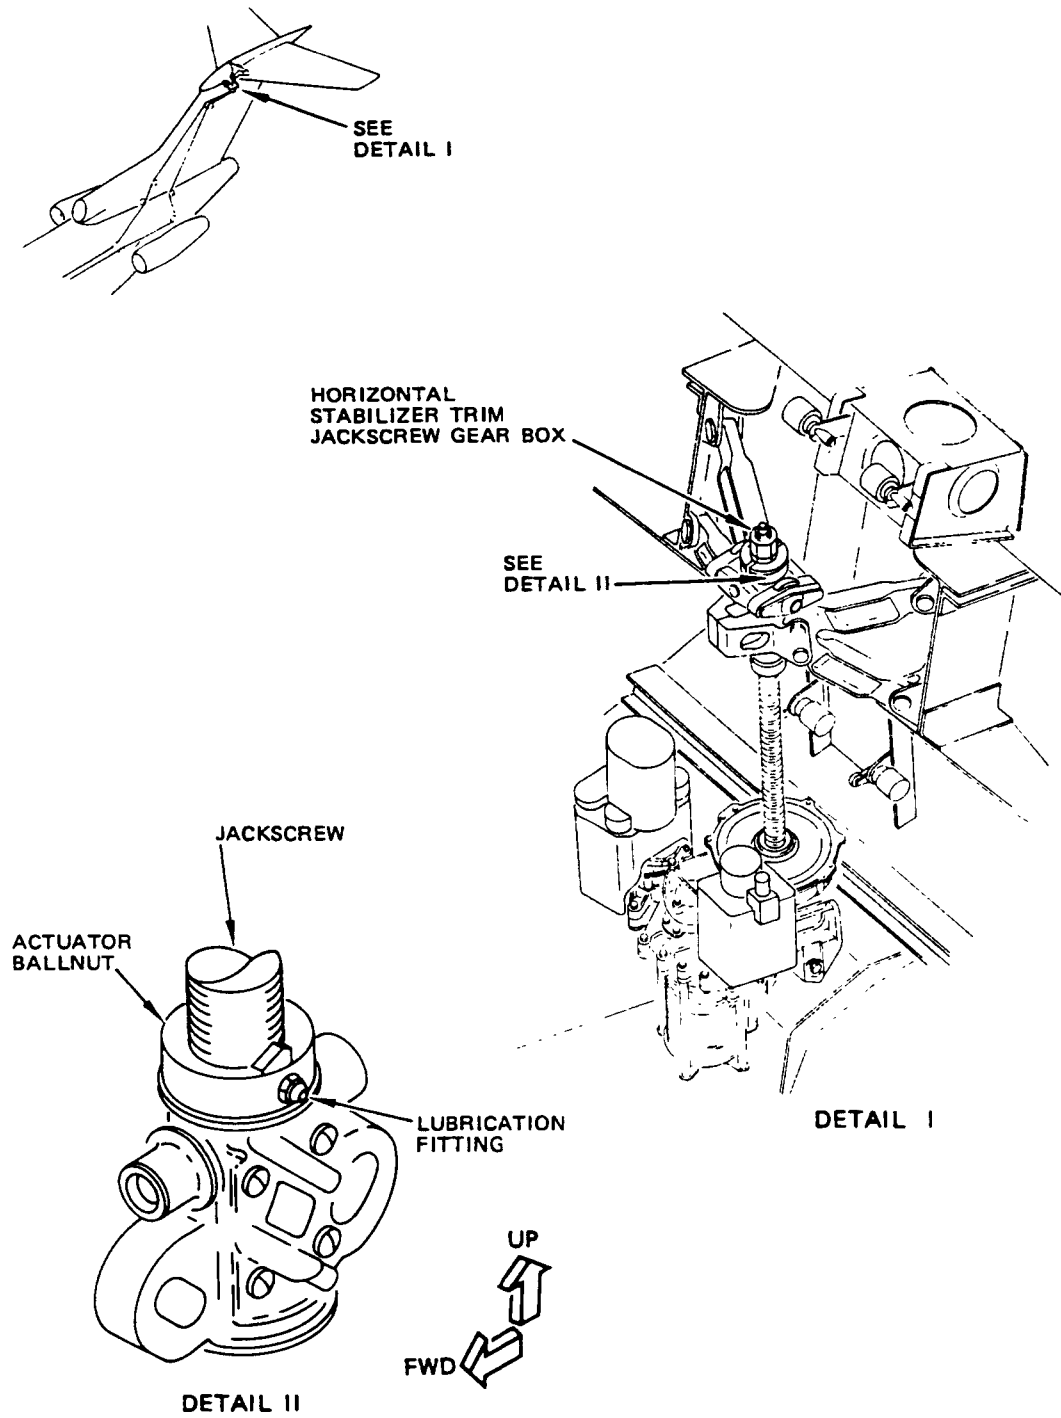
Horizontal Stabilizer Controls
Figure 1

- A. Corrosion and resulting deterioration has been reported on the oil lubricators for the horizontal stabilizer trim jackscrew. Oil lubricator reservoirs were replaced with grease lubrication provisions in production airplanes from cum line number 1419. SB 27-180 provides modification procedures for those airplanes not modified in production.

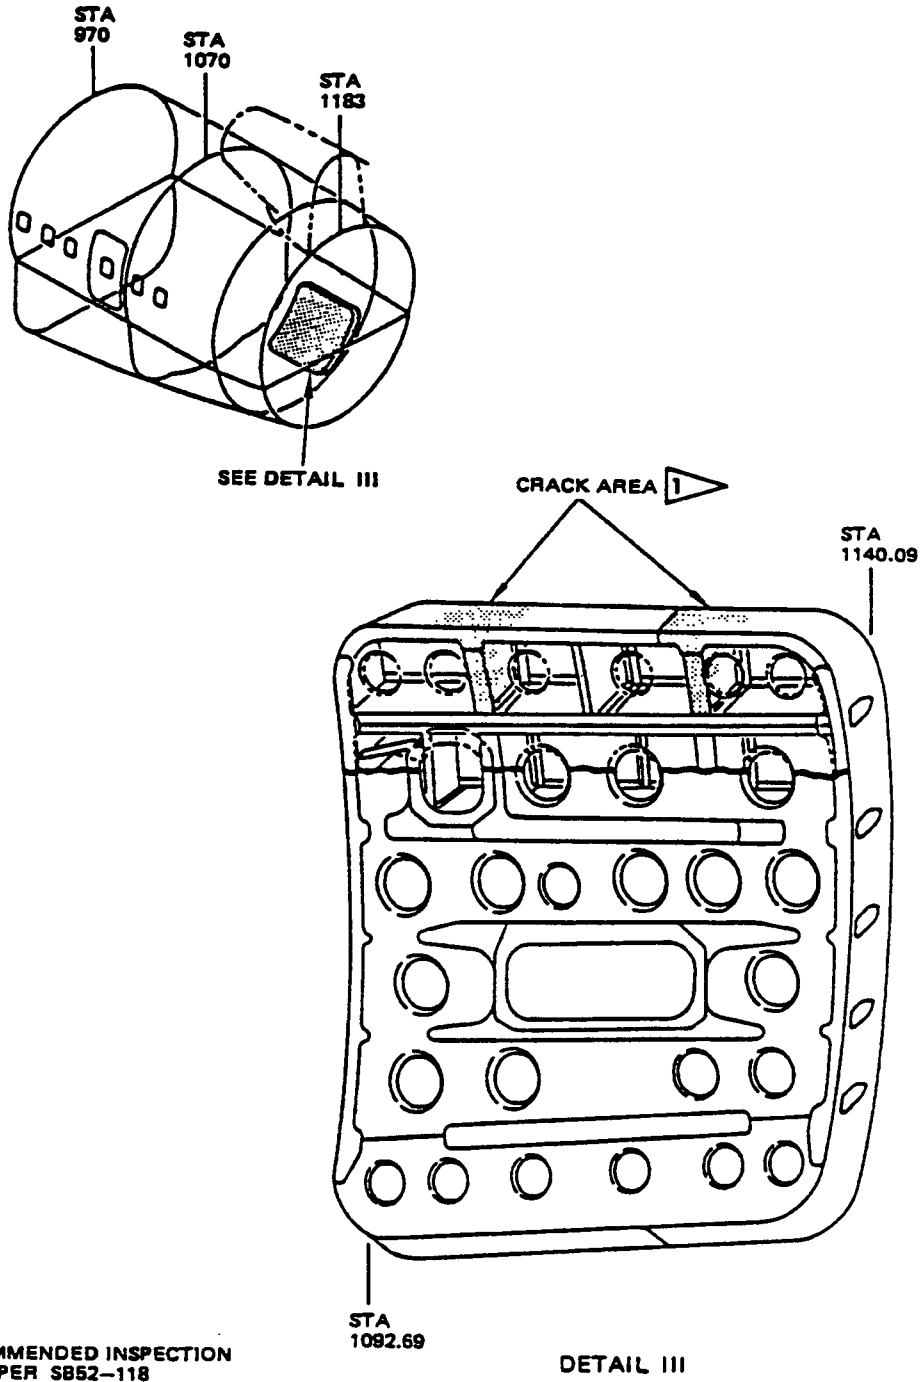
Cargo Doors
Figure 1 (Sheet 2)

1 RECOMMENDED INSPECTION
AREA PER SB52-118

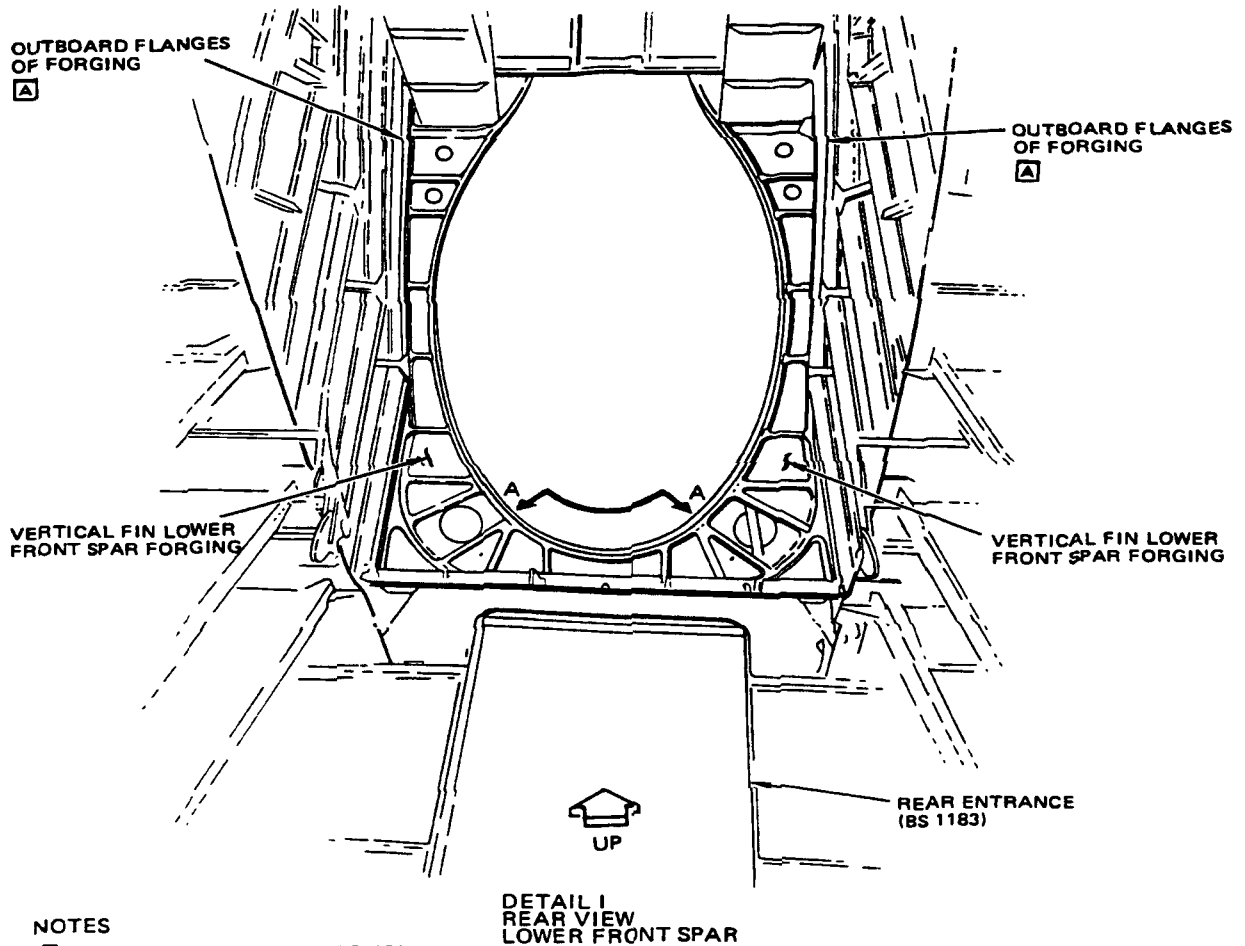
- A** NUMEROUS STRESS CORROSION CRACKS AT FORGING FASTENER HOLES COMMON TO FIN SKIN
