737 CORROSION PREVENTION MANUAL

Volume 2-737

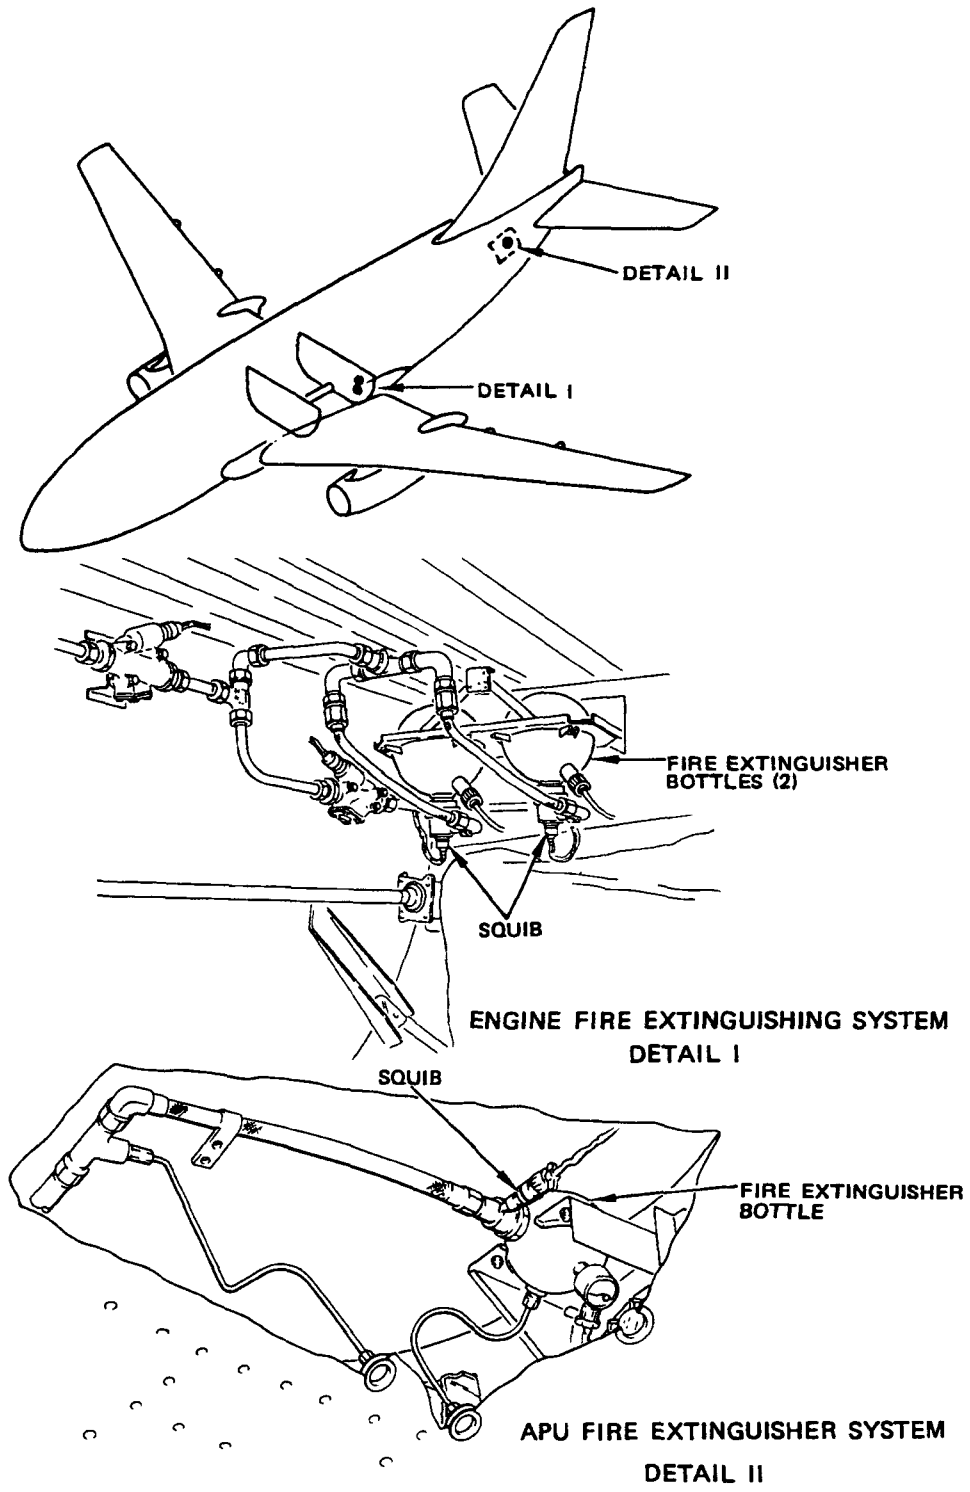
Fire Protection  
Figure 1 (Sheet 1)

AREA	PROBLEM	INDEX	TERMINATING ACTION (IF ANY)
		PREVENTION VOLUME 2	
Fire Extinguishing Bottle Squib	Squib corrosion and epoxy seal deterioration	26-20-37 Fig. 1	Replace with stainless steel squib per APCO Service Bulletin FMTC 331 FMTC 332 FNTC 333

- B. Squib corrosion has been reported. Each tin plated squib is susceptible to corrosion regardless of its location on the airplane. However, the squib installed in the APU area is most susceptible. There have been reports of presence of water in the bottle, indicating that water can seep along the bottle threads and into the discharge plug, thereby causing squib corrosion. The corrosion progressively lifts the epoxy seal, which permits moisture to enter the powder cavity. This can render the powder charge useless or disintegrate the ignition filament.
- C. Corrosion has been reported on the fire switch pull handle shafts at the control stand. Spilled liquids have leaked down along the fire switch pull handle shafts and caused contamination and corrosion of the switch contacts.

- (1) AFCO Service Bulletins FMTC 331, FMTC 332, and FMTC 333 provides replacement procedures on existing tin-plated fire extinguisher squibs with new stainless steel squibs. Compliance to above SB's is recommended to minimize the possibility of squib corrosion.

- (3) SB 26A1023 provides modification procedures on fire control switches seal at the control stand. Compliance to SB 26A1023 is recommended to reduce the possibility of contamination and corrosion of the engine and auxiliary power unit (APU) fire switches by liquids spilled on the control stand fire control module P8-1 (Ref Fig. 1, Detail III).

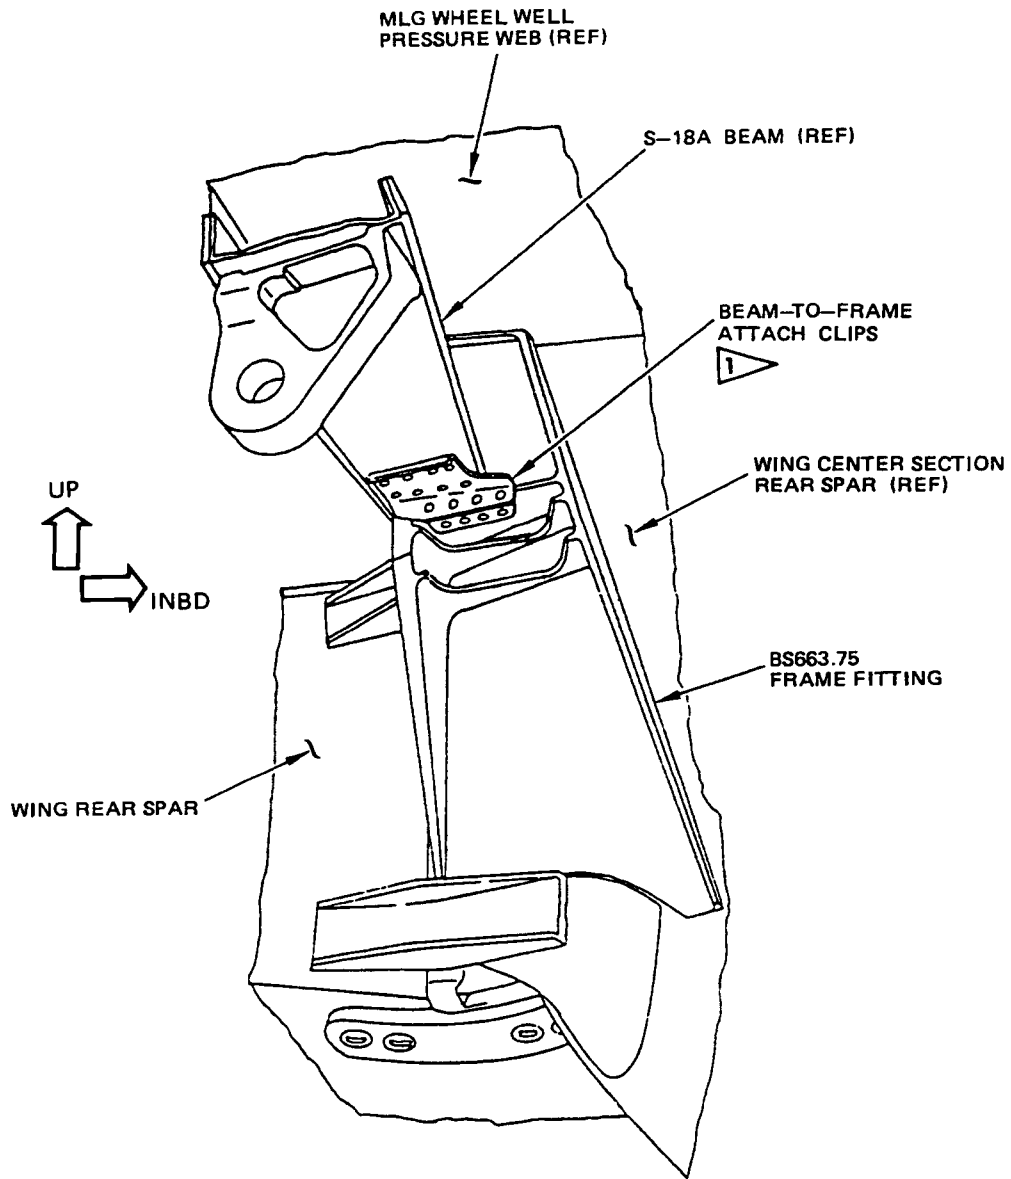
DETAIL VI

1 SB 53-1028 RECOMMENDS  
ONE TIME INSPECTION

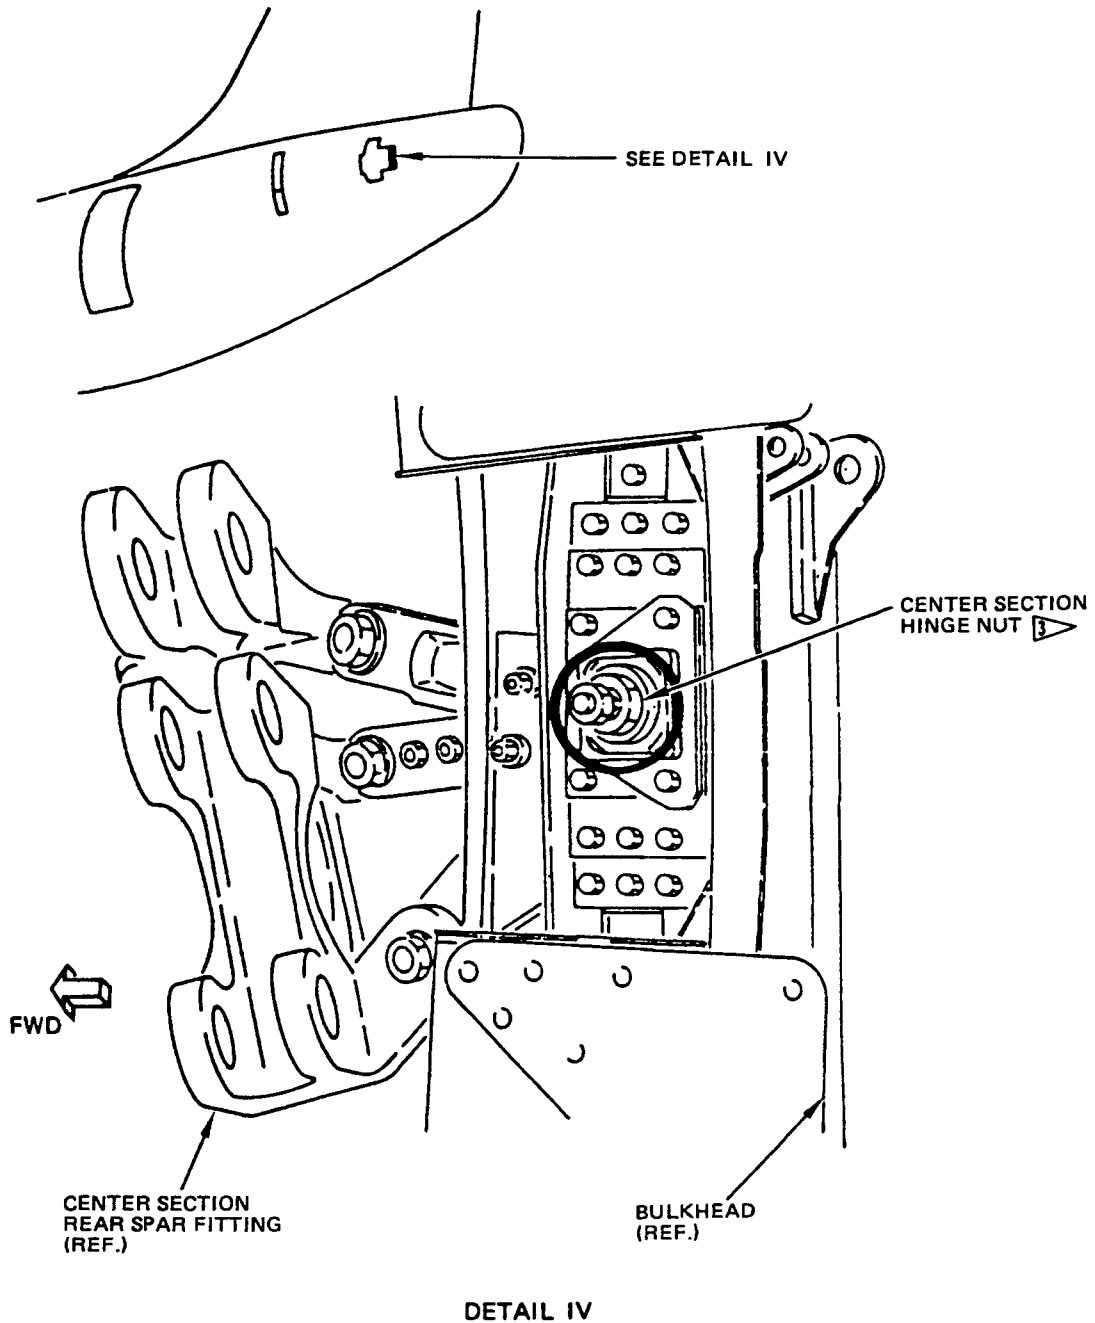
Horizontal Stabilizer  
Figure 1 (Sheet 4)

3 ON VERY EARLY AIRPLANES,  
THIS NUT WAS NOT PLATED.  
REPLACE SUCH NUTS WITH  
PLATED NUTS PER SB 55-1002.
