CORROSION PREVENTION MANUAL

Volume 2-747

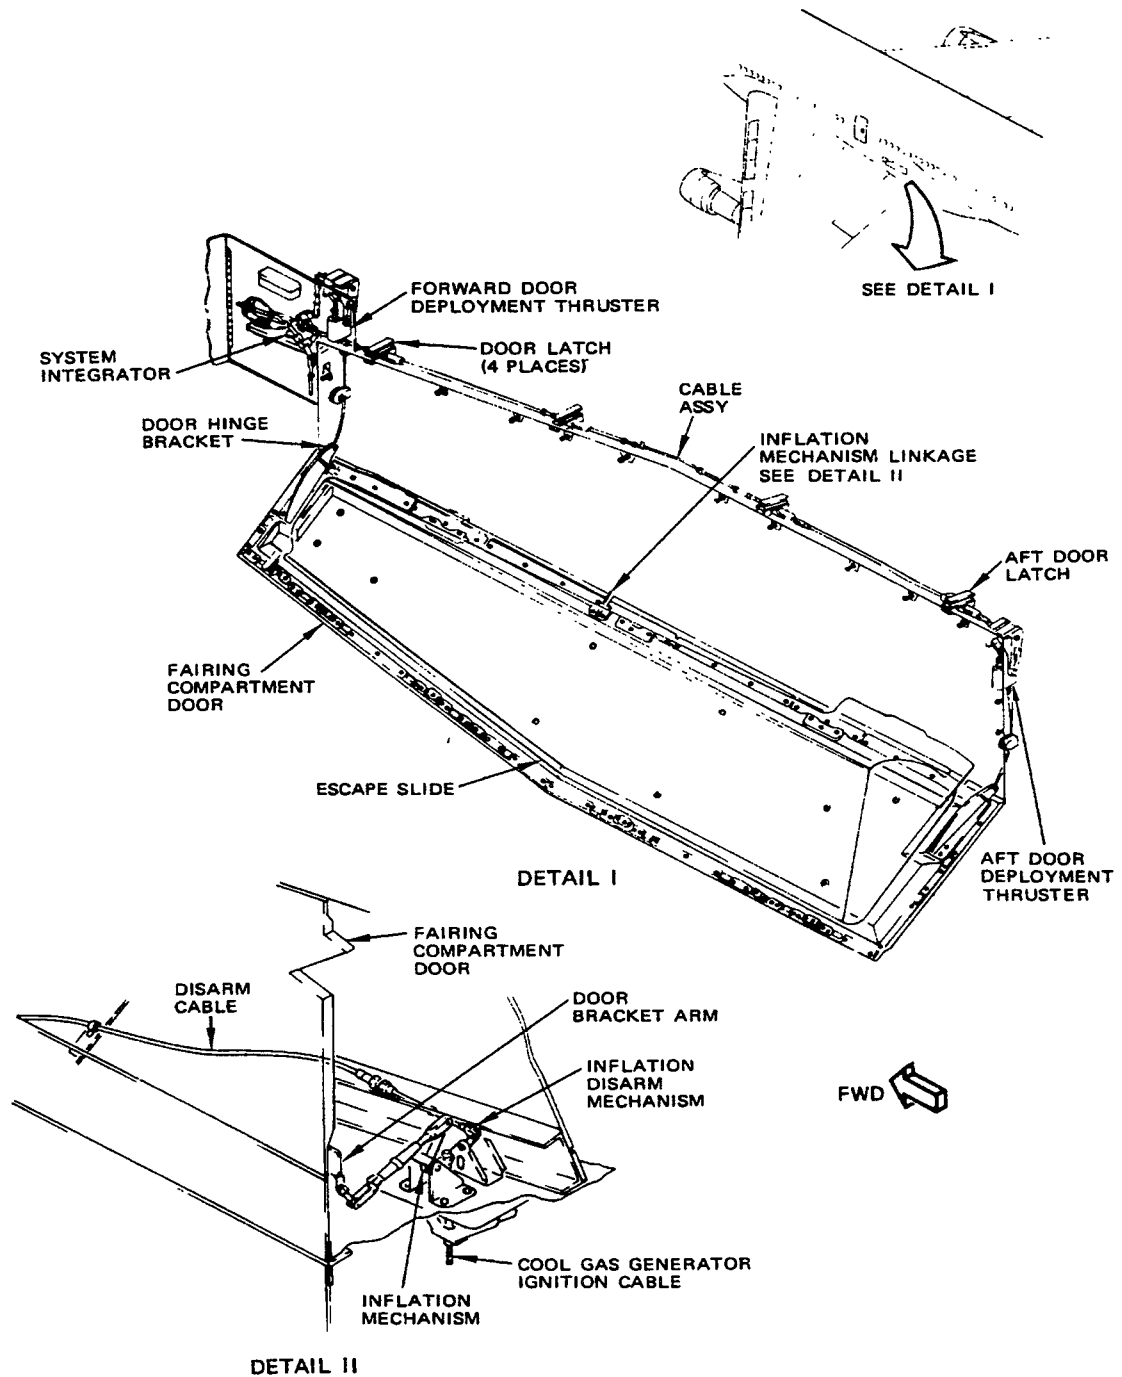
Fairing Mounted Escape Slide Compartment Door
Figure 1

- A. Emergency escape slide system components have been involved with corrosion problems. Various degrees of corrosion on the latch mechanism, manifolds, couplings, fittings and associated lines has been reported. It is possible that prolonged exposure to condensation may be a factor in the deterioration of these components since the installations are not readily accessible for inspection and maintenance.

- A. Off-wing escape slide compartment door components such as the latch integrator, latch mechanism and slide pack release mechanism are protected in production by the application of butter lube with Dow Corning 33 light consistency grease. However, prolonged exposure to condensation during operation has caused moderate corrosion to these components.
- B. In normal operations, the escape slide compartment mechanisms are lubricated during maintenance checks on the escape systems. Where an airline has a history of corrosion in this area, more frequent lubrications should be performed in accordance with 12-21-14 of the Maintenance Manual.
- C. Refer to Structural Repair Manual for corrosion removal procedures.

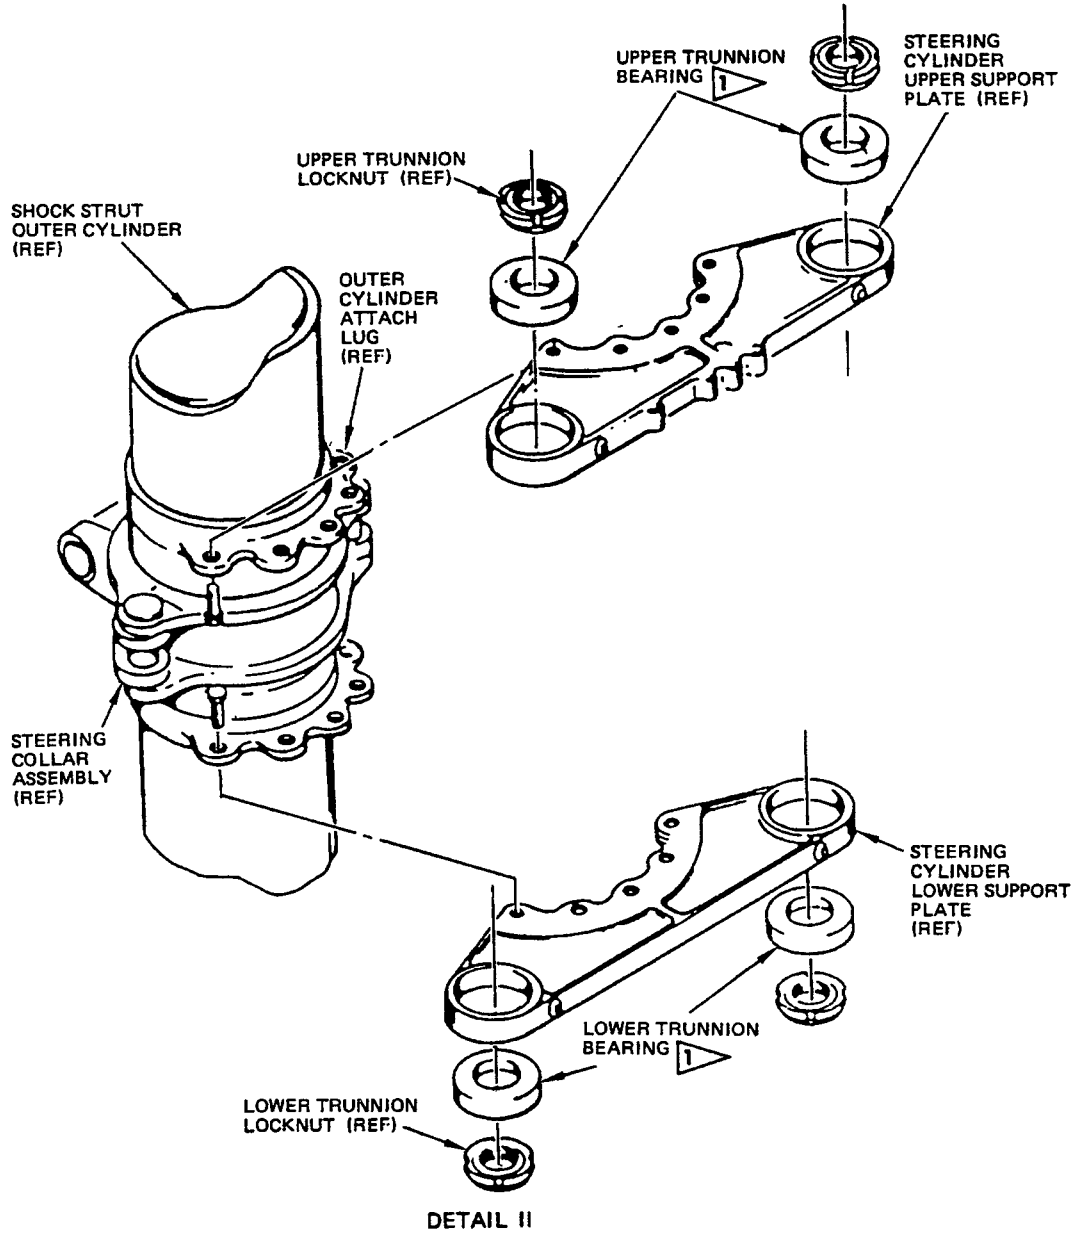
Nose Landing Gear
Figure 1 (Sheet 2)

1 CORROSION HAS BEEN FOUND IN THIS AREA
PERIODIC INSPECTION IS RECOMMENDED
PER SB 32-2065

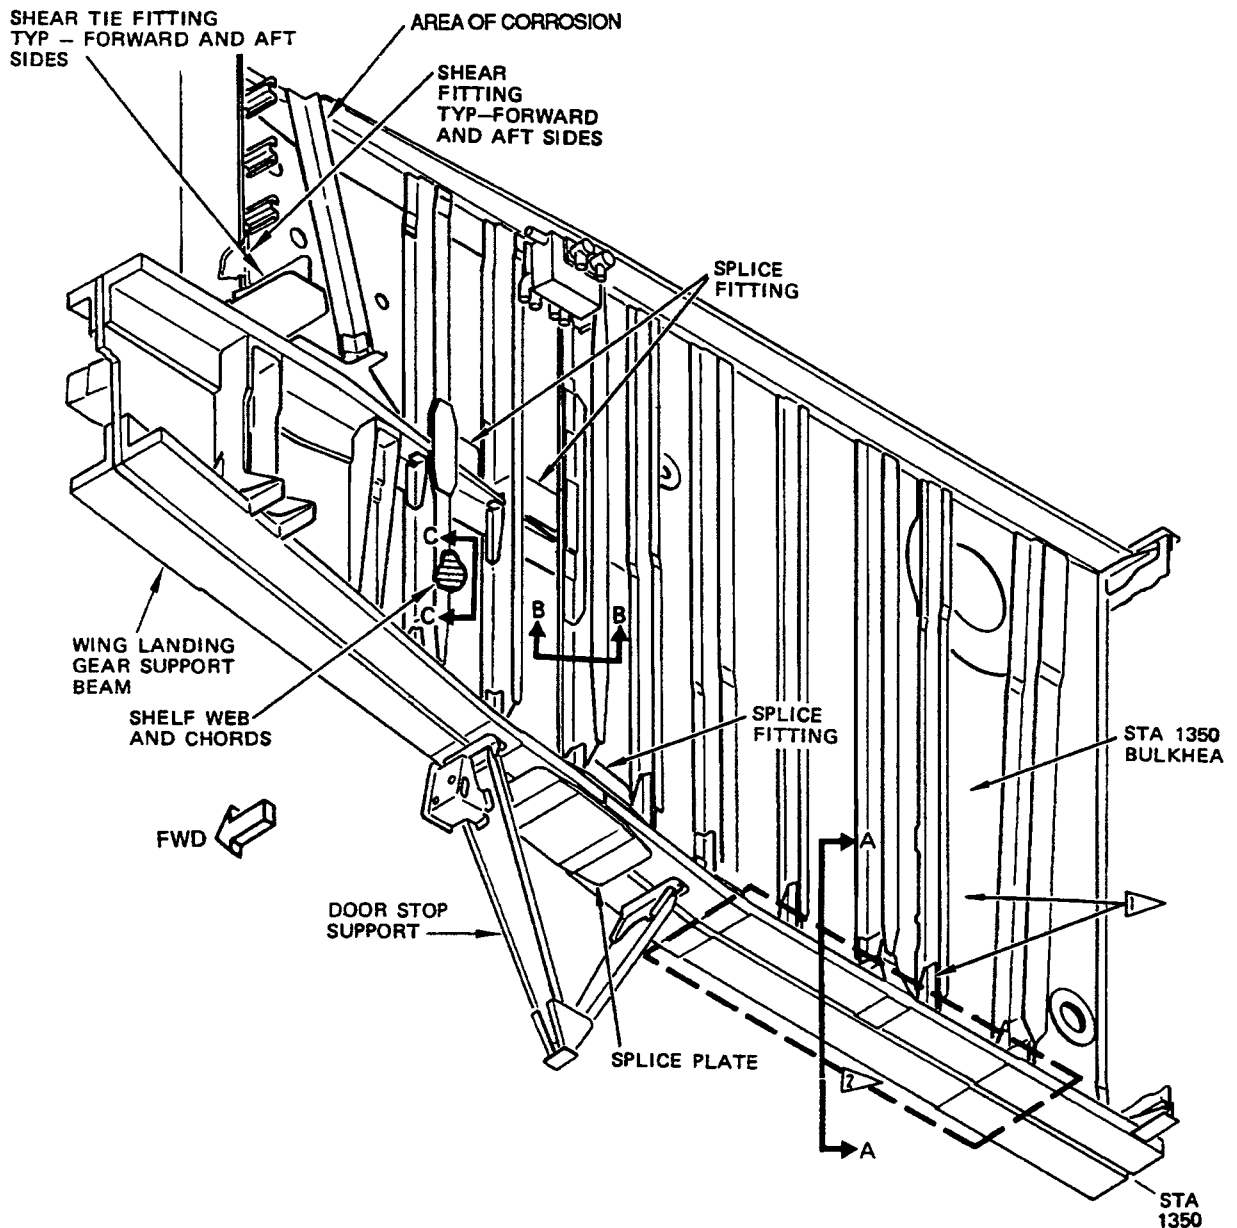
DETAIL II

- 1 ▷ APPLY BMS 3-23 ON ALL EXPOSED STRUCTURE
- 2 ▷ CAREFULLY EXAMINE THE LOWER CHORDS OF THIS BULKHEAD FOR DAMAGED FINISH BECAUSE OF RUNWAY DEBRIS FROM THE TIRES. THE DEBRIS COLLECTS ON THE HORIZONTAL FLANGES, ESPECIALLY AT THE FORWARD CHORD. CLEAN OFF THIS DEBRIS REGULARLY
