Volume 2-767

#### LEP

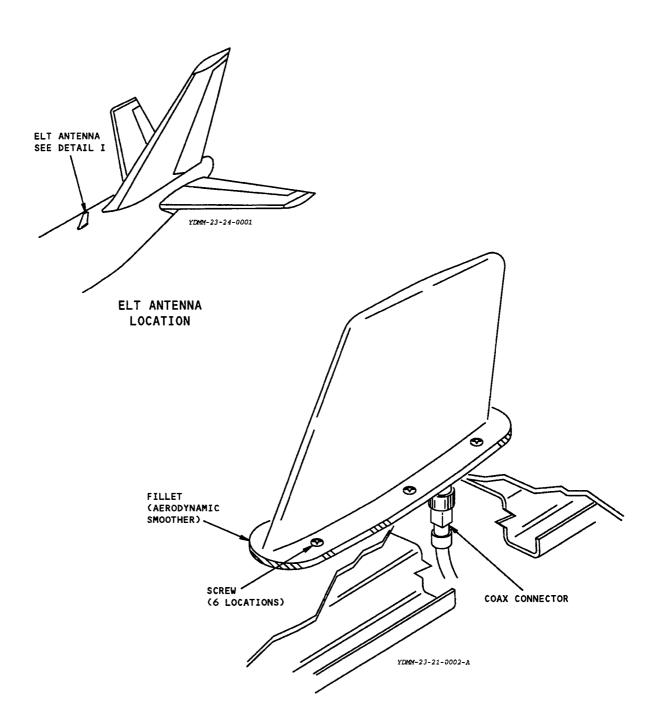
ELT Antenna Installation Figure 1

A. Corrosion can occur between the emergency location transmitter (ELT) antenna and the fuselage skin.

- A. Regularly remove the ELT antenna and examine the mating surfaces for corrosion.
- B. Improved Corrosion Protection
  - (1) At line number 448, PRR B12253 changed the procedures that install the ELT antenna on the exterior of the airplane. BMS 10-79, Type III primer and BMS 3-27 corrosion preventive compound are applied to the skin under the antenna, and the fasteners are cadmium-plated stainless steel.

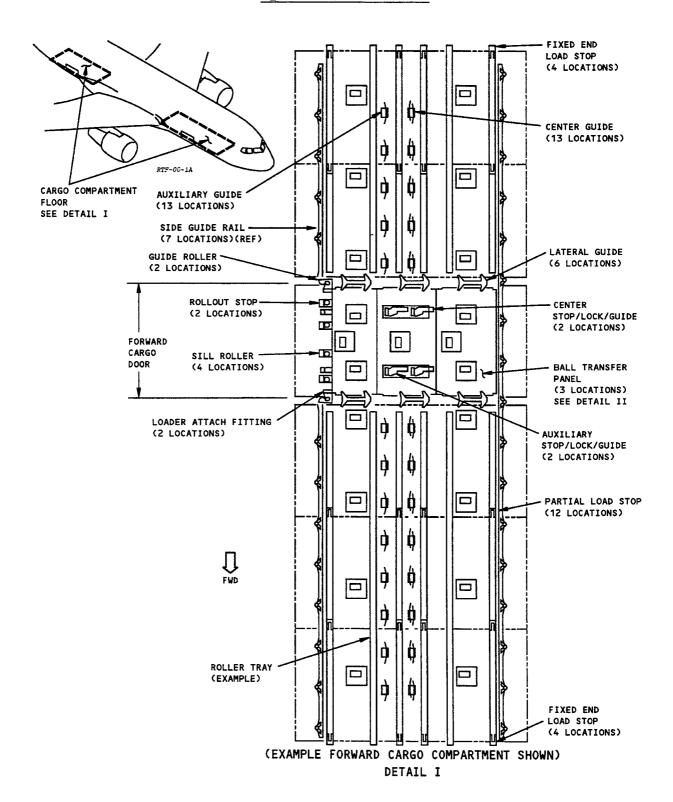
Ball Transfer Panel
Figure 1 (Sheet 1)

A. Corrosion can occur on the ball transfer panels (ball mats) in the forward and aft cargo compartments.

A. Regularly examine the ball transfer panels for corrosion.

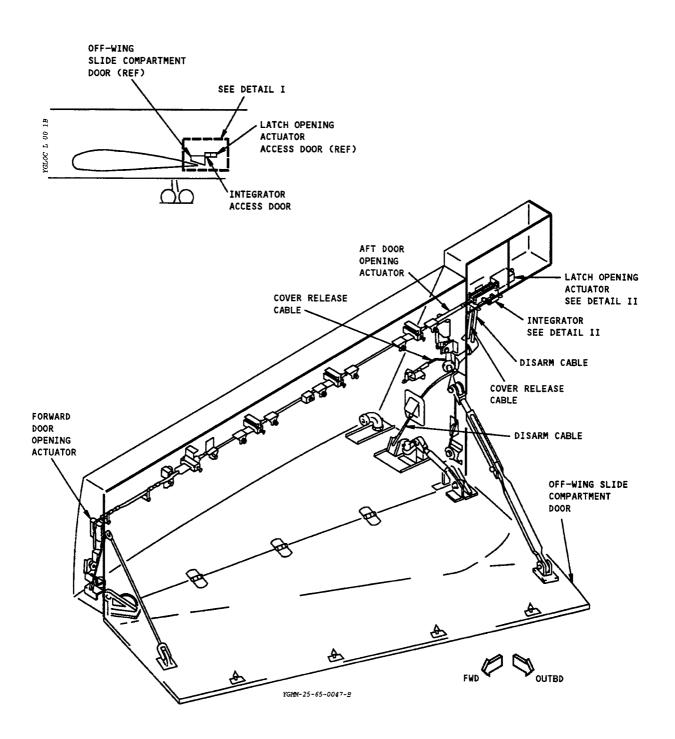
Off-Wing Escape Slide Integrator Figure 1 (Sheet 1)

- (1) Corrosion can cause much friction in the escape slide release mechanism. This condition may prevent the escape slide retaining shaft from rotating. Without rotation of the shaft, the slide cover will not deploy and the pressure vessel will not trigger (Ref 25-60-02, Fig. 1, Detail I).

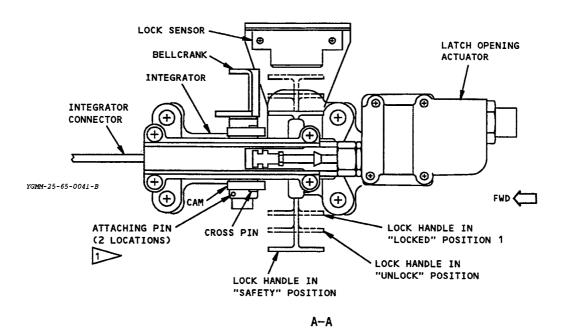
Off-Wing Escape Slide Integrator Figure 1 (Sheet 2)

- (5) In the integrator at the latch opening actuator, stress corrosion can occur on the 400 CRES pins MS16562-236 that attach cams to the bellcrank (Ref 25-60-04, Fig. 1, Detail II).

400 CRES PINS MS16562-236 CAN GET STRESS CORROSION CRACKS

- C. If you find corrosion on the 400 CRES pins MS16562-236 between the bellcrank and the cams in the latch opening integrator, replace the pins with 302 CRES pins MS51923-297. Refer to CMM 25-65-62 for details.

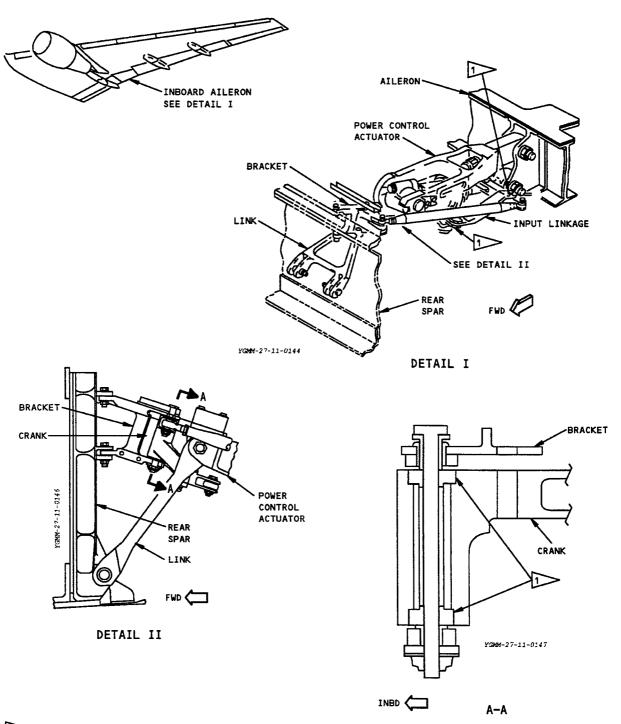
Inboard Aileron Power Control Actuator Figure 1

- B. Corrosion can occur on the bearings in the pilots' control wheel (Ref 27-10-02).
- C. Corrosion can occur on bearings in linkage of the power control actuators (Ref 27-10-03, 27-10-04), the outboard aileron lockout mechanism (Ref 27-10-05), and the aileron control feel mechanism (27-10-06).

CORROSION CAN OCCUR ON THESE BEARINGS

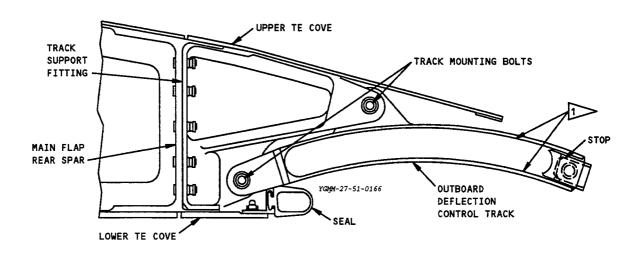
TRACK SURFACE SUSCEPTIBLE
TO CHROMIUM DEPLETION AND
SUBSEQUENT CORROSION

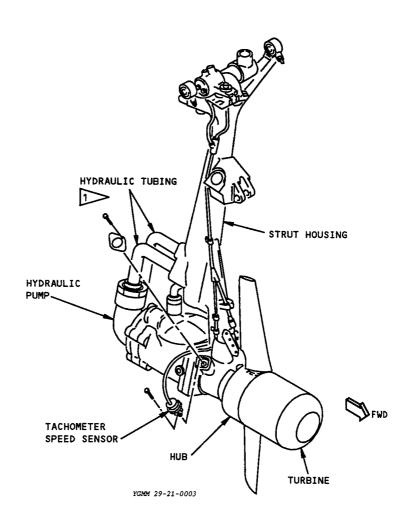
## RAM AIR TURBINE ASSEMBLY DETAIL III

AREA OF POSSIBLE CORROSION
