# LaserJet / LJ2000 Troubleshooting Guide

**Volume 1**  
**April 1995**  
**Revision 13**

# The Classic LaserJet Troubleshooting Manual

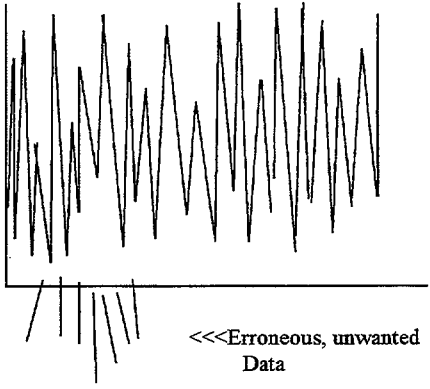
<p><b>Eroneous lines</b> appearing on XY Chart, printing in HPGL2, see example opposite. The problem appears the more complex the XY Chart plot is.</p> <p style="text-align: center;"><i>(LJIII)</i></p>	<ol style="list-style-type: none"> <li>1. Use latest revision of firmware (DC 19900430) on the Formatter PCA.</li> </ol>

<p style="text-align: right;">&lt;&lt;&lt;Erroneous, unwanted Data</p>
<p style="text-align: center;"><b>LJIII Intermittently drops OFF-LINE?</b></p> <p style="text-align: center;"><i>(G. Clark - Leeds - Jan 94)</i></p>	<p style="text-align: center;"><i>Replacing Formatter PCA seem to resolve this pfm.</i></p>
<p><b>COMPLETELY DEAD?</b> No Display, <b>ERROR 12</b>, this fault could be Intermittent.</p> <p style="text-align: center;"><i>(Updated)</i></p>	<ol style="list-style-type: none"> <li>1. <i>Replace DC Controller PCA.</i></li> <li>2. <i>Replace Formatter PCA</i></li> <li>3. Remove any PCA installed in the Optional I/O (JetDirect XIO, i-Data, etc), is fault resolved? If not <i>replace this PCA..</i></li> <li>4. <i>Replace DC Power Supply.</i> If the DC Controller &amp; Formatter PCA are removed you can check DCPS by grounding pin 7, <i>Remote Enable line</i>, on the DC Power Supply, if the supply is OK the +/- 5v &amp; 24v should come up. If not replace DC Power Supply Module.</li> </ol> <p><i>See Flow Diagram towards beginning of this section</i></p>

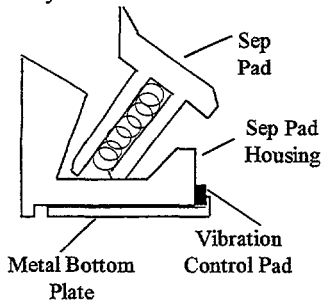
"MOANING" NOISE" in the vicinity of the Paper Pick-up assy

1. New Separation Pad available (P/N RG1-1912-080CN).
2. Try different paper, Xerox 80 paper (Black reams) is known to work well in these printers. Please note HP does not recommend paper, it's the customer's responsibility to test for a suitable paper.
3. Smoother papers can cause problems.

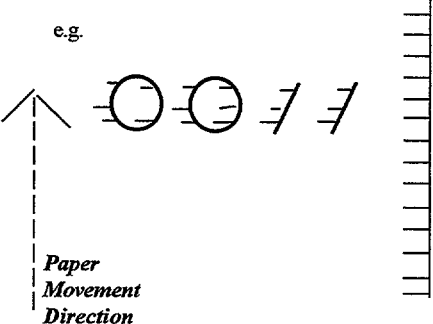
<p>Intermittent <b>DARK 2 inch Wide BAND OF Toner</b> in Laser Scan direction. Occurs every 20-50 pages, edges of band are blurry and extends across the entire length of drum.</p>	<p><i>Faulty POTENTIAL CONTROL PCA.</i> The "ES LOOP" was running out of control causing the Primary Corona current to increase until it began to arc.  <b>TIP:</b> Set SW1 on the mode select switches (P 6C-33) to OFF (right). This sets the Primary Corona control to NON-AUTOMATIC" mode, which keeps the current fixed at the initial (Vdark target) value.</p>
<p><b>STREAKY BACKGROUND</b>  Faint lines across page, approx 1/2mm apart. These lines appear in scan direction, but are not straight lines. They are slightly uneven and looks very much like background.</p>	<ol style="list-style-type: none"> <li>1. Worn/dirty cleaner blade - reverse edge or replace.</li> <li>2. Replace Cleaner Station Assy.</li> </ol>
<p><b>HORIZONTAL Displacement LH PARTS OF ALL CHARACTERS (LANDSCAPE MODE).</b>  Chars are clearly formed (i.e. NOT fuzzy) but have distinctive LH tails (in this case a row at the top and bottom, and one in the middle). See Example opposite.</p>	<p><i>Faulty SCANNER MOTOR assembly.</i></p>
