Product History and
Service Notes

Air Flow from the Fan can Cause Spray and Misdirection

Date: 1 February 1996
Service Note: C3196A-05
C3198A-03
Supersedes: None
Products: HP DesignJet 750C (C3196A)
HP DesignJet 750CM (C3198A)
Serial Numbers: C3196A ESA0000000/ESA4508541
C3198A ESA0000000/ESA4508541

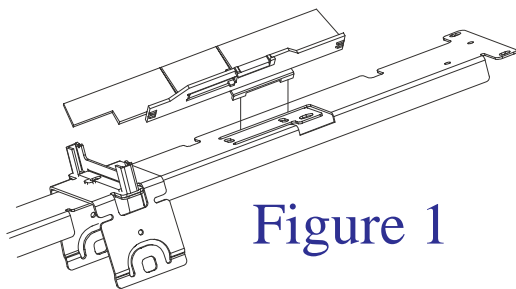
Figure 1

Air flow from the fan can cause spray and misdirection, generating a vertical band in certain prints on glossy media.

The band is on the left side and has a width of about 10 centimeters or 3.94 inches. It is only visible in certain area fills and shows up as:

- 3 Identify the cuts in the Y-yoke where the fan deflector is to be installed. These cuts are on the left side of the plotter.
- 4 Passing the fan deflector between the slider rods and the encoder strip, install the two front clips in the cut as shown in figures 1 and 2.
