# OPERATING AND SERVICE MANUAL

## ADDENDUM

# 5335A UNIVERSAL FREQUENCY COUNTER

ADDENDUM TO:  
5335A OPERATING AND SERVICE MANUAL  
HP PART NUMBER: 05335-90021

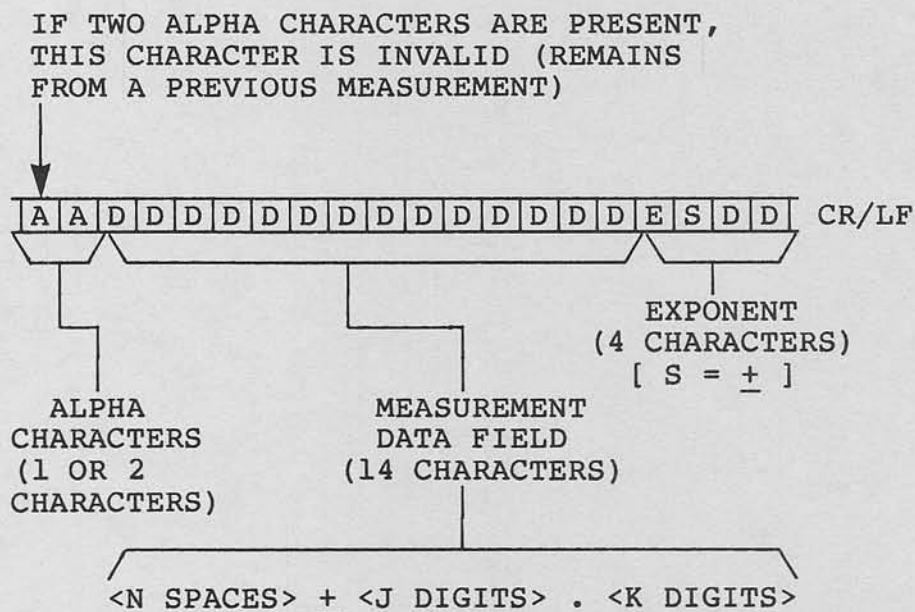
3-212. After a measurement, the 5335A outputs the data to the HP-IB. The output byte will contain 19 or 20 characters, followed by a "CR" and "LF" (carriage return and line feed) as shown in the diagram below:

If firmware Revision 1.1 is installed, dimension output string variables one character longer than with firmware Revision 1.0 to allow for the double alpha output. Failure to do so may result in loss of data or controller error. Also note that the program examples on Pages 3-35 through 3-45 will need to be modified to work properly.

A        3-32    Paragraph 3-212. Replace the paragraph and diagram with the following:
