Qualitative Assessment on the Effects of Damaged Connectors and Optical Interfaces in Fiber Optic Measurements

White Paper

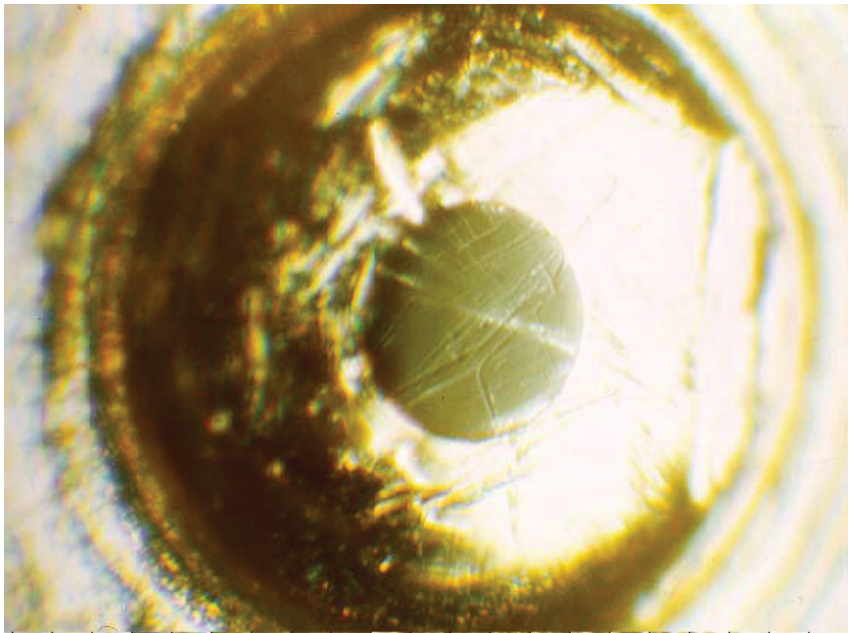
- 125 μm fiber and scratches;
- elbow scratch approx. 3 μm wide

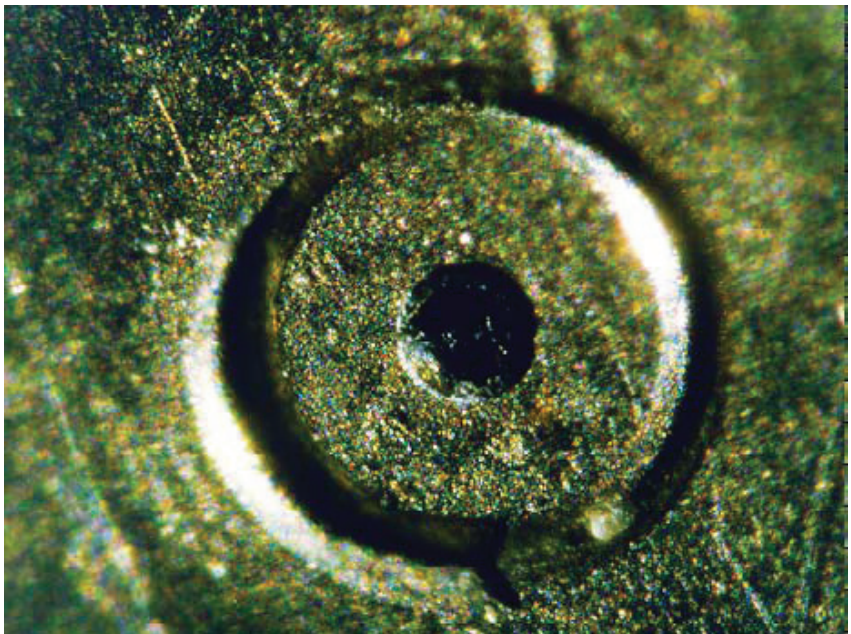
Extreme fiber damage on connector.

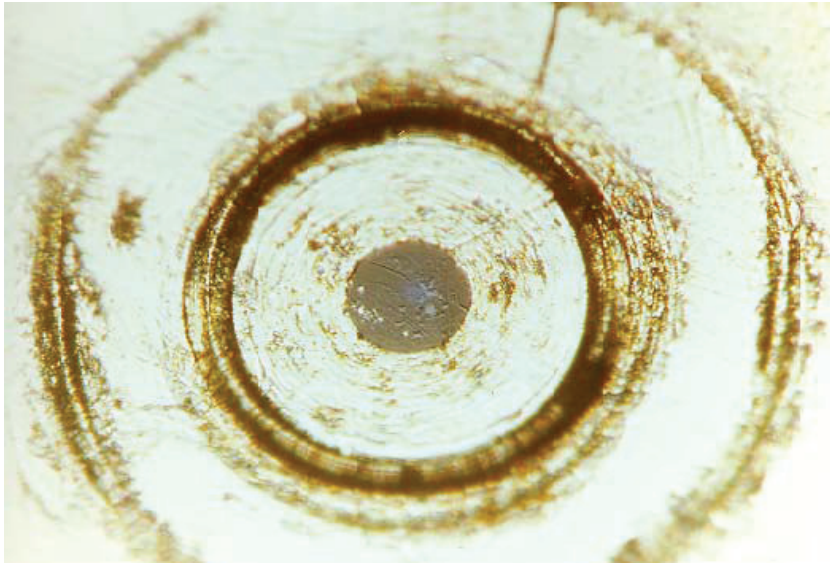
HMS-10

General example of damage:

- Scratches
- White objects are metallic particles embedded in fiber
- Pits are where metallic particles have fallen out

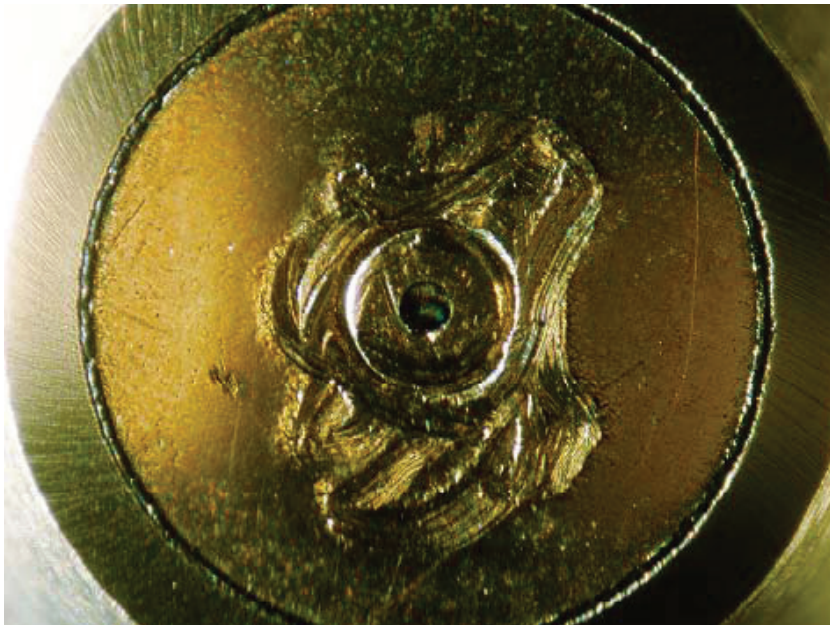
2.5 mm Ferrule

Assume that ferrule end was 'cleaned' by probing with pin.

Nickel/silver insert within Tungsten carbide ferrule easily scratched with pin.
Insertion loss was approx. 8 dB.

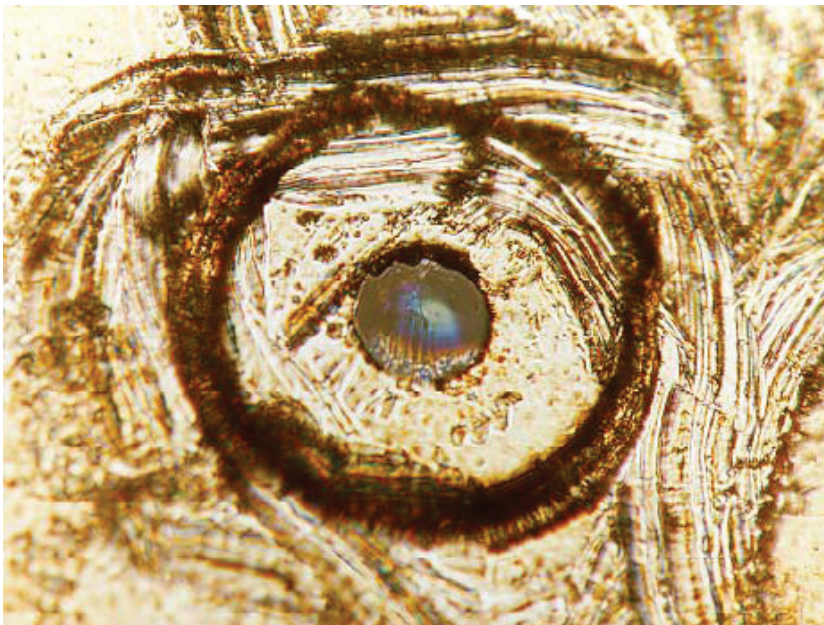
Fiber within 2.5 mm Ferrule

Previous slide magnified.

- Note where scratch leads to broken fiber edge
- Crescent mark across bottom of fiber is where metallic disposition has taken place when pin was drawn across surface of fiber

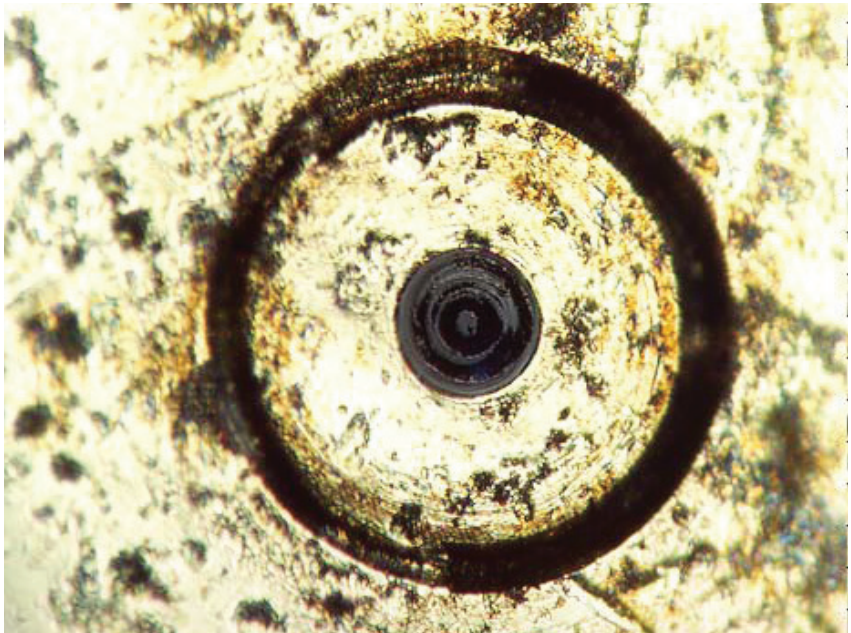
Fiber within 2.5 mm Ferrule

OTDR front panel connector/ferrule

Recessed ring effect either due to incorrect fiber inserted and rotated or missing key on correct connector. This caused extreme multiple reflections between this and the fiber .

See page 14 for effects on OTDR measurement.

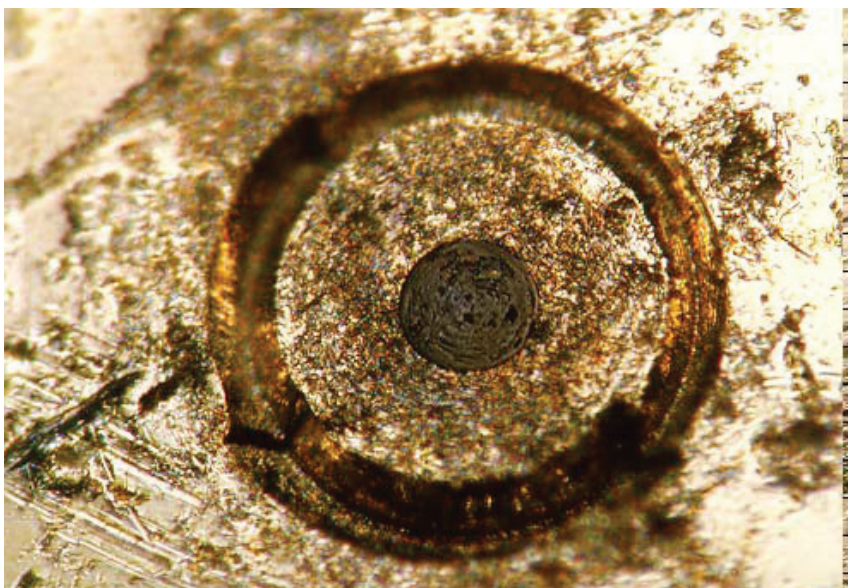
Fiber within 2.5 mm Ferrule

- After seeing this unit over a period of 1 year, the connector finally gave up.
- See page 13 for effects on OTDR measurement.

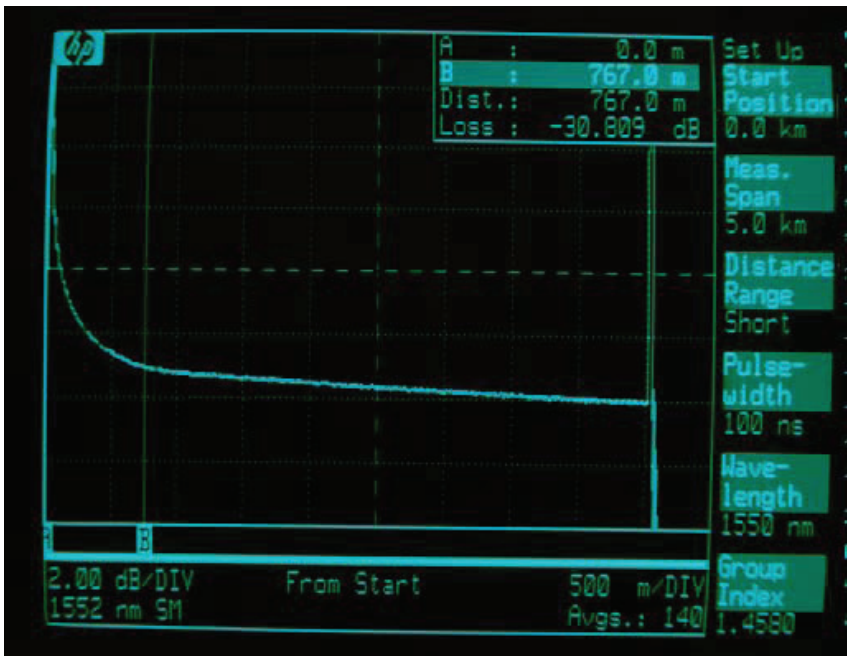
OTDR Trace

Typical result of damaged front panel connector

Note! Extreme back reflection at pulse launch and loss of 0.75 km before use-able measurements can be made.

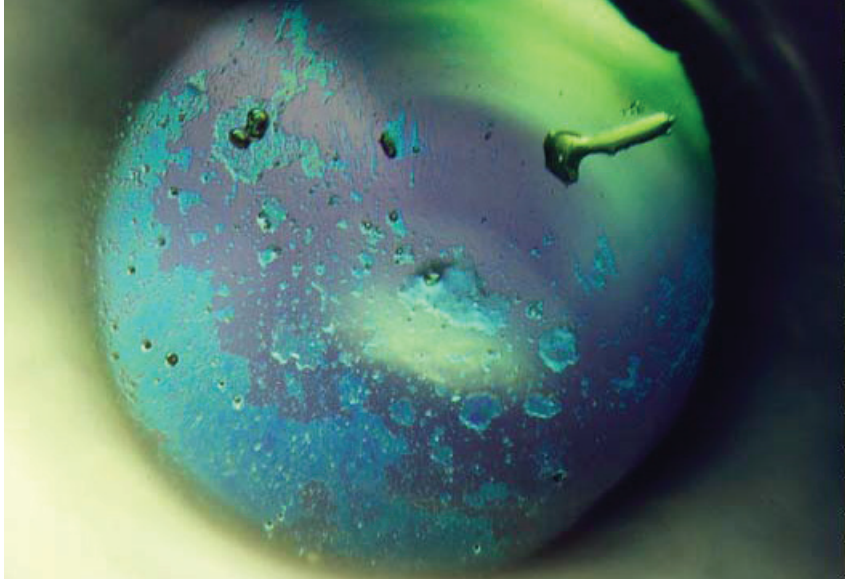
Picture through front panel connector of collimating lens.

- Lens coated with Refractive Index matching (RI) liquid which has collected particles of dust and grit
- This unit showed approx. 10 dB insertion loss.

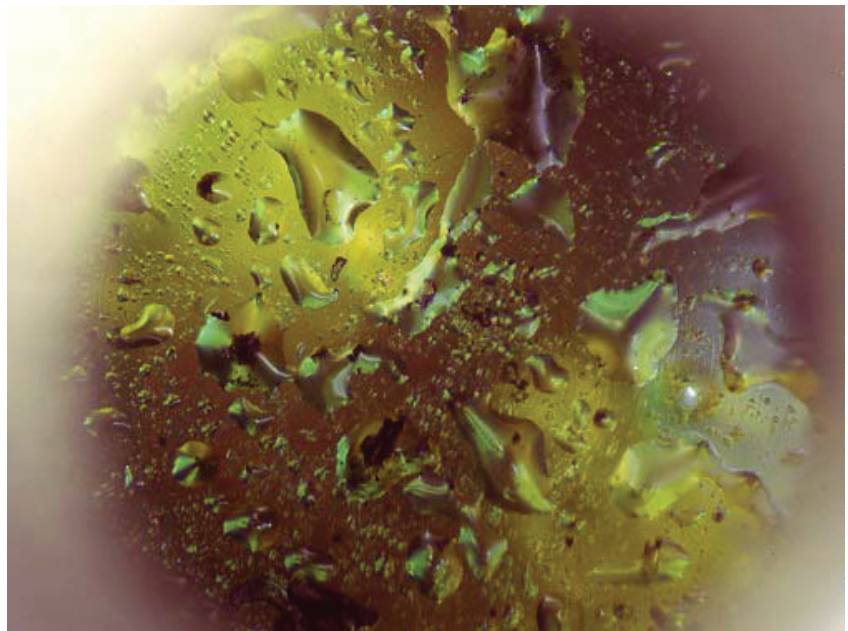
Picture through front panel connector of collimating lens.

User has attempted to remove RI liquid with solvent.

- Typical globular RI liquid pattern results when solvent has evaporated.
- This unit showed approx. 20 dB insertion loss.

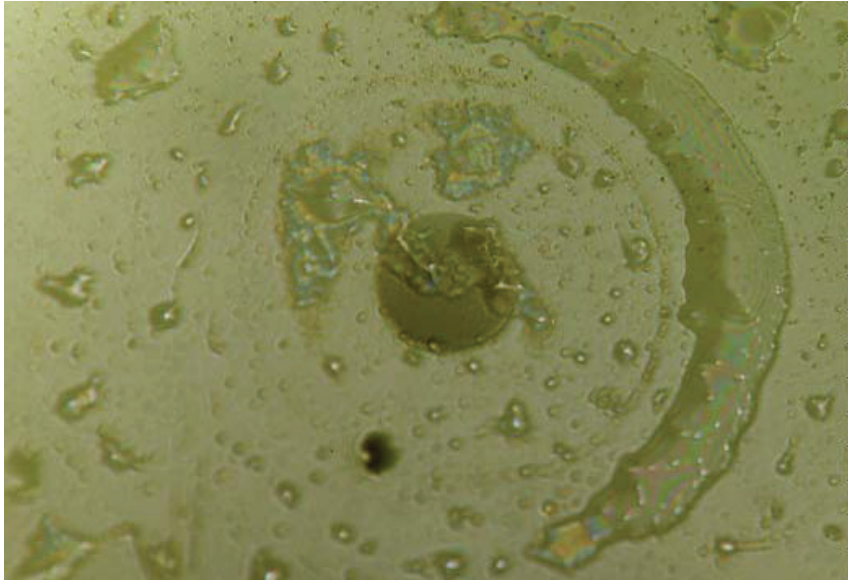
Ceramic ferrule showing RI liquid contamination

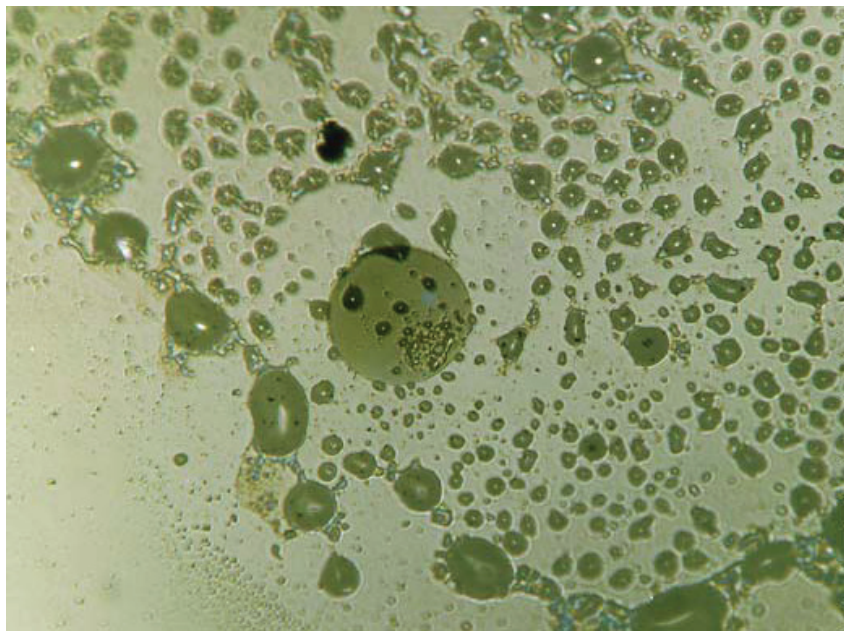
Isopropyl alcohol (IPA) applied with cotton bud and cleaned, waved in air to evaporate IPA.

Result: RI liquid reforms into globules.

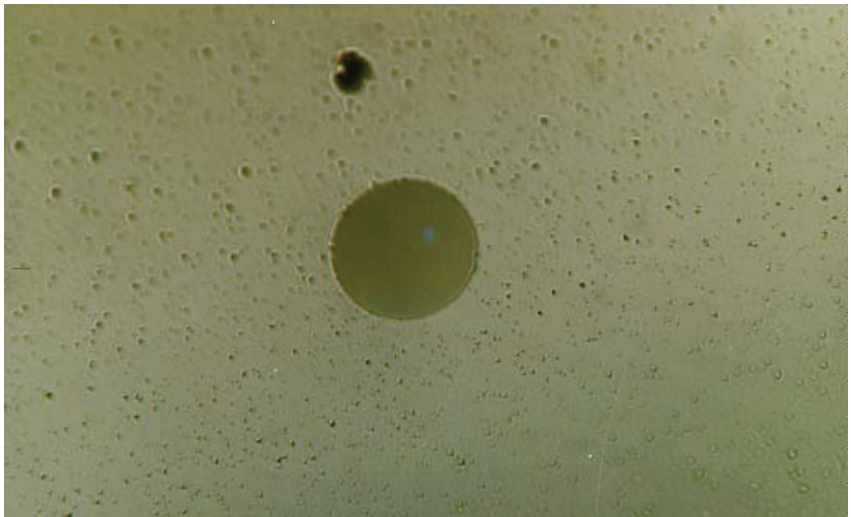
FC/PC Connector

Again cleaned with isopropyl alcohol in some way but compressed air blown over ferrule end.

Result: clean connector/ferrule. Marks on ferrule end are part of the ceramic material.

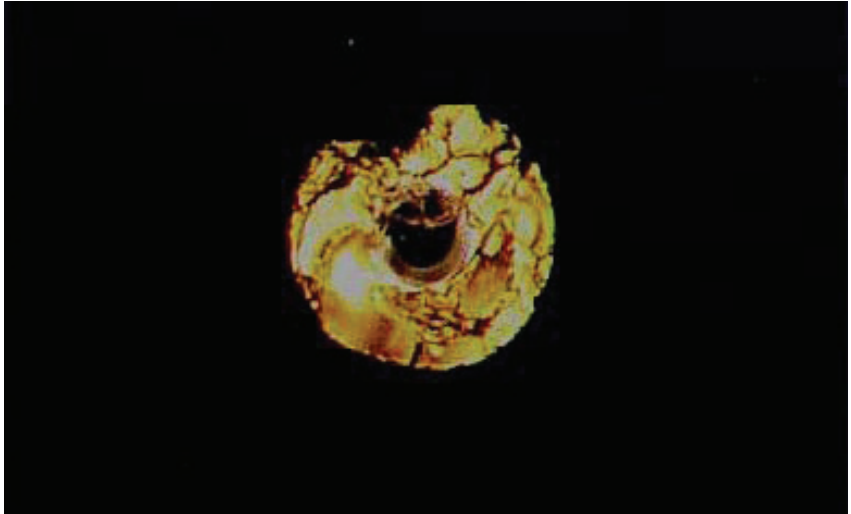
OSA Input Connector

Multimode fiber from previous slide, back illuminated now.

Light is traveling through the cladding, where the center of the core is nearly without any light.

Note the scratches on the core and chipped effect across the entire surface of the fiber end face.

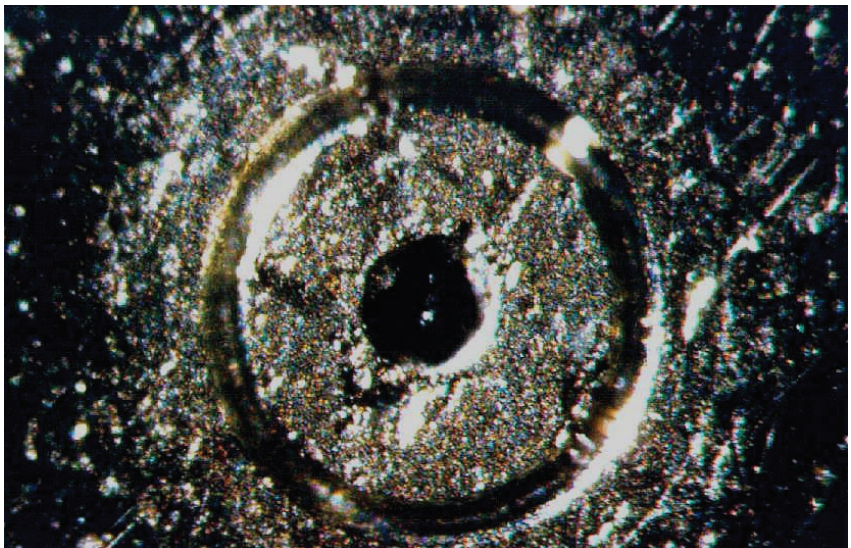
OSA Input Connector

Multimode fiber

Front illumination.

Scratches on the core or cladding and chipped fiber end face are hard to see.

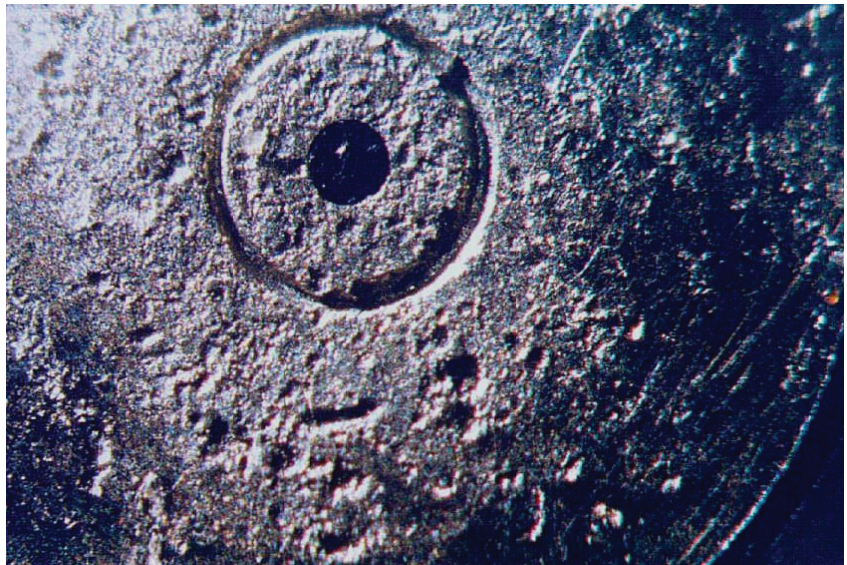
OTDR Input Connector

Singlemode fiber with even distributed dirt and dust.

- Note the fine scratches at the edge of the ferrule.
- They are generated by scrubbing the connector with other tools than lint-free cotton swaps or lens papers.

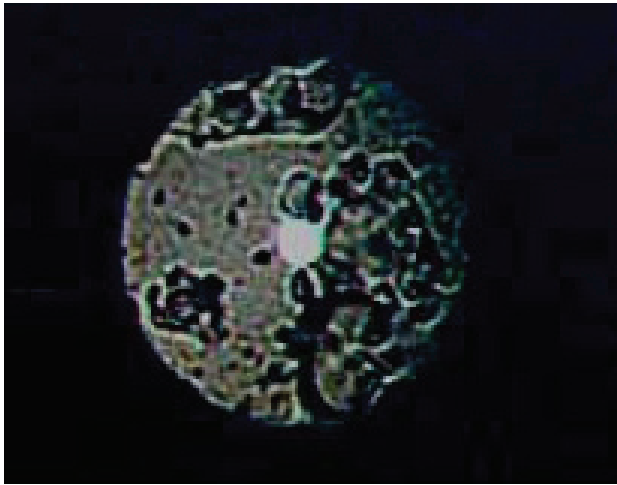
OTDR Input Connector

Singlemode fiber cladding and core of the previous slide (black) are now both visible (back illuminated).

- The core guides the most light.
- Damage is primarily on the cladding, but also on the edge of the core.

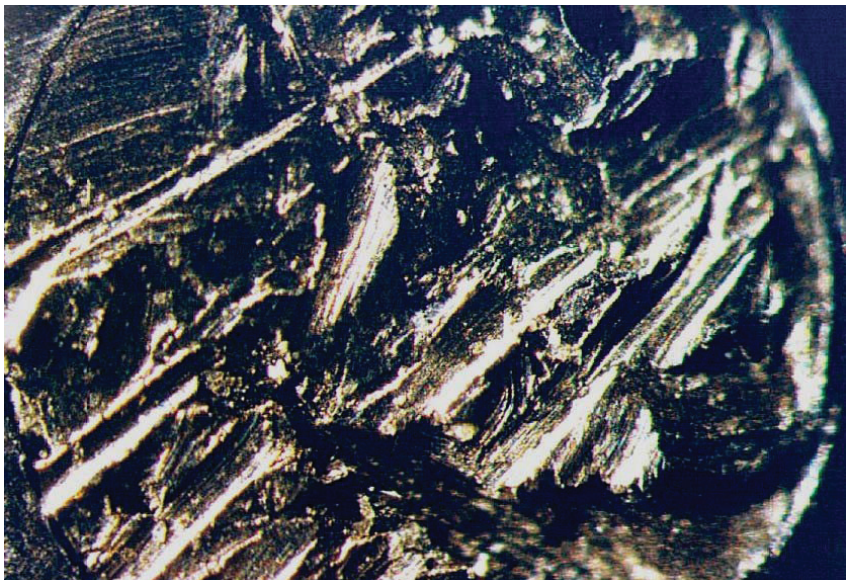
A completely damaged connector...
