The 1990 Changes in National Reference Standards

Service Tip

Attention HP 8757C/E Network Analyzer Owners

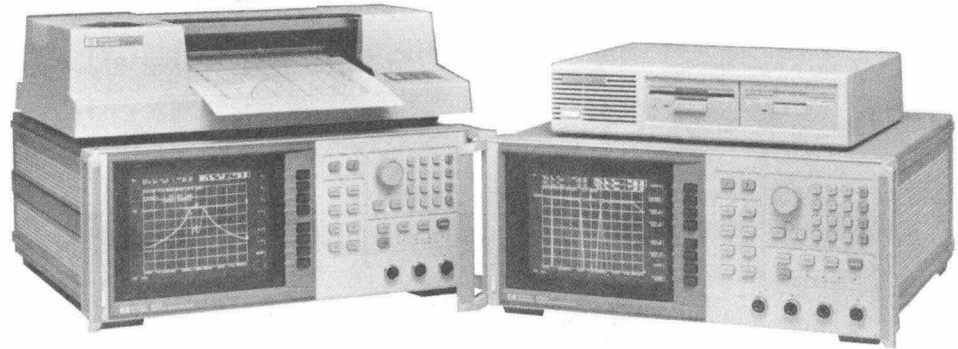
As with all color monitors, these displays are very susceptible to external magnetic fields. These fields can originate from many sources, including metal-frame tables and from the earth itself. The usual symptom is a discoloration or slight dimming of the display, usually near the top left hand corner of the CRT. In extreme cases, a total color shift may be observed; for example, a trace that was red may shift to green. This does not indicate any problem with the display; it is characteristic of all color displays. In fact, you can take a perfectly good display, turn it upside-down on a metal table, and usually see some discoloration. This is most visible while viewing a solid red test pattern.

While every effort is made to ensure the display is free of any residual magnetism, changing the instrument's location or orientation may affect magnetic fields enough to cause color purity problems. This may be especially noticeable in the southern hemisphere. Generally, the built-in degaussing coil, which is engaged

each time the unit is turned on, is sufficient to maintain color purity. In some cases, especially after the instrument is moved or repositioned, it may be necessary to cycle the power several times to regain color purity.

If the automatic internal degaussing is insufficient to regain color purity, the CRT will have to be degaussed using a commercially available CRT degaussing coil. If a commercial degaussing coil is not available, a bulk magnetic tape eraser (such as Radio Shack #44-232 @ \$19.95) can be used if it is held about four inches from the face of the CRT. Only bring it closer than four inches if this distance is insufficient to regain color purity. If

none of these are available, an electric pencil sharpener will usually act as a reasonably good substitute for a degaussing coil. Use the electric pencil sharpener in the same manner as previously described.

For best results, the CRT should be degaussed in the exact position in which it will be used. Always make sure any magnetic tapes or disks are removed from the immediate area or you may demagnetize more than just the CRT! In summary, we recommend that you do not replace any color display for color purity or mis-convergence problems unless it has first been completely degaussed using one of the above methods. □
