Procedure for updating a LXI 1.3 component on the E5061B network analyzer

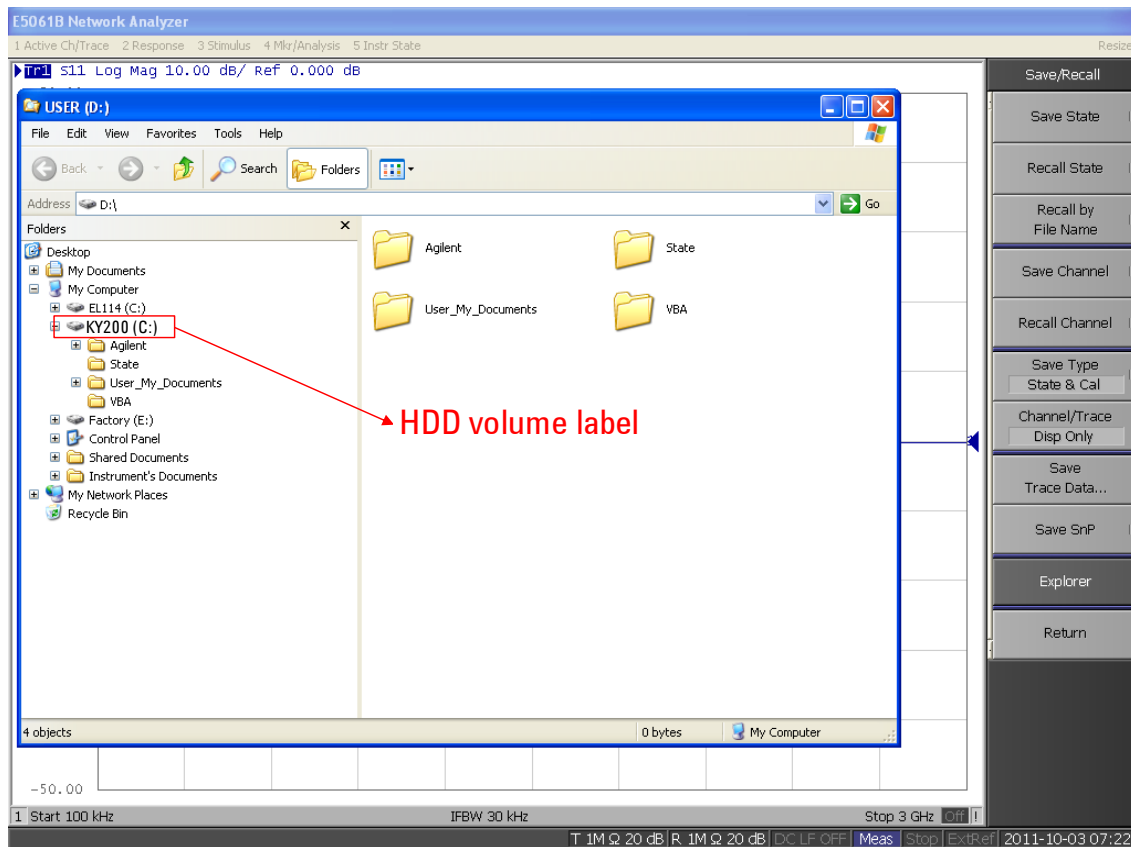
This document describes the procedure for updating a software component of the LXI 1.3 installed on the E5061B network analyzer. If your E5061B's HDD volume label is **EL200**, **KY200**, **EL203**, **KY203**, or **KY204**, it is recommended to update the LXI component by following the procedure shown below. Updating this LXI component will ensure the system's stability in the long-term continuous operation (e.g. more than 24 hours), especially if additional software such as security software is installed and operated on the E5061B.

Figure 1. HDD volume label (example of “KY200”)

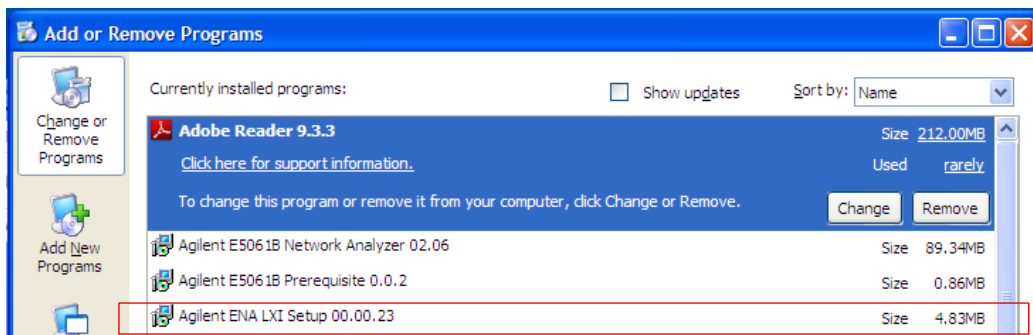
Figure 2. Confirming the LXI component installation

2-5) After the installation is finished, confirm that the new LXI component (Agilent ENA LXI Setup 00.00.23) is successfully installed (Start → Control Panel → Add or Remove Programs).
