Installation Note

Agilent Technologies 85105A Option 50 Installation Instructions for RF Switch Replacement Kit 85105-60047

Part Number 85105-90023 Printed in USA August 2002

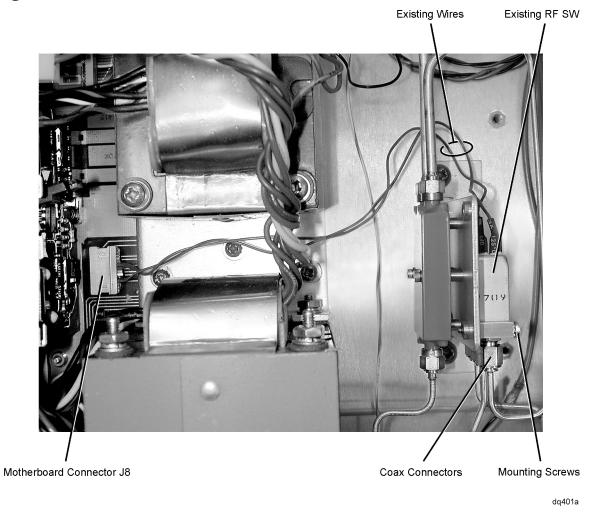
Figure 1 Removal of old A24

This document details a procedure for replacing the DC-50 GHz RF switch (A24) in the 85105A mm waveguide controller. This procedure is necessary if the existing RF switch (A24) is defective.

3. Loosen the three 2.4 mm semirigid coax cables from the existing RF switch (A24). Refer to Figure 1 on page 5.

- 4. Carefully remove the switch control cable from the J8 connector on the motherboard (refer to Figure 1).
- 5. Remove the two screws that attach the RF switch to the switch bracket and remove the old A24 (refer to Figure 1).
- 6. Carefully back the switch away from the three semirigid coax cables and remove the old A24 (refer to Figure 1).
