Installation Note

Agilent Technologies 8643A Synthesized Signal Generator Firmware Upgrade Kit 08643-61018

Part Number 08643-90022

Firmware Upgrade Kit 08643-61018 for the HP 8643A Synthesized Signal Generator

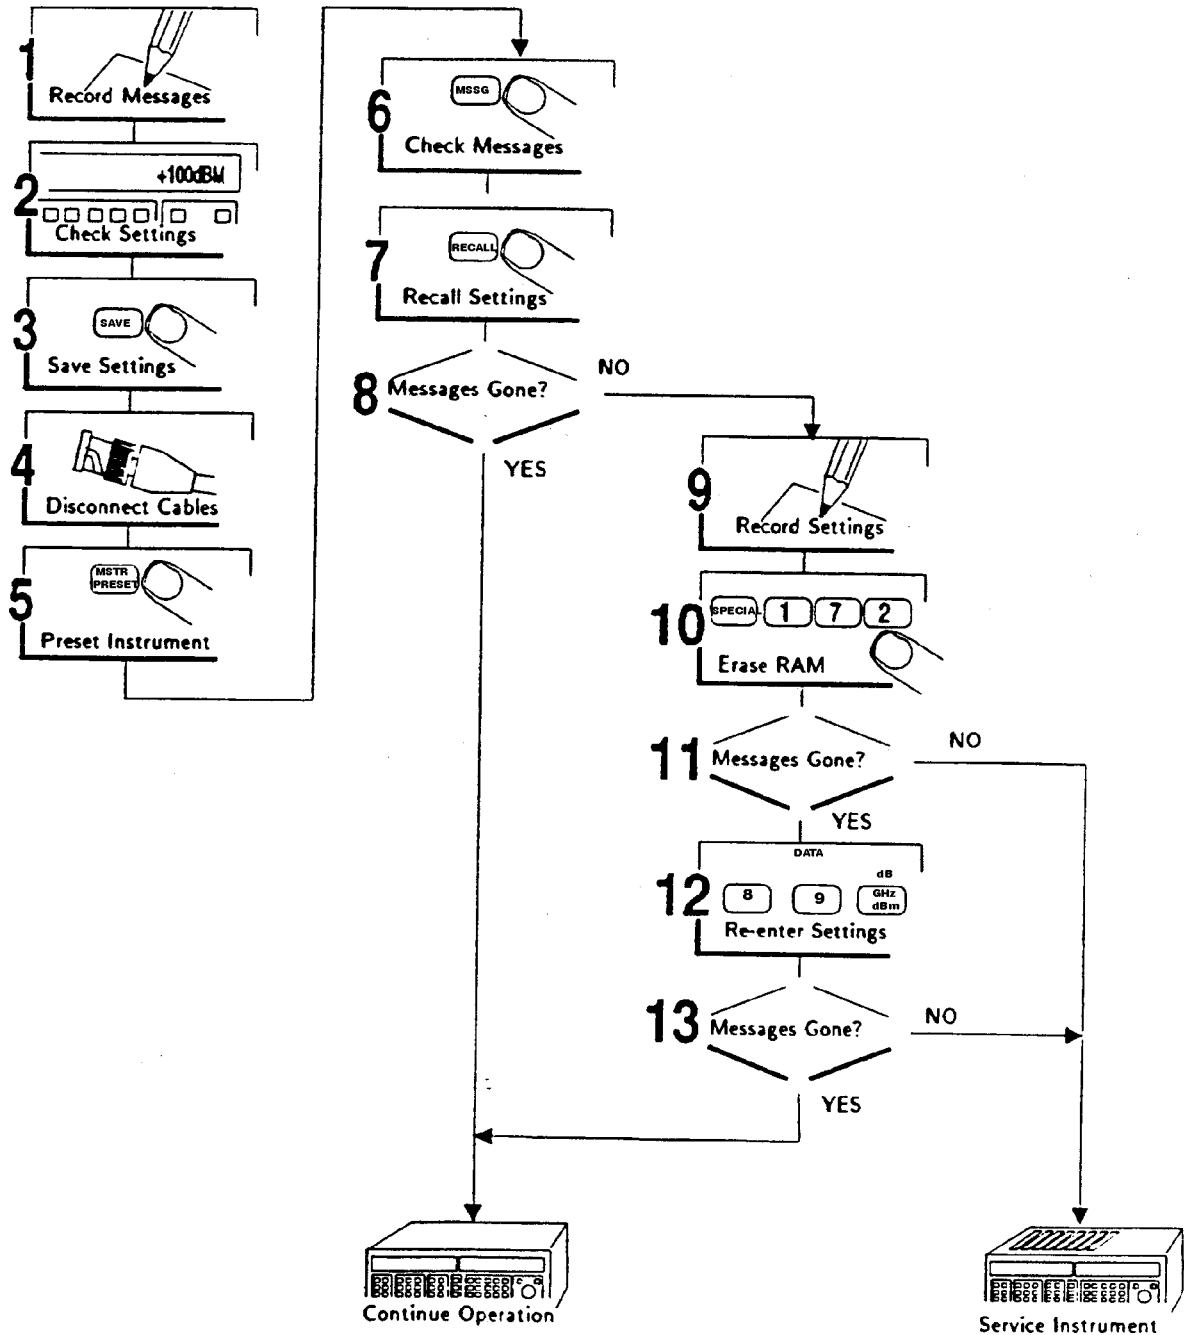
Figure 1. Corrective Action for Error Messages

Error Message	Description
Hardware Failure 1	A communications discriminator failure has been detected at power up, or detected as a result of a self-calibration or self-test. Refer to Figure 1 for corrective action.
Hardware Failure 2	A VCO failure has been detected at power up, or detected as a result of a self-calibration or self-test. Refer to Figure 1 for corrective action.
Hardware Failure 3	A Fractional-N failure has been detected at power up, or detected as a result of a self-calibration or self-test. Refer to Figure 1 for corrective action.
Hardware Failure 4	A modulation distribution failure has been detected at power up, or detected as a result of a self-calibration or self-test. Refer to Figure 1 for corrective action.
Hardware Failure 5	An ALC failure has been detected at power up, or detected as a result of a self-calibration or self-test. Refer to Figure 1 for corrective action.
Hardware Failure 6	An attenuator failure has been detected at power up, or detected as a result of a self-calibration or self-test. Refer to Figure 1 for corrective action.

Hardware Failure 7	An audio source failure has been detected at power up, or detected as a result of a self-calibration or self-test. Refer to Figure 1 for corrective action.
Hardware Failure 8	A reference failure has been detected at power up, or detected as a result of a self-calibration or self-test. Refer to Figure 1 for corrective action.
Hardware Failure 9	A doubler failure has been detected at power up, or detected as a result of a self-calibration or self-test. Refer to Figure 1 for corrective action.
Hardware Failure 13	A front panel failure has been detected at power up, or detected as a result of a self-calibration or self-test. Refer to Figure 1 for corrective action.
Hardware Failure 14	A power supply failure has been detected at power up, or detected as a result of a self-calibration or self-test. Refer to Figure 1 for corrective action.
Hardware Failure 15	An I/O board failure has been detected at power up, or detected as a result of a self-calibration or self-test. Refer to Figure 1 for corrective action.

Hardware Failure 16	A controller failure has been detected at power up, or detected as a result of a self-calibration or self-test. Refer to Figure 1 for corrective action.
Hardware Failure 18	A frequency counter failure has been detected at power up, or detected as a result of a self-calibration or self-test. Refer to Figure 1 for corrective action.
Hardware Failure 21	A communications discriminator out-of-lock (OOL) condition exists. Refer to Figure 1 for corrective action.
Hardware Failure 23	A Fractional-N (NF) phase-locked-loop (PLL) out-of- lock (OOL) condition exists. Refer to Figure 1 for corrective action.

Error Message	Description
Hardware Failure 24	A VCO frequency-locked-loop (FLL) out-of-lock (OOL) condition exists. Refer to Figure 1 for corrective action.
Hardware Failure 25	A VCO phase-locked-loop (PLL) out-of-lock (OOL) condition exists. Refer to Figure 1 for corrective action.
Hardware Failure 26	A fast controller failure has been detected at power up, or detected as a result of a self-calibration or self-test. Refer to Figure 1 for corrective action.
Hardware Failure 27	An audio source out-of-lock (OOL) condition exists. Refer to Figure 1 for corrective action.
Hardware Failure 28	A reference out-of-lock (OOL) condition exists. Refer to Figure 1 for corrective action.
Hardware Failure 31	A ROM failure has been detected at power up, or detected as a result of a self-calibration or self-test. Refer to Figure 1 for corrective action.
Hardware Failure 32	A ROM failure has been detected at power up, or detected as a result of a self-calibration or self-test. Refer to Figure 1 for corrective action.

Hardware Failure 33	A ROM failure has been detected at power up, or detected as a result of a self-calibration or self-test. Refer to Figure 1 for corrective action.
Hardware Failure 34	A ROM failure has been detected at power up, or detected as a result of a self-calibration or self-test. Refer to Figure 1 for corrective action.
Hardware Failure 35	A voltmeter failure has been detected at power up, or detected as a result of a self-calibration or self-test. Refer to Figure 1 for corrective action.
Hardware Failure 36	A RAM failure has been detected at power up, or detected as a result of a self-calibration or self-test. Refer to Figure 1 for corrective action.
Calibration Error 1	A condition occurred where invalid level calibration data resides in either the Output or the Attenuator modules. Follow the external calibration procedures outlined in Figure 1.
Calibration Error 2	At sometime during the calibration or self-test, a condition occurred where some hardware was unable to be calibrated. Fix the hardware and re-calibrate. Refer to Figure 1 for corrective action. This error message will always be accompanied by other error messages.
