# Installation Note

## **Agilent Technologies Firmware Upgrade Kit 08665-61114 for the 8665A Synthesized Signal Generator**

Part Number 08665-90067  
Printed in USA November 2004  
Supersedes March 2004

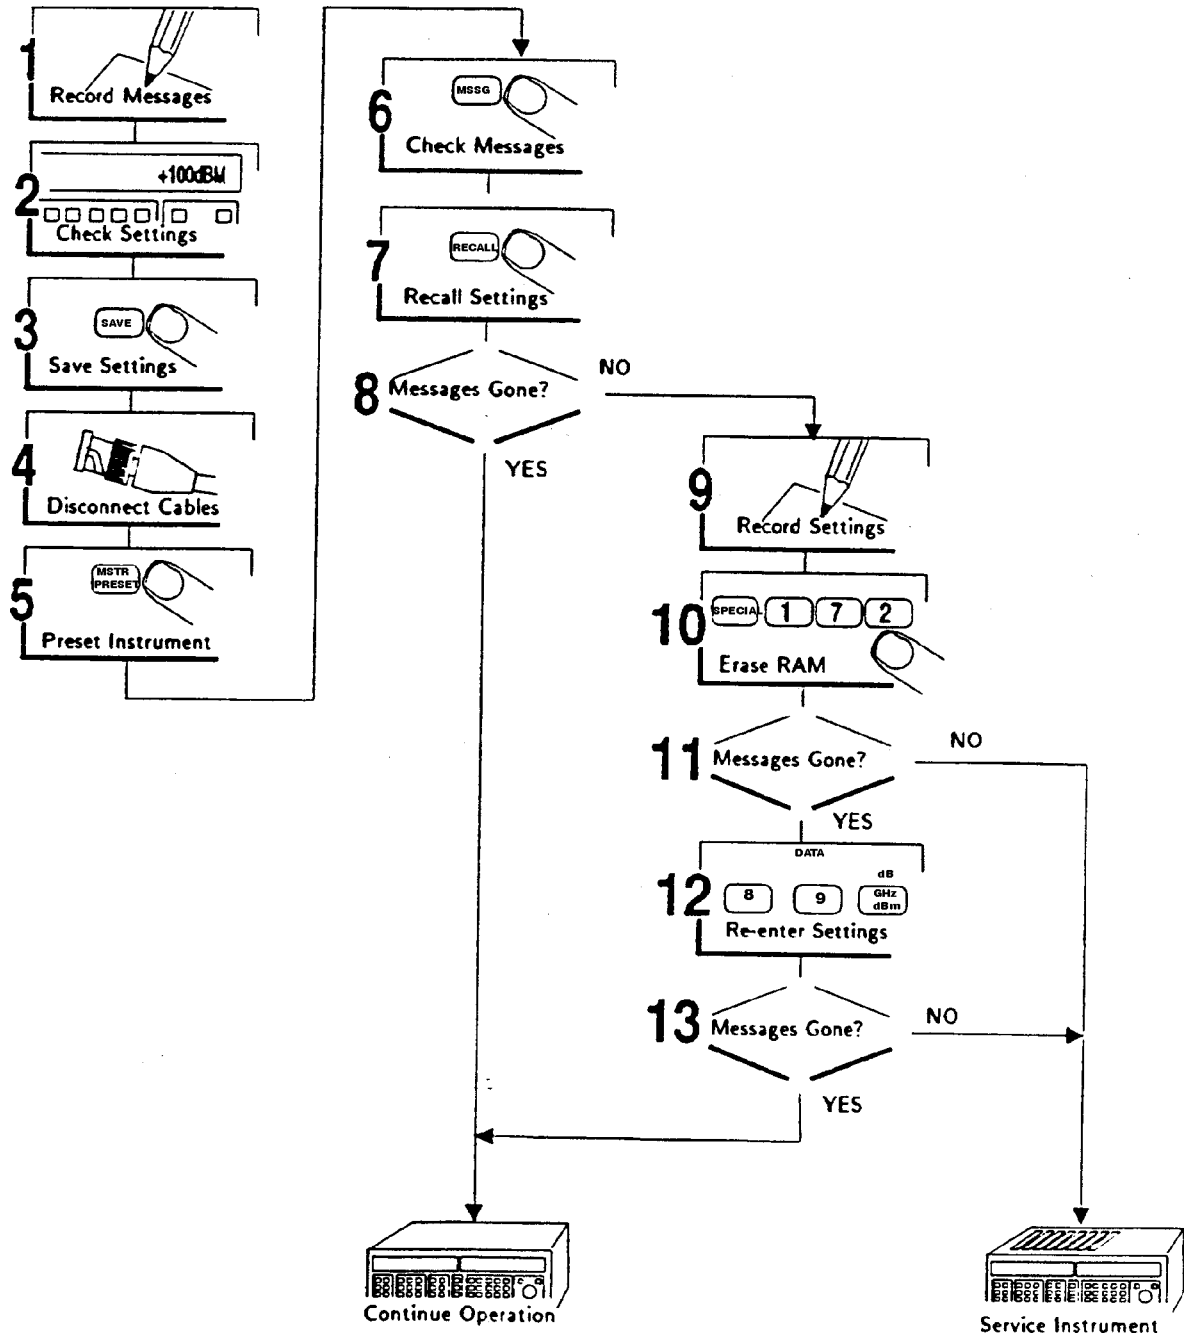
Figure 1. Corrective Action for Error Messages

<b>Error Message</b>	<b>Description</b>
Hardware Failure 1	A communications discriminator failure has been detected at power up, or detected as a result of a self-calibration or self-test. Refer to Figure 1 for corrective action.
Hardware Failure 2	A VCO failure has been detected at power up, or detected as a result of a self-calibration or self-test. Refer to Figure 1 for corrective action.
Hardware Failure 3	A Fractional-N failure has been detected at power up, or detected as a result of a self-calibration or self-test. Refer to Figure 1 for corrective action.
Hardware Failure 4	A modulation distribution failure has been detected at power up, or detected as a result of a self-calibration or self-test. Refer to Figure 1 for corrective action.
Hardware Failure 5	An ALC failure has been detected at power up, or detected as a result of a self-calibration or self-test. Refer to Figure 1 for corrective action.

Hardware Failure 6	An attenuator failure has been detected at power up, or detected as a result of a self-calibration or self-test. Refer to Figure 1 for corrective action.
Hardware Failure 7	An audio source failure has been detected at power up, or detected as a result of a self-calibration or self-test. Refer to Figure 1 for corrective action.
Hardware Failure 8	A reference failure has been detected at power up, or detected as a result of a self-calibration or self-test. Refer to Figure 1 for corrective action.
Hardware Failure 9	A doubler failure has been detected at power up, or detected as a result of a self-calibration or self-test. Refer to Figure 1 for corrective action.
Hardware Failure 10	A High Frequency Output Section failure has been detected at power up, or detected as a result of self-calibration or self-test. Refer to Figure 1 for corrective action.
Hardware Failure 11	A Low Frequency Output Section failure has been detected at power up, or detected as a result of self-calibration or self-test. Refer to Figure 1 for corrective action.

Hardware Failure 12	A Microwave Extender Automatic-Level-Control (ALC) out-of-lock (OOL) condition occurred. Refer to Figure 1 for corrective action.
Hardware Failure 13	A front panel failure has been detected at power up, or detected as a result of a self-calibration or self-test. Refer to Figure 1 for corrective action.
Hardware Failure 14	A power supply failure has been detected at power up, or detected as a result of a self-calibration or self-test. Refer to Figure 1 for corrective action.
Hardware Failure 15	An I/O board failure has been detected at power up, or detected as a result of a self-calibration or self-test. Refer to Figure 1 for corrective action.

<b>Error Message</b>	<b>Description</b>
Hardware Failure 16	A controller failure has been detected at power up, or detected as a result of a self-calibration or self-test. Refer to Figure 1 for corrective action.
Hardware Failure 17	A Pulse Modulator failure has been detected at power up, or detected as a result of a self-calibration or self-test. Refer to Figure 1 for corrective action.
Hardware Failure 18	A frequency counter failure has been detected at power up, or detected as a result of a self-calibration or self-test. Refer to Figure 1 for corrective action.
Hardware Failure 21	A communications discriminator out-of-lock (OOL) condition exists. Refer to Figure 1 for corrective action.
Hardware Failure 22	A VCO out-of-lock (OOL) condition exists. Refer to Figure 1 for corrective action.
Hardware Failure 23	A Fractional-N (NF) phase-locked-loop (PLL) out-of- lock (OOL) condition exists. Refer to Figure 1 for corrective action.

Hardware Failure 24	A VCO frequency-locked-loop (FLL) out-of-lock (OOL) condition exists. Refer to Figure 1 for corrective action.
Hardware Failure 25	A VCO phase-locked-loop (PLL) out-of-lock (OOL) condition exists. Refer to Figure 1 for corrective action.
Hardware Failure 26	A fast controller failure has been detected at power up, or detected as a result of a self-calibration or self-test. Refer to Figure 1 for corrective action.
Hardware Failure 27	An audio source out-of-lock (OOL) condition exists. Refer to Figure 1 for corrective action.
Hardware Failure 28	A reference out-of-lock (OOL) condition exists. Refer to Figure 1 for corrective action.
Hardware Failure 30	A High Frequency Output Section Automatic-Level-Control (ALC) out-of-lock (OOL) conditon occurred. Refer to Figure 1 for corrective action
Hardware Failure 31	A ROM failure has been detected at power up, or detected as a result of a self-calibration or self-test. Refer to Figure 1 for corrective action.

Hardware Failure 32	A ROM failure has been detected at power up, or detected as a result of a self-calibration or self-test. Refer to Figure 1 for corrective action.
Hardware Failure 33	A ROM failure has been detected at power up, or detected as a result of a self-calibration or self-test. Refer to Figure 1 for corrective action.

<b>Error Message</b>	<b>Description</b>
Hardware Failure 34	A ROM failure has been detected at power up, or detected as a result of a self-calibration or self-test. Refer to Figure 1 for corrective action.
Hardware Failure 35	A voltmeter failure has been detected at power up, or detected as a result of a self-calibration or self-test. Refer to Figure 1 for corrective action.
Hardware Failure 36	A RAM failure has been detected at power up, or detected as a result of a self-calibration or self-test. Refer to Figure 1 for corrective action.
Calibration Error 1	A condition occurred where invalid level calibration data resides in either the Output or the Attenuator modules. Follow the external calibration procedures outlined in Figure 1.
Calibration Error 2	At sometime during the calibration or self-test, a condition occurred where some hardware was unable to be calibrated. Fix the hardware and re-calibrate. Refer to Figure 1 for corrective action. This error message will always be accompanied by other error messages.
