Installation Note

**HP ESG-D Series Option UND Signal Generators
Dual Arbitrary Waveform Generator Assembly
Replacement Kit
HP Kit Part Number E4400-69196**

HP Part Number E4400-90271

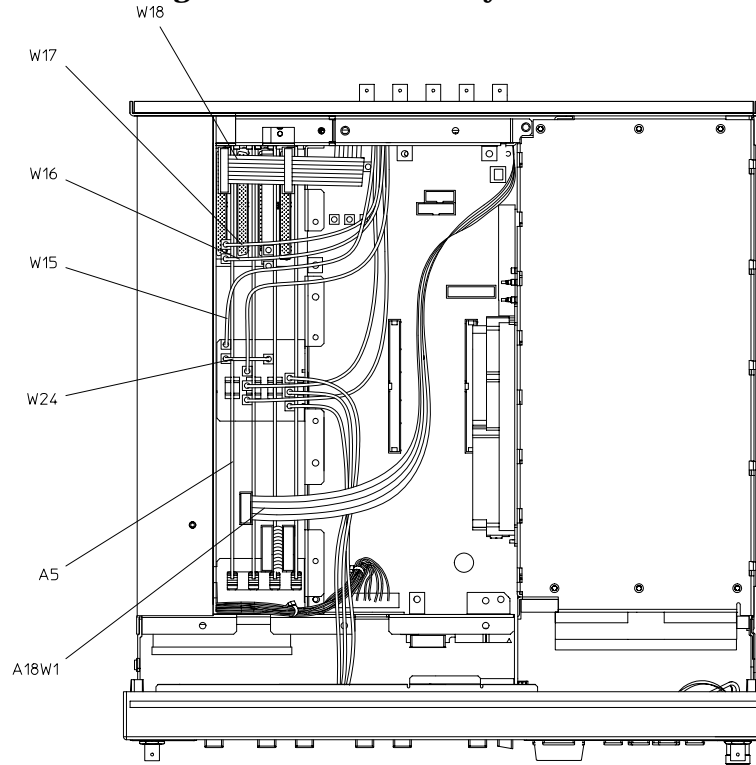
Figure 2 **Removing the A5 Dual Arbitrary Waveform Generator Assembly**

The Option UND Dual Arbitrary Waveform Generator Assembly Replacement Kit is intended to repair an ESG-D series signal generator which has a faulty dual arbitrary waveform generator assembly. For an ESG-D series signal generator that already has an Option UND installed, this kit can also be used to upgrade the signal generator to the latest shipping version of Option UND.

2. Perform the following steps to remove the A5 dual arbitrary waveform generator assembly. (Refer to [Figure 2.](#))
 - a. Remove the top cover by removing the screws that secure it.
 - b. Disconnect W15, W16, W17, and W18 from the dual arbitrary waveform generator assembly. If the instrument has Option UN3, UN4, UN8, or UN9, then W24 must also be disconnected from the dual arbitrary waveform generator assembly.
 - c. Pull up on the dual arbitrary waveform generator assembly to remove it from the motherboard connector.
