# Improving The Heathkit HW-101 Transceiver

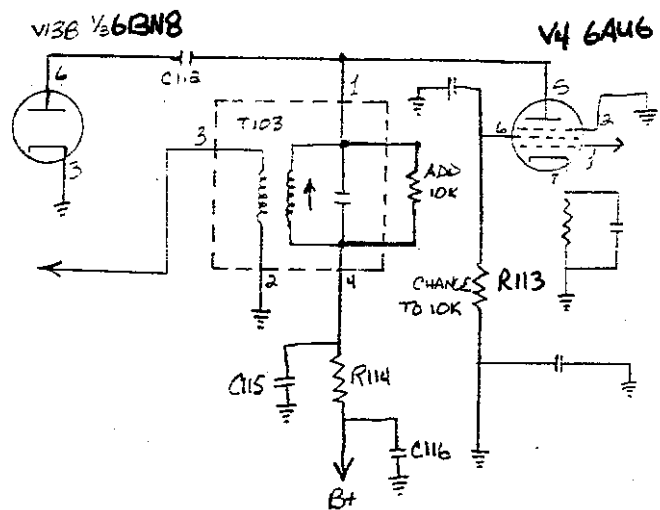
The screen voltage dropping resistor at  $V_4$  (2nd i.f. amplifier) identified as  $R_{113}$  in fig. 1 is 1K, which seems too low and should be changed to 10K  $\frac{1}{2}$  watt. This improves the operation of the i.f. chain somewhat in that it lowers the gain some, bringing about better product detector action and a lower heat dissipation at  $V_4$ , thus avoiding its early failure. The overall gain may still be too high and can be lowered further as will be seen later.

Fig. 1—Changes to the second i.f. amplifier stage,  $V_4$ , reduce overall gain of the HW-101 to useable levels and make S9 meter readings 50  $\mu$ v.

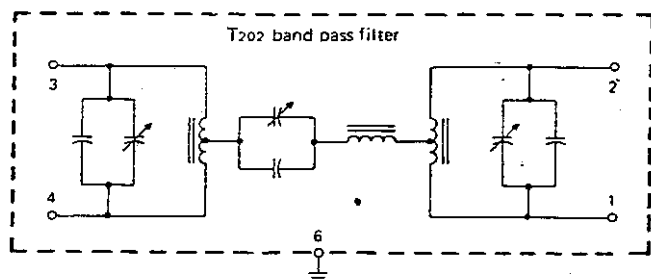
The bandpass transformer  $T_{202}$  is a constant-K network using three toroid coils (see fig. 2) and comes adjusted from the factory. Nevertheless, it is possible for it to drift out of adjustment during shipment or after prolonged use. If this is suspected, it can be checked as follows: connect the transceiver antenna connector to a 50 ohm non-inductive resistor, set the bandswitch to the 3.5 to 4.0 MHz band, turn the calibrator on and check the S-meter readings, keeping the preselector peaked for maximum throughout the band. If the readings are within one S unit from one end to the other, the transformer is probably OK. If not, it should be adjusted by removing the shield temporarily and peaking all trimmers found inside with the set tuned to 3.75 MHz (a signal generator is needed for this adjustment, but it can be approximated using the calibrator at either 3.7 or 3.8 MHz mark). After the adjustment, replace the shield and check to see

Fig. 2—Bandpass filter  $T_{202}$ , may require re-adjustment after long use. Peaking the three trimmers at the center of the 80 meter band should provide flat coverage across the entire band.

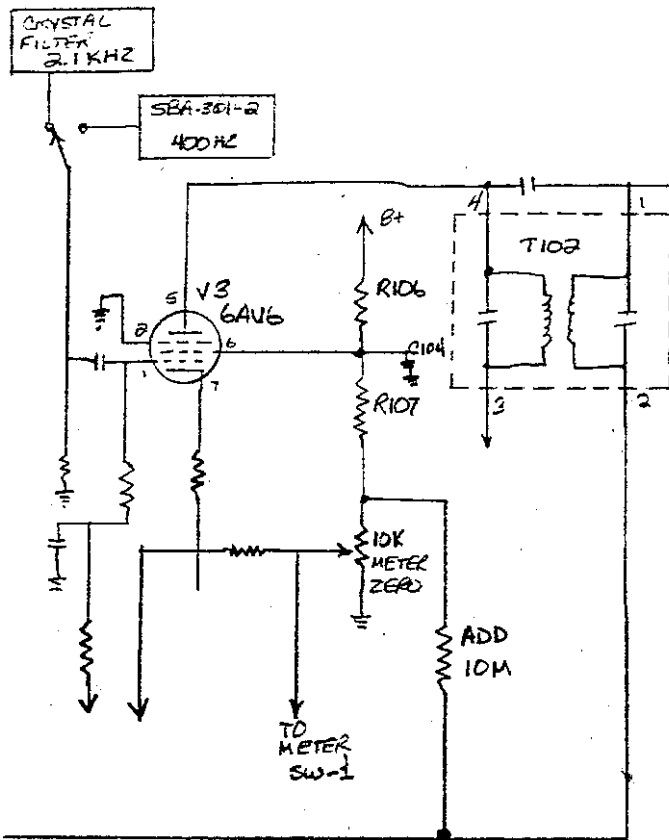
Fig. 3—Adding a 10 meg resistor as shown will raise the zero point of the meter when reading a.l.c. voltage.

During transmitting, the S-meter measures the a.l.c. action when the meter switch is set to a.l.c. However, the zero setting offsets considerably,

keeping the indications at very low values. This is easily corrected by adding a 10 meg  $\frac{1}{2}$  watt resistor between lug 3 (hot end) of the zero adjusting potentiometer and pin 2 of  $T_{102}$  where the a.g.c. is connected to. This compensates automatically between transmit and receive with no ill effects except that the a.g.c. discharge time is shortened slightly. The potentiometer action is less critical now and more towards the middle of the range. If a large discrepancy remains in the zero settings it is probably due to gassy tubes in the a.g.c. stages. For proper modulation, the mic. gain should be adjusted so that the a.l.c. swings up to about S-6 (with the meter in the a.l.c. position). Refer to fig. 3.

After some warm-up the S-meter will start indicating a lower reading in the receive mode. This is caused by resistor R107 (see fig 3) overheating and thus causing its resistance to drop. R107 should be replaced by a 100K 1-watt. Also resistor R106 should be changed to a 33K 1-watt, this reduces voltage feeding meter circuitry, thus causing less heat in R107.
