IBM 8260 Multiprotocol Intelligent Switching Hub Token Ring Media Modules Release Note

IBM Corporation • IBM Part Number 02L2482 • August 7, 1997

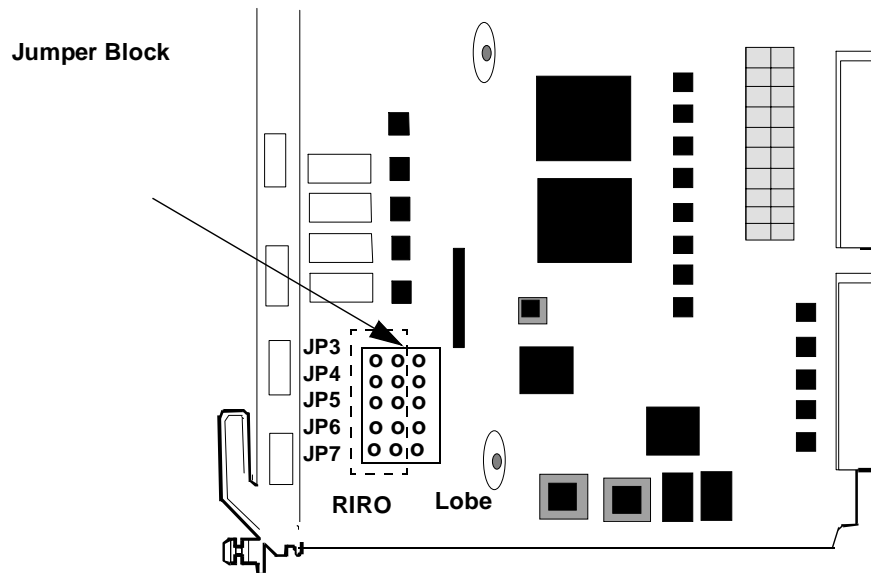
This section applies to Chapter 3, Installing the Module, the section titled Setting the Lobe/Trunk Jumper (T18PSA and T18MSA). In Figure 3-2, the module component side view is missing the JP3 switch on the jumper block.

The following diagram shows the correct jumper for Figure 3-2.
