Icom IC-765 Notes

Don Stalkowski, VE3HUR

June 10, 2003

Version 1.03

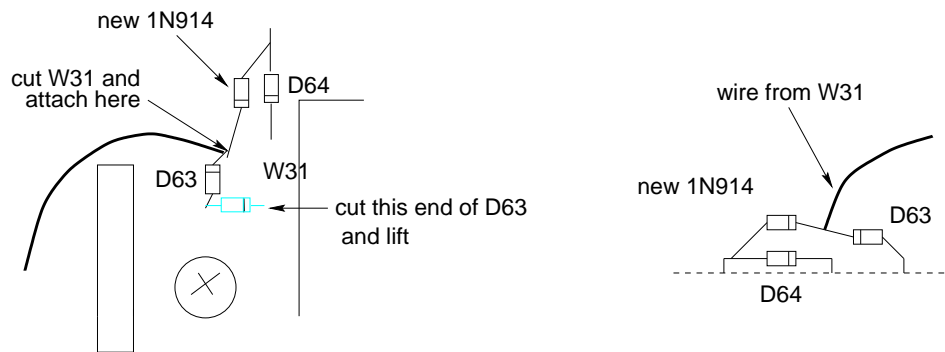
Figure 1: PBT modification top and side views.

1. Cut (or lift) cathode end of D63
2. Add a 1N914 - solder anode end to anode of D64
3. Cut W31 (brown wire) and solder to cathode end of D63 and cathode end of new diode.

IF SHIFT button out = PBT, IF SHIFT button in = IF shift.

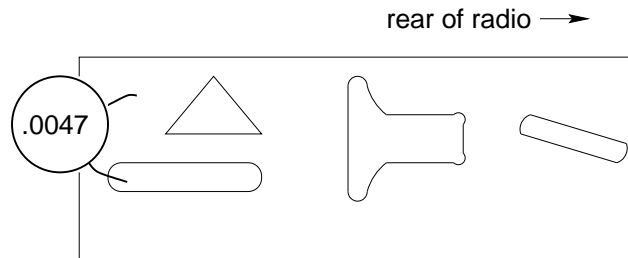
Figure 2: Rear of antenna switch circuit board.

1. Remove top cover
2. Locate antenna switch unit at right rear of radio (at antenna jack).
3. Solder a 0.0047 uF, 500V ceramic capacitor to back side of pc board as shown. (Board removal is not necessary). The capacitor is effectively installed between ground and the junction of R1 and L1.
4. Reinstall top cover and check for proper transmitter operation. This modification prevents failure of R1, R2, D1 and L1.

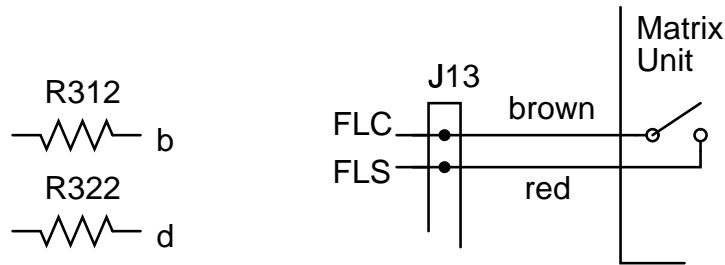
Figure 4: The Circuit Prior to Modification

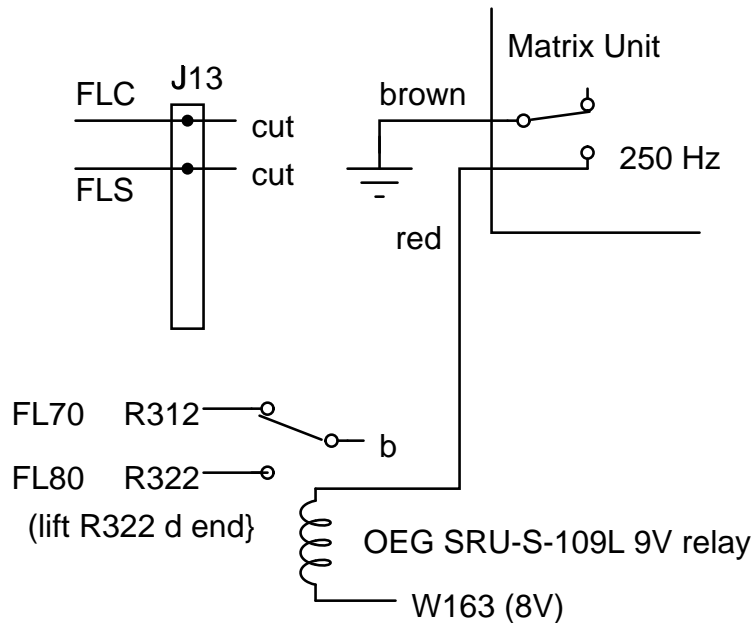
Figure 5: Circuit After Modification

1. Cut the red (FLS) and brown (FLC) wires from J13.
2. Ground the brown wire (FLC).
3. Connect the red wire (FLS) to one end of the relay coil. Connect the other end of the relay coil to W163.
4. Cut W154.
5. Connect the end (“d”) of W154 nearest to the PCB edge, to the relay “common”.

6. Connect the other end (R312) of W154 to the relay NC connection.
7. Lift the end of R322, farthest from the filter, and connect it to the relay NO.

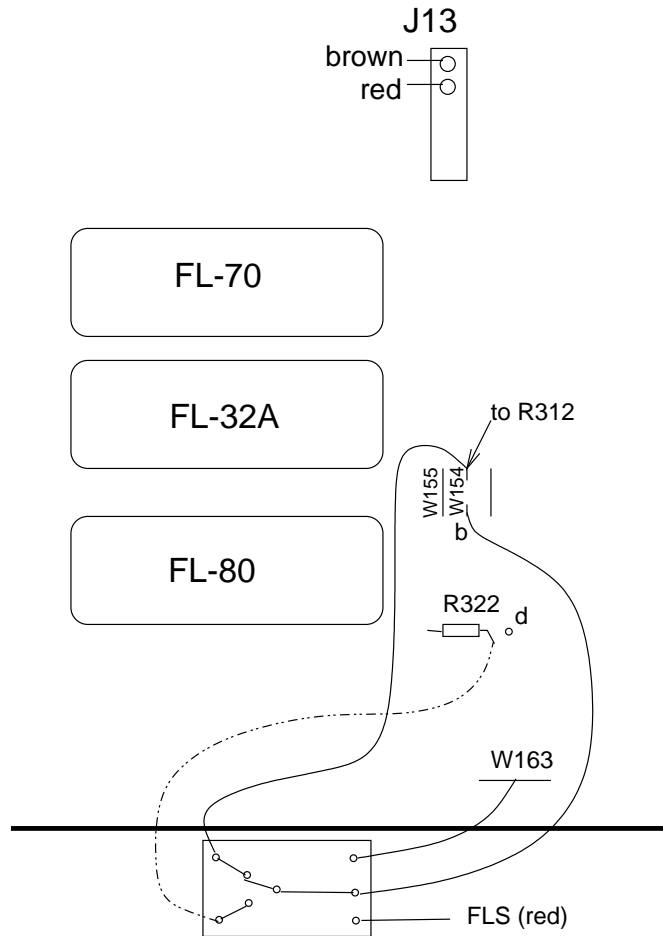
Figure 6: Pictorial of the Filter Modification
