To: All NCX-3 Customers
Subject: NCX-3 Suggestions &

Sales Bulletin: CIB-64-9

MODEL NCX-A and NCX-D

NCX-3 CSB 66-2

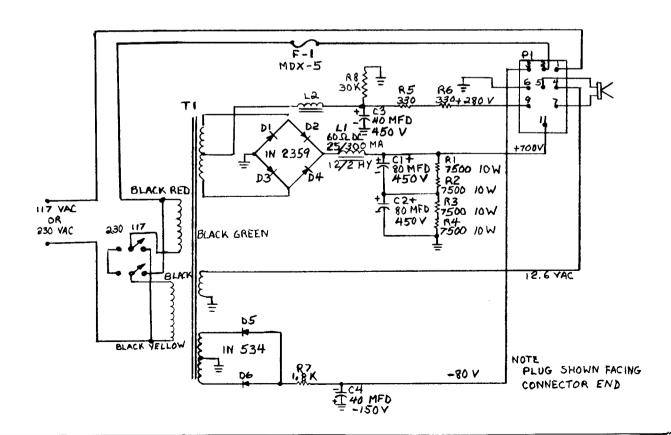
NCX-A SCHEMATIC

- 1. Resistor R7 has been changed from 1000 $\uparrow \uparrow$ 10% to 1800 $\uparrow \uparrow$ 10%.
- 2. A 0.01 uf 600 volt capacitor from one side of the AC line to chassis is not indicated on the schematic.
- 3. A revised primary power schematic is shown below:
