Repairhints

3210

NSE-8/9

The purpose of this document is to provide some further service information for NOKIA 3210 phones.

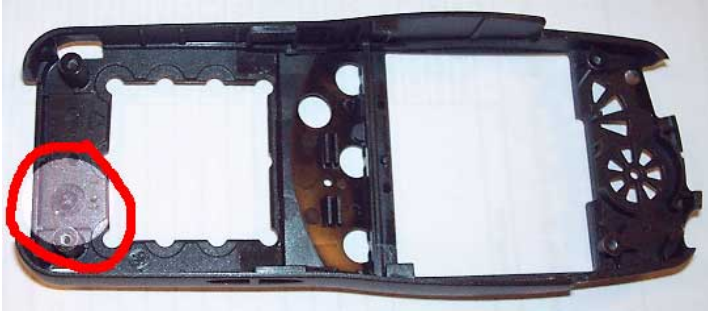
CHARGING PROBLEMS

Check if R103 is broken – if resistor was broken or missing: Change N101, too.
Check C-Cover version, cut the arrow of the time dial in cover or change C-Cover if necessary.
(Service Bulletin 024).

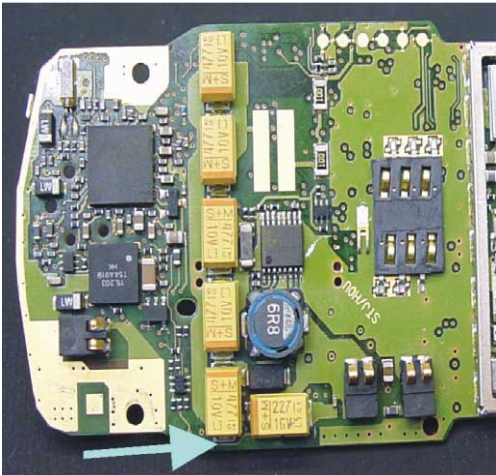
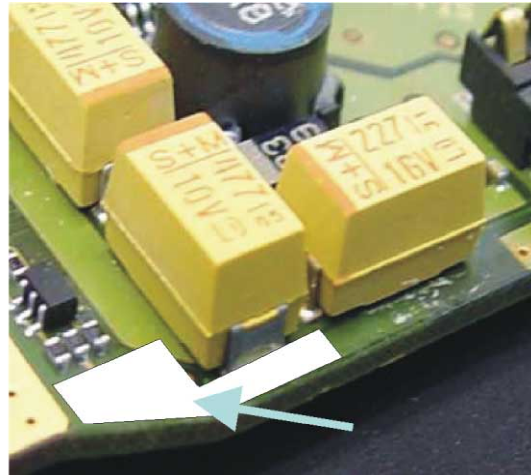
PHONE DOES NOT SWITCH ON

Check if track (R132 to L102), located at C110, is printed as upper layer and if this line is 0 Ohm. Also place an isolation label on this track (see pictures) to protect it for short cuts to D-Cover. This is necessary in IMEI number range below 448896/20/485419/5 and 448896/10/205064/9 (**Service Bulletin 011**).

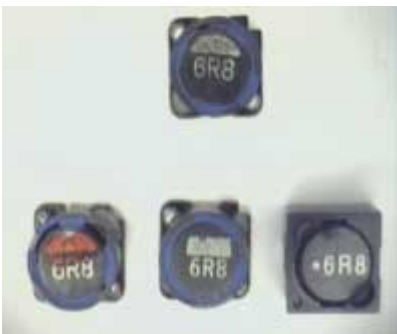
L102 SOLDERING PROBLEMS

Check soldering of L102 – In some cases the soldering of the coil can be broken on both sides – change if necessary. Note the different (approved) versions of L102.

The first (oldest version with soldering problem)

The new versions for better reliability below.

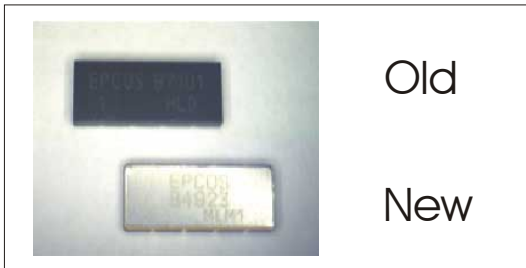
NEW PCB (GD_7), COMPONENT & VENDOR CHANGES**Z700 71MHz FILTER – NEW CERAMIC PACKAGE**

If it is necessary to change this filter, please note: The old and the latest type are not compatible and cannot be changed one for the other!

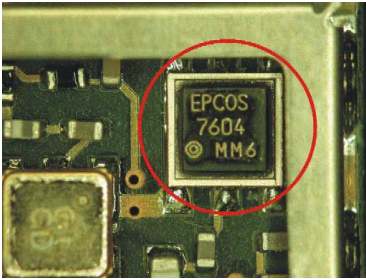
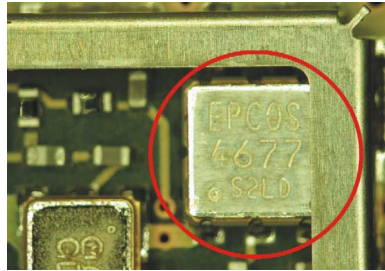
New GSM TX Filter (Z601)

The ceramic version of Z601 is changed to a new version – changes apply to HW versions 5.xx / 55.xx.

These versions can be changed against one for the other.

left side: old version / right side: new CSSP version

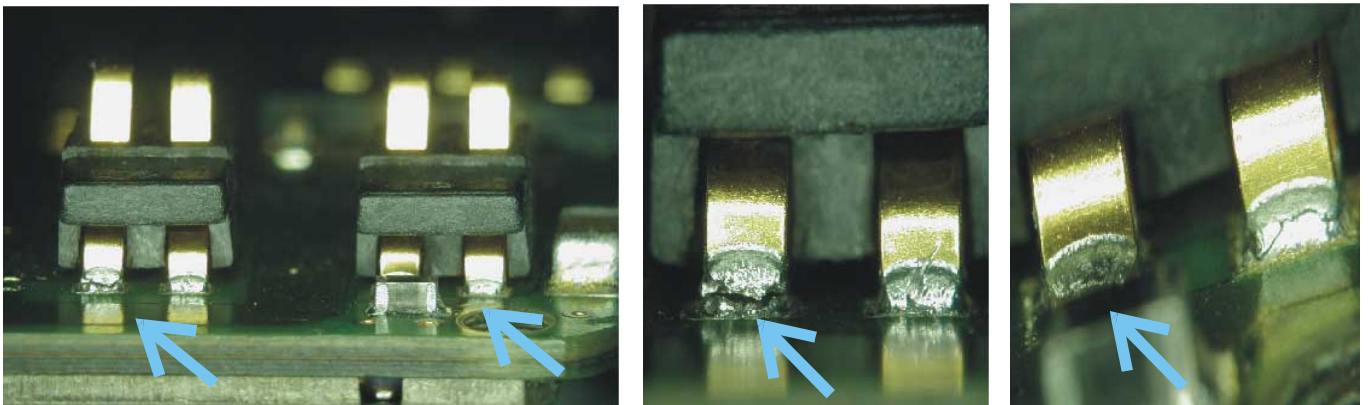
Check battery connectors X101 / X102 for broken solderings or bent spring contacts (see pictures below).

Check if phone works also after connecting LCD module in jig (short circuit in VBB line from LCD possible).

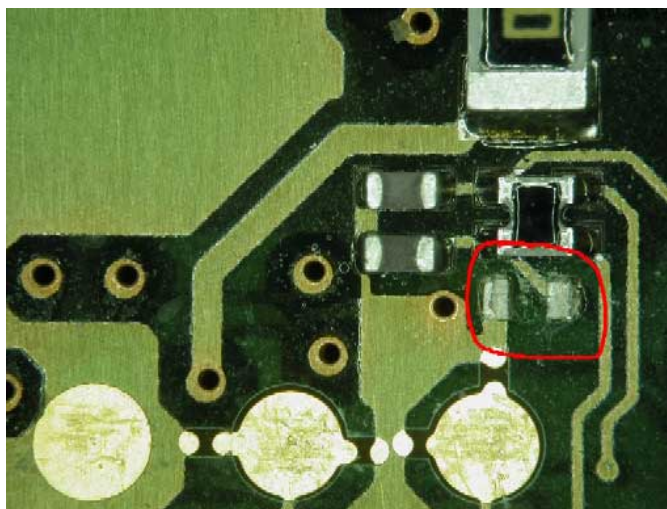
Check also near the service contacts on the PCB - If any component is missing (like on picture below) – flashing will not work!

Torn off components are the result of sliding the phone on the service battery – the contacts can be damaged, too.

NOTE: Always handle the phone in combination with the service battery with care to prevent those failures!

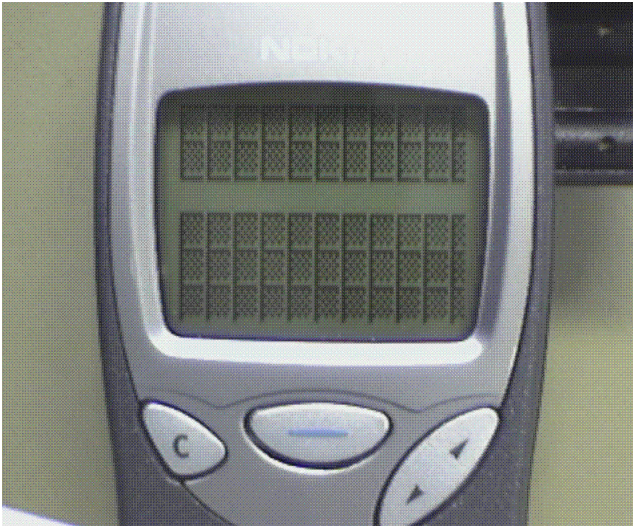
Faulty display sample

If one or more lines are missing completely as in picture below, change LCD unit

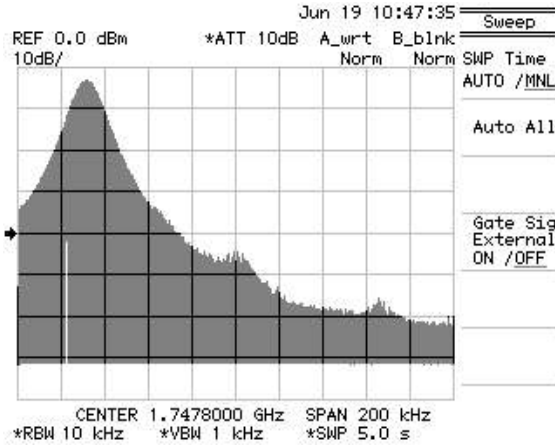
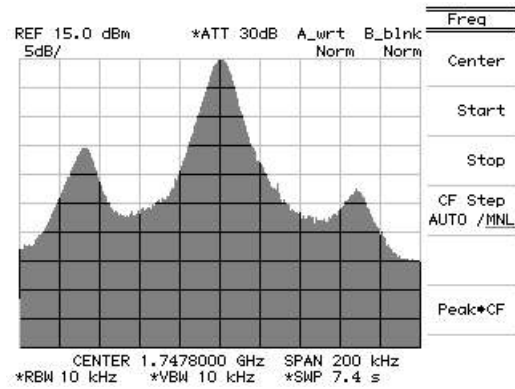
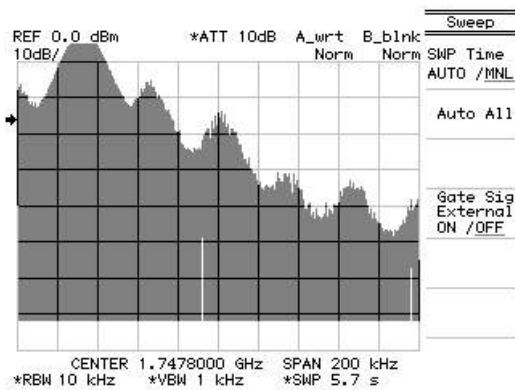
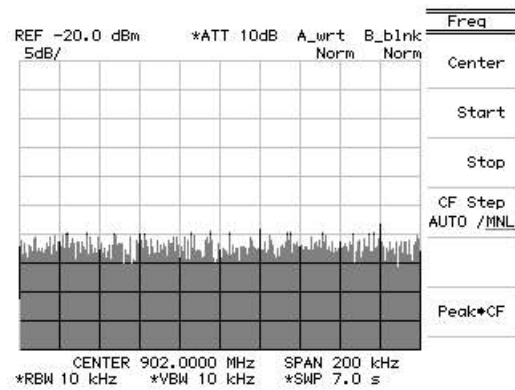
Faulty spectrum – COBBA faulty, COBBA and CCONT broken solderings

1) Normal spectrum

3) Spectrum of faulty COBBA

2) Spectrum with broken solderings under CCONT
 Turns to picture 1 if CCONT is pushed careful with some nonmetallic item

4) Spectrum of faulty oscillator G500
