Repair-Hints

3210

NSE-8/9

The purpose of this document is to provide some further service information for NOKIA 3210 phones.

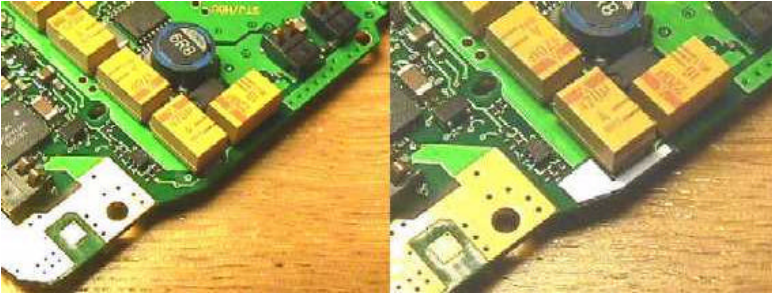
Check if track (R132 to L102) located at C110, is printed as upper layer and if this line is 0 Ohm - also place an isolation label on this track (see pictures) to protect this for short cuts to D-Cover. This is necessary in IMEI Number range below 448896/20/485419/5 and 448896/10/205064/9 (Service Bulletin 011).

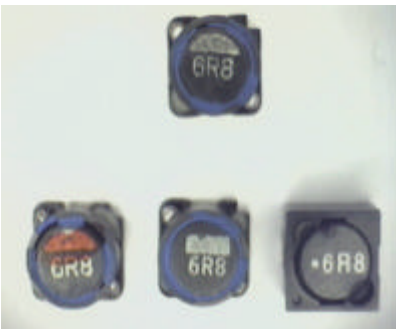
Check soldering of L102 – In some cases the soldering of the coil can be broken on both sides – change if necessary – Note the different (approved) versions of L102.

The first (oldest version with soldering problem)

The new versions for better reliability below.

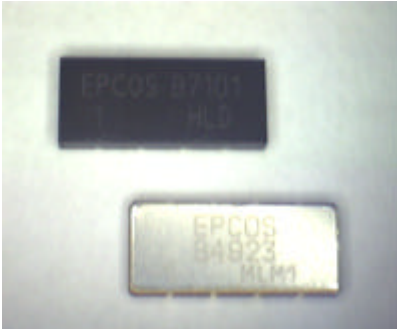
NEW PCB / vendor changes (GD_7) and other component changes**Z 700 / 71 MHz SAW Filter – new ceramic package**

If it is necessary to change this Filter, please note: The old (CSSP) and the new (SAW) type are not compatible and cannot be changed against each other

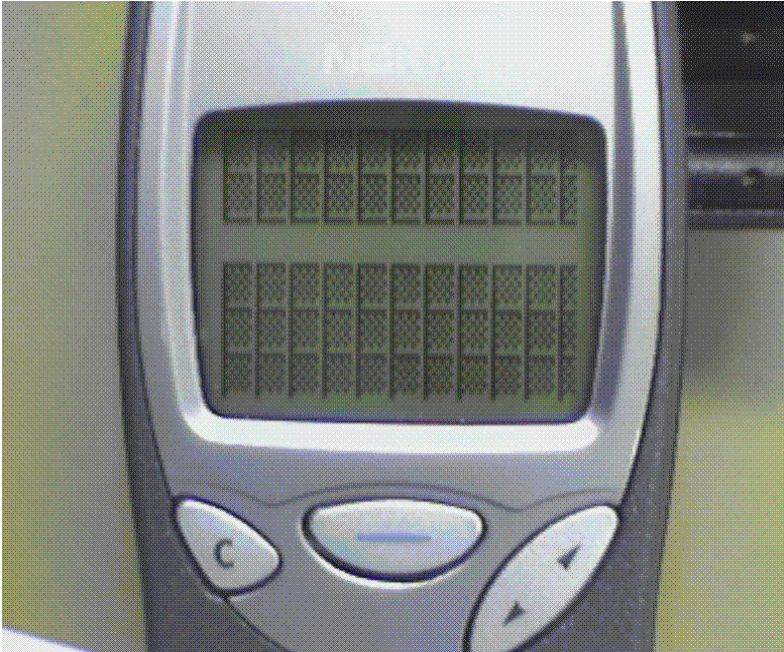
Figure 5: Faulty display

Black lines on the display or no display function

- Check VBB 2.8V DC at C400 and R420
- Change display

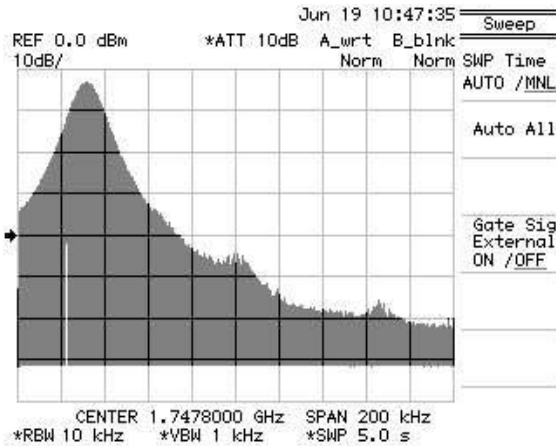
1)

Pic1) Normal Spectrum

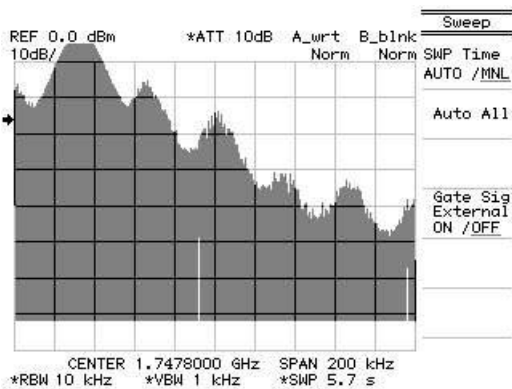
2)

Pic2) Spectrum with broken soldering under CCONT (No PCN_low reference settings in RSSI alignment).

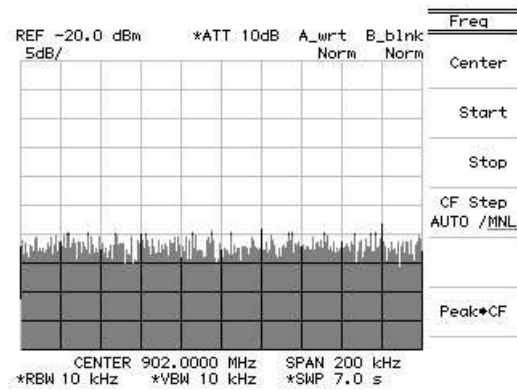
4)

Pic4) Spectrum with broken soldering under COBBA, RSSI- alignment is not possible. Spectrum turns to pic 1 if N200 is pushed carefully with some nonmetallic item.

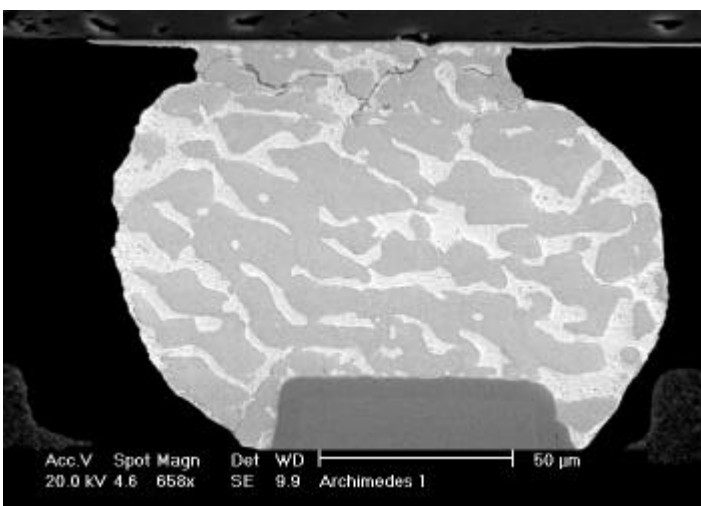
COBBA N200 broken solder balls

. The picture shows a broken ball -viewed through a X-ray machine.

- Check VBB 2,8V DC at C117 near to CCONT
- Check VCOBBA 2,8V DC C248 near to COBBA
- Check COBBACLK 13MHz 3,2Vpp at J 201 (see the diagram in chapter "COBBA contact service")
- Check module in call mode with a simulator.
- Knock very careful with some nonmetallic item around the COBBA
- Check if some errors appear on the tester (phase /frequency / RX-Quality/TX-Power level)
- Change the circuit with a µBGA solder machine
