Repairhints

3310

NHM-5

HDa 12

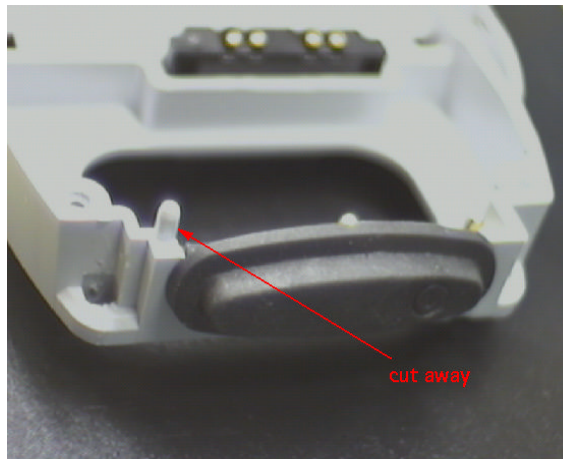
Difficulties when removing B-Cover (SB 13)

If customers criticize bad removal of B-Cover cut away the guiding pin of the D-Cover (see picture below)
After this procedure it is necessary to assemble the phone with a torque screwdriver prepared for **30Ncm!**

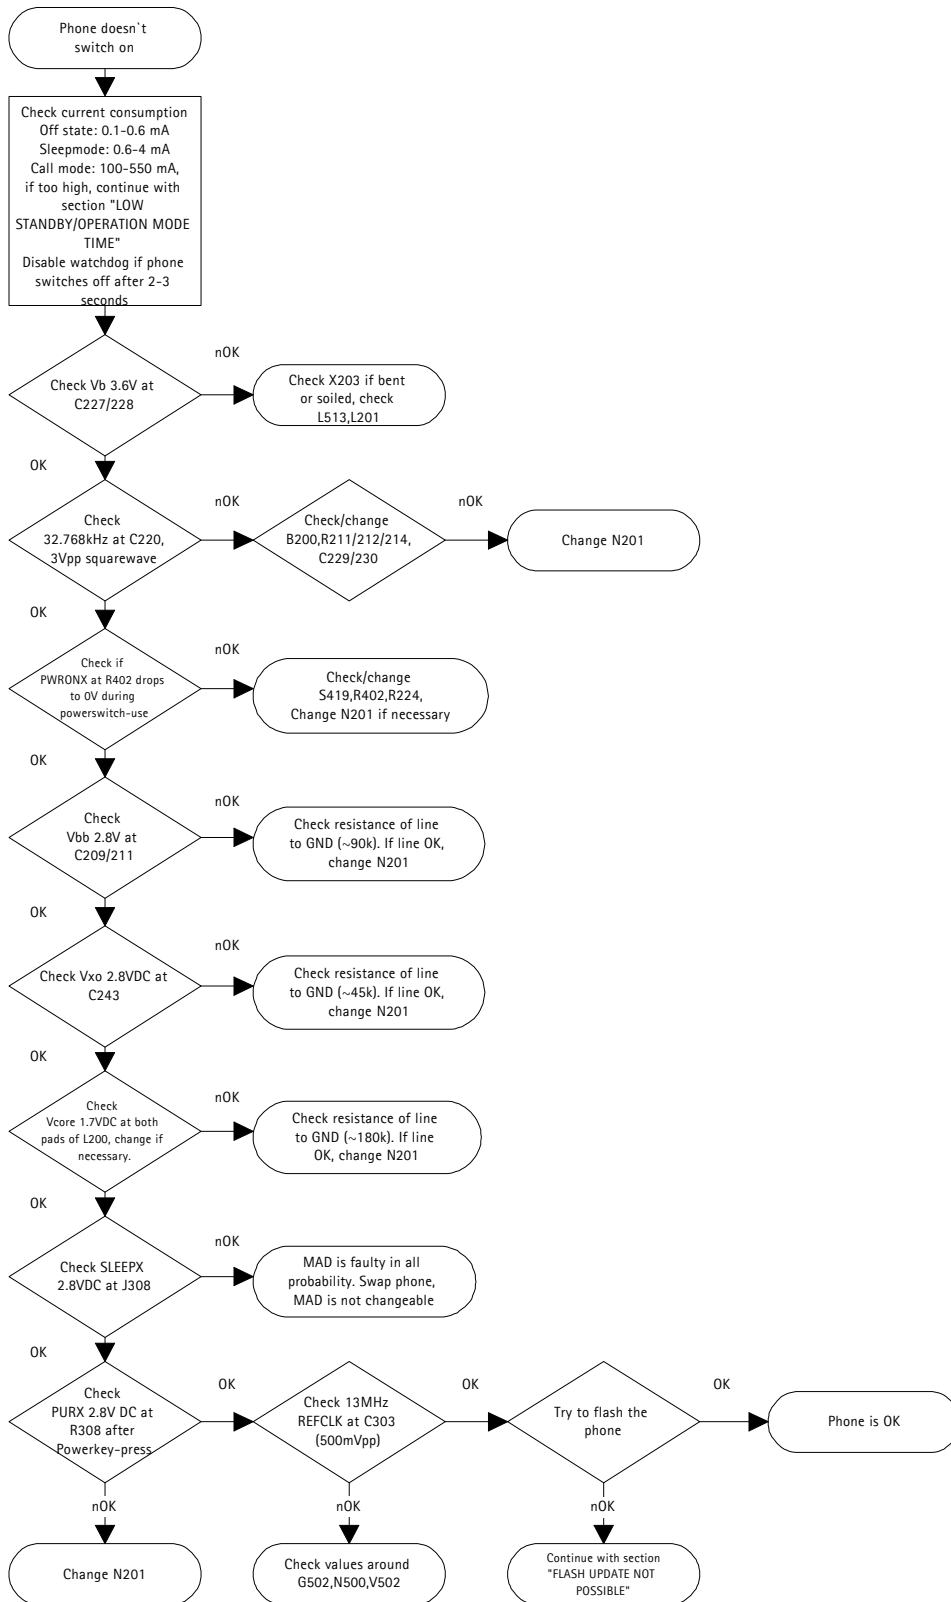
PHONE DOESN'T SWITCH ON

X203 Battery connector

Check if bent or soiled.
Check that pads of connector on PCB are clean.

S419 Power on/off switch faulty

Check that voltage at R402 is 3.6V when powerswitch is not pressed.
If voltage is not ok, check R402 and R224, change N201 if necessary.
If voltage at R402 is ok, it must decrease to 0V if S419 is pressed, else change S419.
Disable watchdog by connecting R224 to GND if phone switches off after 2 or 3 seconds.

B200 Sleep Clock Oscillator faulty

Check 32.768kHz, 3Vpp squarewave at pad of C220 located towards B200.
If oscillator does not work, check voltage at the two pads of B200 which are located towards N201, normally 1.6V DC. If not ok, check periphery of B200 or change CCONT N201.
If frequency is not ok, check parts around B200 (R211, R212, R214, C229/230).

G502 Reference oscillator faulty

Check Vcc 2.7V DC at G502 pin 2 and Vcont (varies between 0.03V and 2.3V, typically 1.3VDC) at C552.
Check 26MHz Clk-frequency at pin 3 of G502, 1Vpp
Check 13MHz Clk-frequency at C559, 300mVpp
If not ok, check voltages for HAGAR N500. (Detailed information in chapter "No Service").
Check 13MHz Clk-frequency at C303, 500mVpp at pad located towards V103.
If not ok, check values around V502

N201 CCONT faulty

Check Vb 3.6V DC at C227/228.
Check 32.768kHz, 3Vpp squarewave at pad of C220 located towards B200.
Check that PWRONX decreases from 3.6V DC to 0V at R402 if powerswitch is pressed.
If these conditions are fulfilled output voltage lines should rise to their intended values and PURX is released after some milliseconds by CCONT.
If CCONT does not work, check output voltage lines for shorts to ground (check current consumption!),
if ok, change CCONT with μ BGA soldering machine and run energy management calibration.

D300 MAD faulty

Check 32.768kHz squarewave at C220.
Check 13MHz Clk-frequency at C303.
Check Vbb 2.8V DC at C209/211 and Vcore 1.7V DC at L200.
Check SLEEPX 2.8V DC at J308.
Check PURX 2.8V DC at R308.
Try to flash the phone.
MAD is probably faulty, swap the phone because MAD is not changeable.

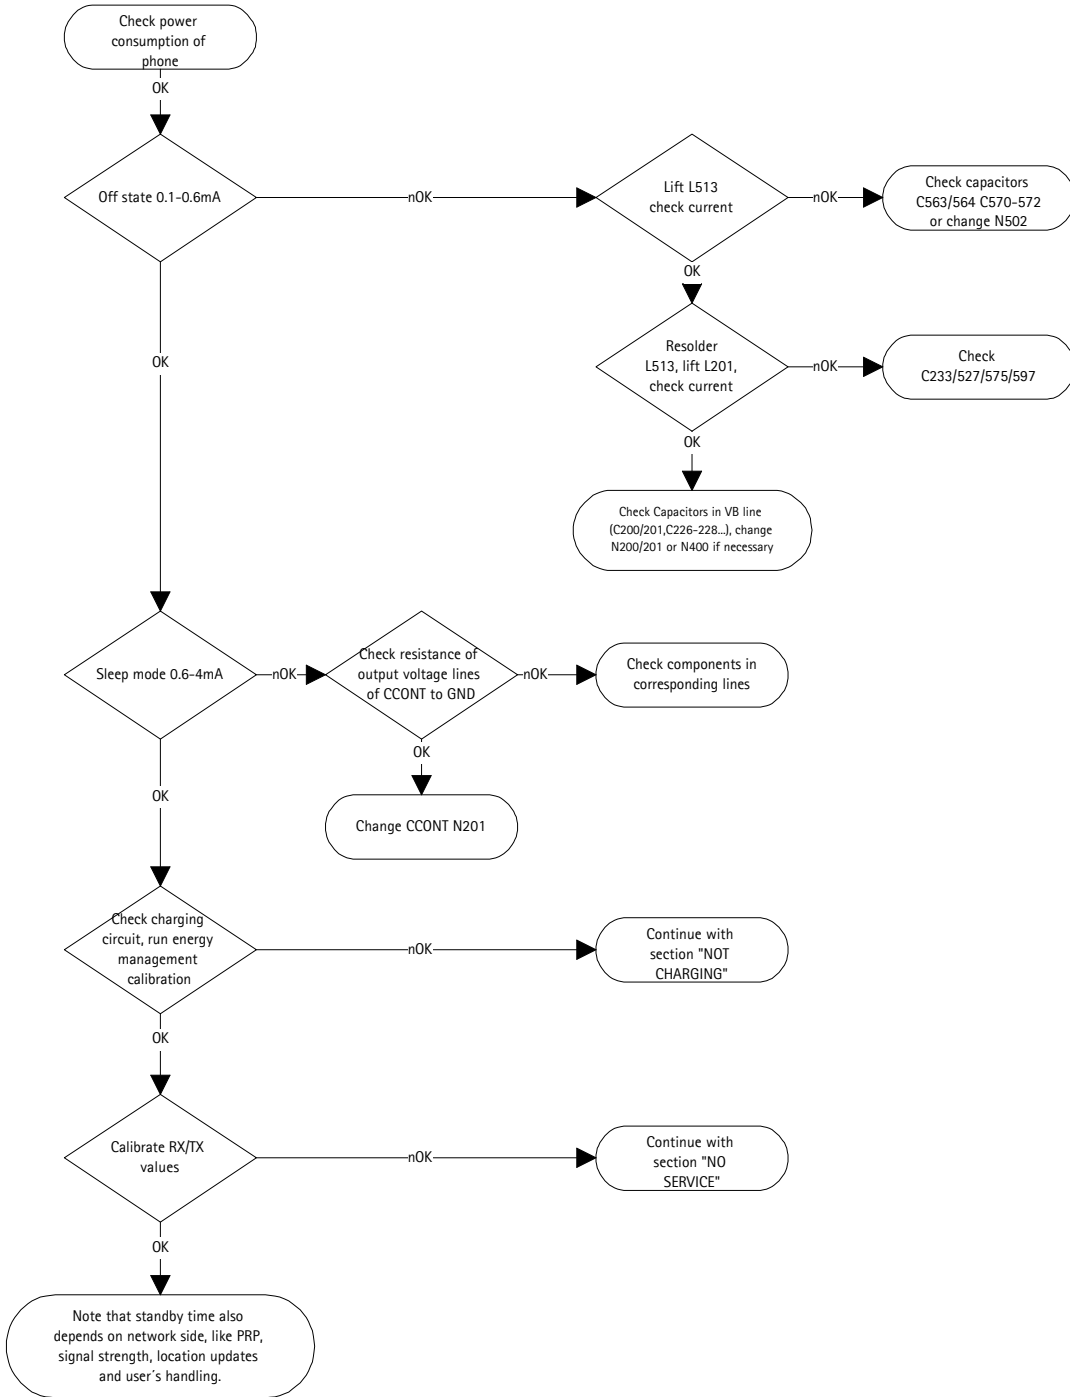
LOW STANDBY/OPERATION MODE TIME

Check current consumption in different operation modes:

Off state current fail

Lift L513 to define the fault if off state current is not ok.
If current is still not ok, lift C563/564 and C570-572 one by one or change power amplifier N502, which is the reason in most cases.
If current is ok after removing L513, resolder it and lift L201. If current is too high, check capacitors C233,C527,C575 and C597. If current consumption is ok after lifting L201, you have to check capacitors in Vb-line (eg C200/201, C226-228,C247...) or change N200/201, N400.

Sleep mode current fail

Check resistance of output voltage lines of CCONT N201 to ground.
Resistance should be higher than 10kΩ except Vsyn1 (~ 4.7kΩ),
if resistance of any line is not ok, check/change parts of this line,
if resistance of all lines is ok, change CCONT N201.

If the standby/operation mode time is still not ok, check charging circuit and run the energy management calibration.
It also can be necessary to calibrate the Rx/TX values of the phone.

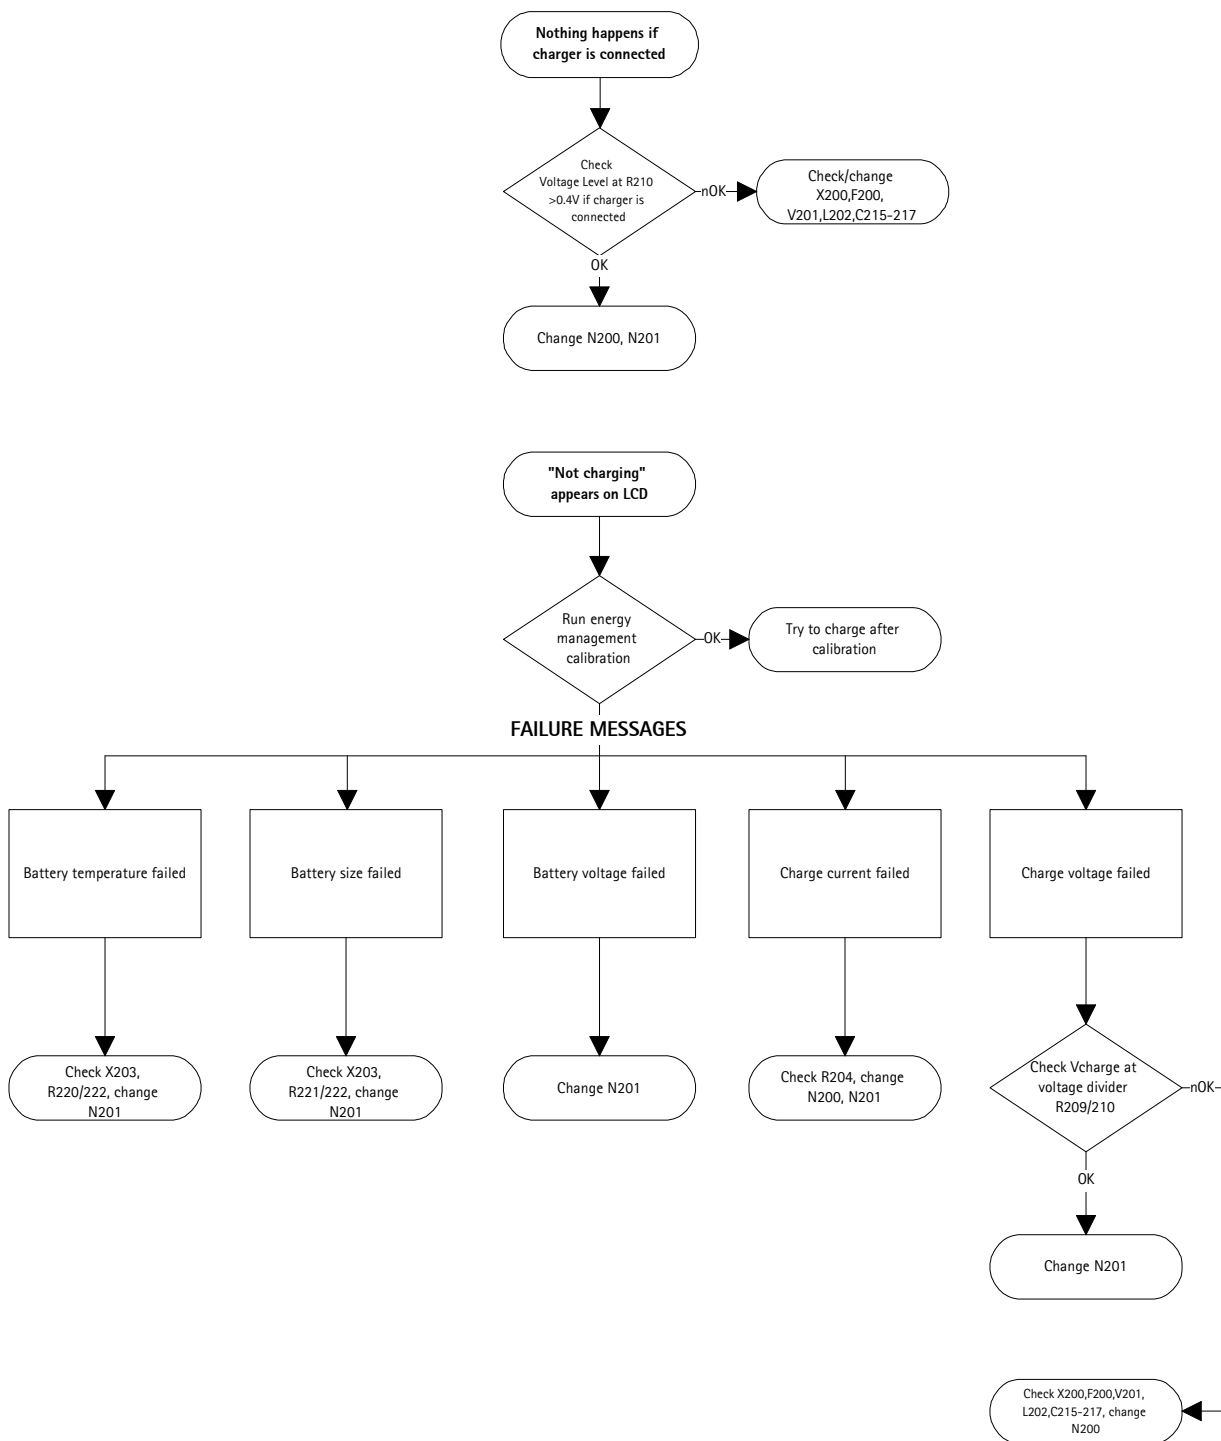
NOT CHARGING

X200 DC/HS connector, X203 battery connector

Check mechanical appearance of connectors,
make sure that pads for connectors on PCB are clean.

F200 faulty

Check resistance of fuse F200 (0 Ω)

CHRGR+ line short circuited to ground

Check resistance of CHRGR+ line at F200 to GND (~ 50 k Ω),
if resistance is not ok, remove L202 and check again.
If resistance is ok now, C215/216 or N200 should be the reason,
if resistance is still not ok, V201 faulty in all probability, also check C217.

CCONT N201 faulty

Change CCONT if any A/D value is out of limit but DC voltage is ok.
If DC voltages are not ok, check corresponding voltage dividers and
battery connector X203.
Run energy management calibration after changing CCONT!

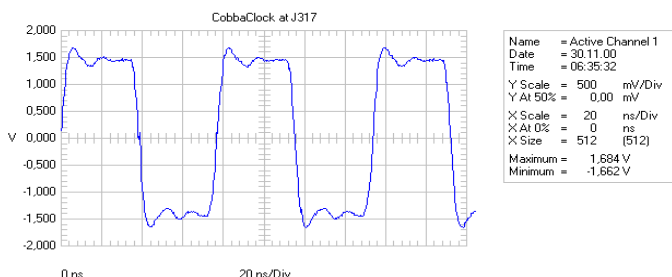
COBBA parallel/serial failed

Check Vbb 2.8V at C119 and VCOBBA 2.8V at C116/117
Check COBBAClk at J317

Probably COBBA N100 faulty or broken solderings under it – change COBBA.
If fault remains MAD or PCB faulty.

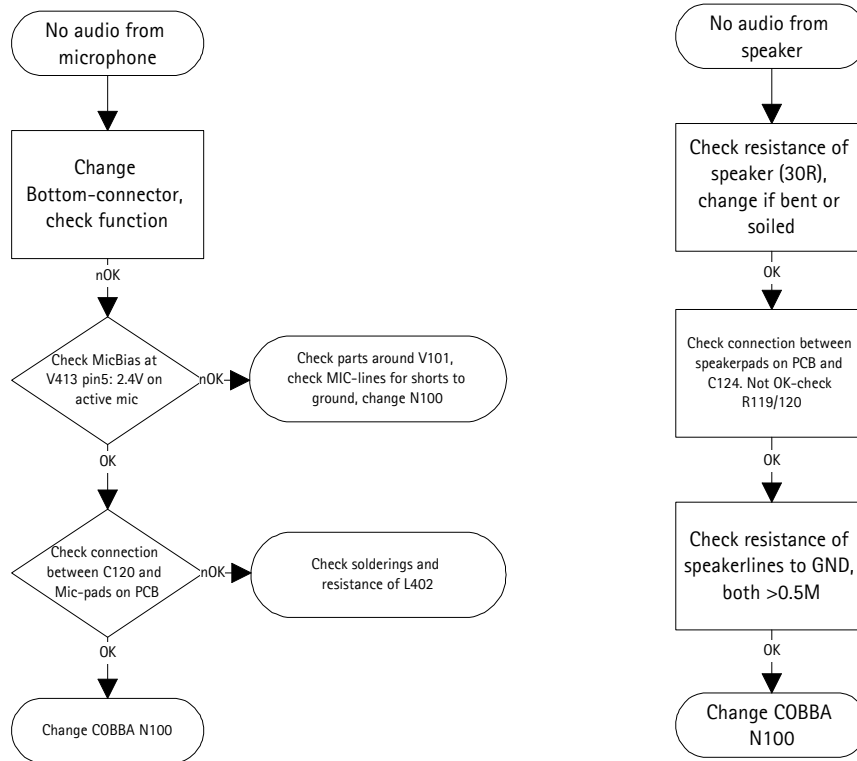
AUDIO FAULTS

Speaker faulty

Check resistance of speaker (30 Ω)
Check mechanical appearance of speaker if audio signal is too quiet or distorted.

Speakerlines short circuited to GND or disconnected

Check resistance of R119/120 (22 Ω).
Check resistance of lines to GND (> 0.5MΩ).

Microphone doesn't work

Check/change microphone,
make sure that pads for microphone on PCB are clean.
Check microphone voltage at V413 pin 5, 2.4 V on active micro.
Check connection between Mic-pads on PCB and R120, change COBBA N100 if necessary.

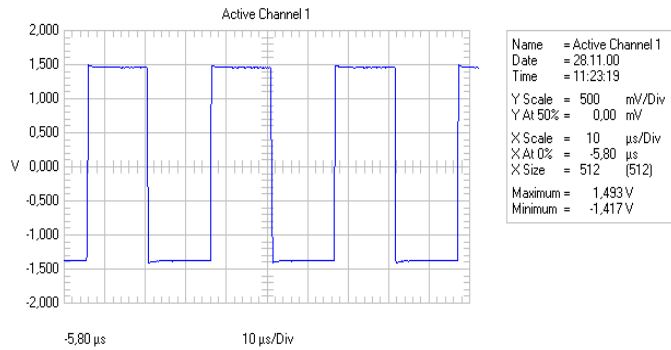
Clock time problems

Clock time has to be corrected in short periods:

In case of this fault check amplitude and frequency of sleepclock-oscillator at C220, should be 3Vpp squarewave at 32.768kHz.

32.768kHz measured at pad of C220 located towards crystal B200.

If amplitude or frequency is not ok, change crystal B200. If fault persists, check parts around B200 like R211/212/214 and C229/230.

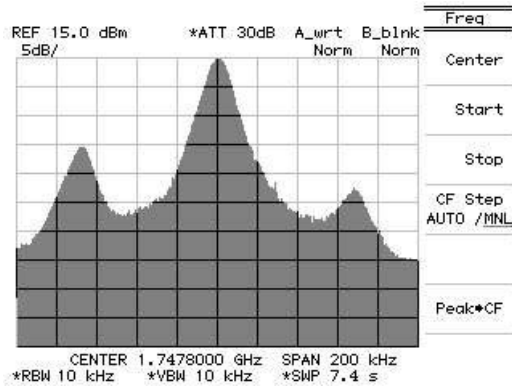
2) Spectrum of faulty COBBA

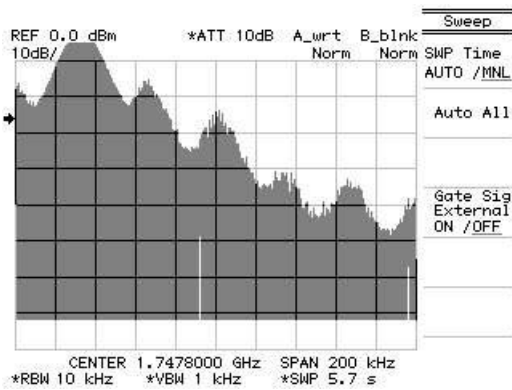
3) Spectrum with broken solderings under CCONT
Spectrum turns to picture 1 if CCONT is pushed careful with some nonmetalled item.

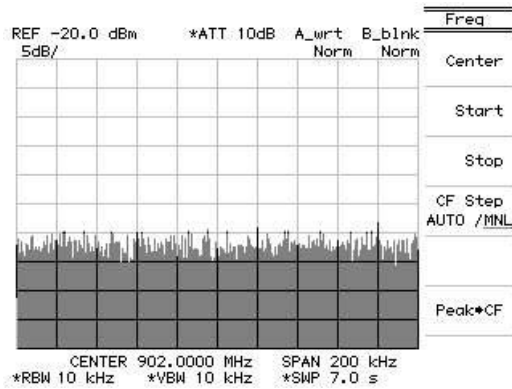
4) Spectrum of faulty oscillator G500

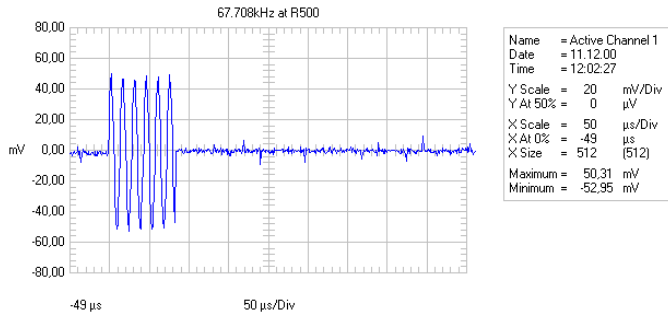
Check 67.708kHz at R500 (burst mode, input level -65dBm)

If signal is not ok at R500, check C508 for shorts to ground, check resistance of R500 (4 * 1000hm) or change HAGAR N500.

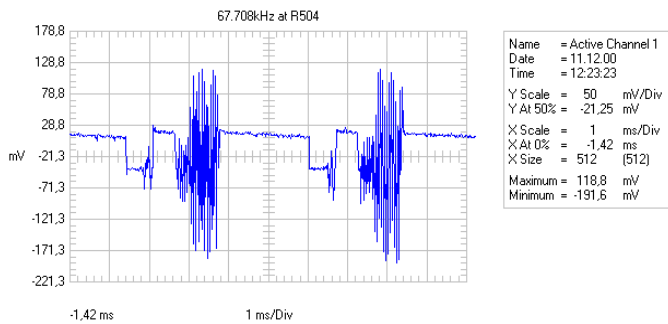
Check 67.708kHz at R504 (burst mode, input level -65dBm)

If signal is not ok at R504, check Vref 1.35V at C536, check also C514/526 if broken or cold soldered, change HAGAR N500 if necessary.
