HD947 GF7\_17 Vers.2

The purpose of this document is to provide some further service information for NOKIA 6150 phones.

# Doesn't switch on

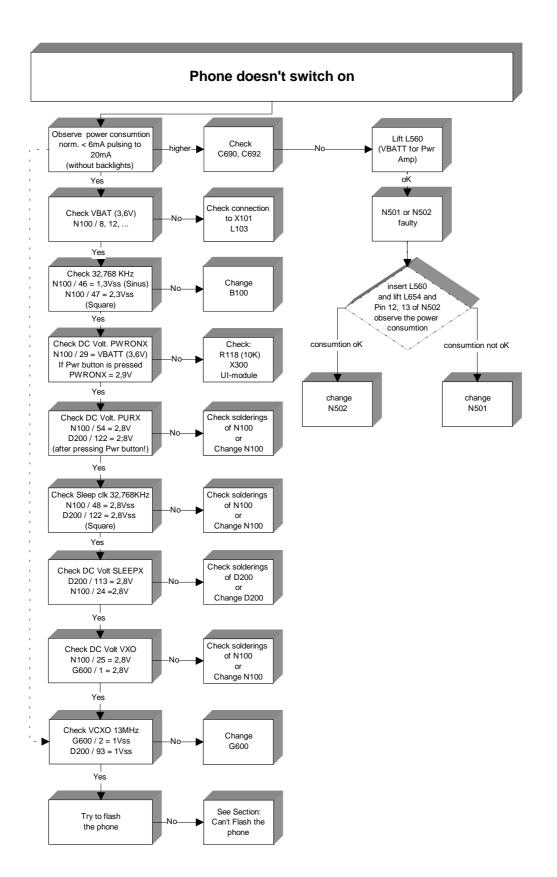
Figure 1: doesn't switch on troubleshooting

#### N100 faulty/ poor soldering

- Check if voltage on Pin 29 drops of 700 mV during pressing the Power on button
- Check if there is a 32.768 kHz square wave on Pin 48
- Check if PURX Pin 54 goes up to 2.8 V DC
- Check if VXO Pin 28 goes up to 2.8 V DC

## B100 faulty 32,768KHz

• Check 32.768 kHz; 1 Vpp clock signal on B100

# G650 faulty 13 MHz

- Check VXO 2,8V DC on pin 1 from G650
- Check 13 MHz; 1 Vpp on output pin 2

#### D200 MAD faulty/ poor soldering

- Check 32.768 kHz square wave on Pin 124 (comes from CCONT Pin 48)
- Check 13 MHz on Pin 93 (comes from G650)
- Check VBB 2.8 V DC
- Check PURX 2.8 V DC on Pin 122 (comes from CCONT Pin 54)
- Check SLEEPX 2.8 V DC 0n Pin 113
- Resolder MAD complete

#### D210 FLASH faulty / poor soldering/empty

- Check VBB 2.8 V DC on Pin 37
- If power consumption is around 20mA try to flash the phone
- Resolder FLASH completely

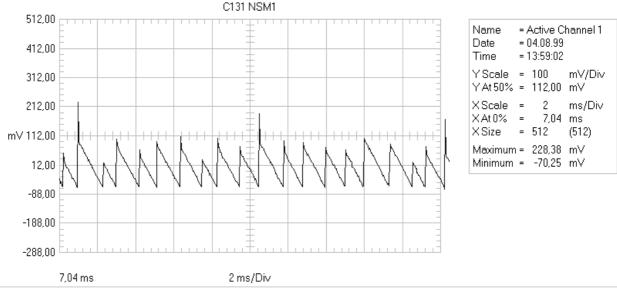
Figure 5: maximal noise on C131

- Check that the handset work with 3V SIM-cards
- Check that the 5V voltage over the capacitor C131 are around 4,8V-5,2V with maximal 350mVpp noise overlap (look to the diagram below)

Maximum noise on C131 with 5V SIM-card

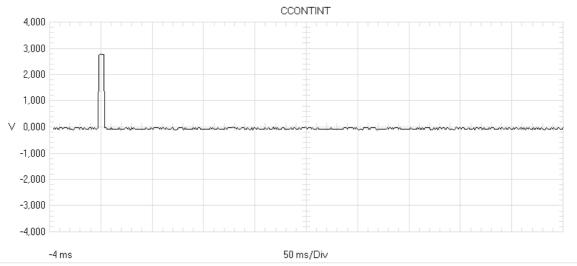
Figure 6: CCONTINT impulse

CCONTINT short circuit / break

- Check the CCONTINT impulse on pin 52 CCONT or pin 123 MAD (see the diagram below)
- Check pin 52 CCONT pin 123 MAD short circuit or break

CCONTINT mesurable, afer connect or disconnect a charger (ACP-7/9) Measurement point J223 or pin 52 CCONT, pin123 MAD

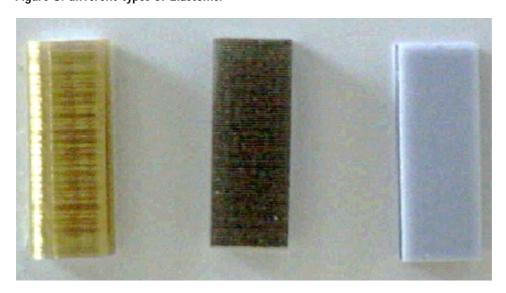
Figure 8: different types of Elastomer

Change Elastomer if contrast disappears, missing segments

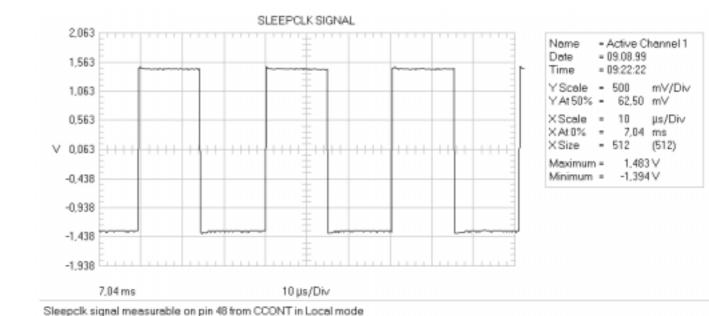
Figure 13: Sleepclock signal

## B100 32,768KHz crystal

Check the amplitude of the 32,768KHz square wave on pin 48 from CCONT

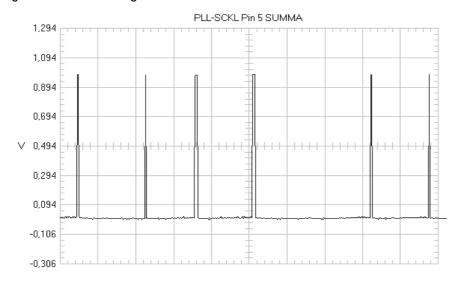
Figure 14: PLL-SCKL Signal

- check the UHF- and VHF oscillator frequency
- check the control-lines for the PLL, pin 5, 6, 7 from N600 (see the diagrams below)
- check the UHF-VC on pin 21 N600 1,9V-3.2V depending of the channel
- check the VHF-VC on pin 12 N600 2,6V
- check the 5V VCP supply voltage drop over R606 (normal 0,2V)
- change the N600 SUMMA

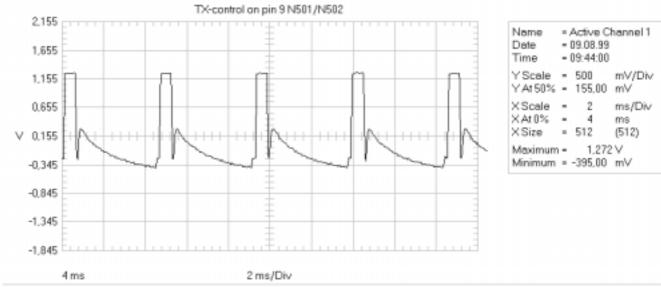
Figure 17: TX-Control Signal

- Check the power supply Vbat N502 pin 2,3,4,12,13 / N501 pin 4,6,11,12,13
- Check the input power on pin 8 N501/ pin 6 N502 depend of the band (nominal Odbm)
- Check the outgoing power on pin 12 or 13 N501/ N502
- Check the TX-Power control on pin 9 N501/ N502 ,1Vpp-1,5Vpp / 0,4..V 0,9..V DC depend of the power-level (see the diagram below)
- Change the PA if no power or to low power comes out
- Check the TX-Power on the antenna IN/OUT pads from X 560
- Check the X560 connector if it's a high attenuation

TX-control line measurable on pin 9 from N501/N502
