CONFIDENTIAL HDa-13/S 893 Introduction Date 2001-02-07 1 (29) Repairhints Version 1.0 Approved

# Repairhints

6210/6250 NPE-3/NHM-3 HDa13/S 893

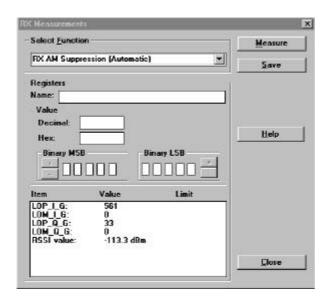
AM supression results should be in a range for: EGSM –86dBm to –130dBm, PCN -95dBm to –130dBm

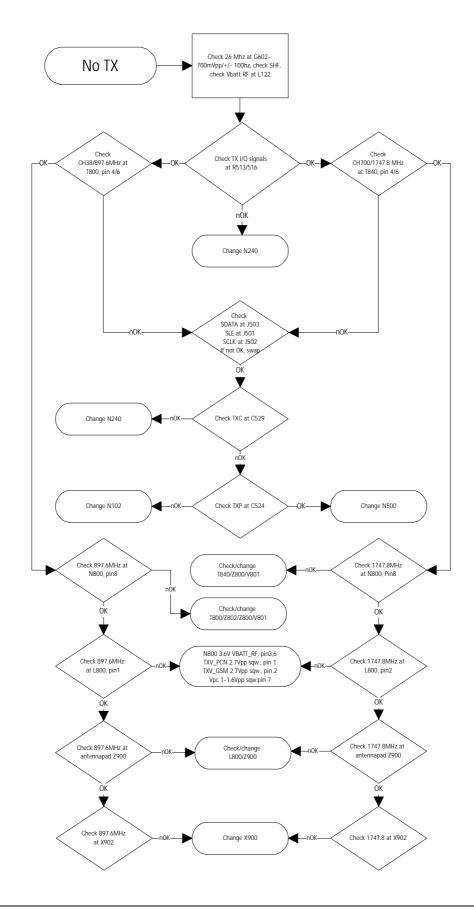
NO TX

If all values are ok but no TX - signal is measurable at **T800**, there are probably broken solderings under HAGAR, or **N500** is faulty.

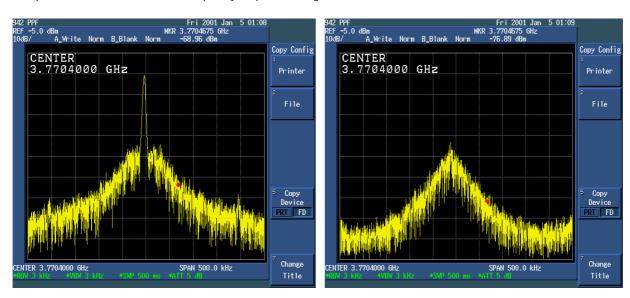
This causes problems in EGSM and PCN mode (RX/TX).

If this is the case, check the periphery – capacitors of SHF Oscillator **G602** in VC circuit (**C603**, **C604**, **C605**) Check their resistance to GND (approximately 3MOhm at **R612** to GND in normal case / otherwise the value should be in lower kOhm range (around 10k):

Left picture shows a normal SHF frequency amplitude – right side in defect case
