NOKIA	CONFIDENTIAL		1(5)
Service & Analysis Center Europe	RF Quick Repair Layout	Version 1.0) Approved
SACE CC Training Group	NPE-3		
©NMP 2001 Only for Training and Service Purposes	06.02.2001

NOKIA	CONFIDENTIAL		2(5)
Service & Analysis Center Europe	Baseband Quick Repair Layout	Version 1.0) Approved
SACE CC Training Group	NPE-3		
©NMP 2001 Only for Training and Service Purposes	06.02.2001

NOKIA	CONFIDENTIAL		4(5)
Service & Analysis Center Europe	Measurement Points	Version 1.0) Approved
SACE CC Training Group	NPE-3/ NHM-3		
©NMP 2001 Only for Training and Service Purposes	06.02.2001

NOKIA	CONFIDENTIAL		5(5)
Service & Analysis Center Europe	Colored Component Finder	Version 1.0) Approved
SACE CC Training Group	NPE-3/NHM-3		
©NMP 2001 Only for Training and Service Purposes	06.02.2001

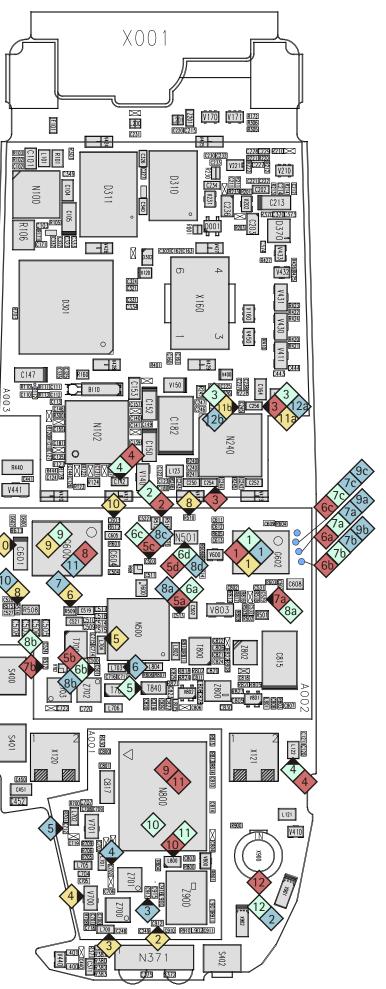
No TX EGSM

- 1. Check 26MHz reference oscillator at G602: 800mVpp/frequency deviation < 100Hz, if not ok, change G602.
- 2. Check TXIQ signals at R513/R516.
- 3. Check VBB 2,7V at C256 and VCOBBA at C254 check COBBACLK at J200, N240 faulty, or there are probably broken solderings under COBBA if ok, goto 7.

- 4. Check VTX (2,7V) at C142 and VBATTRF 3,6V at L122 if not ok, change N102.
- 5. Check supply voltages (2,7V) for HAGAR at a:C513(VXO), b:C501(VRX), c:C503 (VSYN_2), d:N501 input 4,8V (VCP) if one or more of these fails change N102.

- 6. Check SDATA at a: J503/J507, SCLK atb: J502/J506 and SLE at c: J501/J505 if not ok MAD D301 faulty.
- 7. Check TXC at C529, check TXP at R512, change N240 for TXC- and N102 for TXP fault.

- 8. Check frequency of SHF oscillator G600 if possible refer to EGSM frequency list.
- If there is no possibility to check frequency check if oscillator works by measuring VCC at C601 (2,7V) and VC at C603, which varies between 0,7V and 3,8V (see EGSM list). If VC is 4,8V the oscillator doesn't work in all probability.

- If values are ok but no TX signal at T800 measurable N500 faulty, or there are probably broken solderings under HAGAR.
- 9. Check 897,6 MHz (CH56) at N800, pin 8 if not ok, check T800, Z802, Z800, V801.

- 10. Check 897,6 MHz (CH56) at L800, pin 1 if not ok, check VBATTRF at N800,pin 3 & 6.
- 11. Check also TXVGSM (2,7Vpp squarewave) at N800, pin 2 and Vapc 1-1,6Vpp squarewave, (depends on TX powerlevel) at N800, pin 7.

- 12. Check 897,6 MHz (CH56) at X902 (antenna pad) and at X900 (antenna connector) if not ok, check L800 in & out also check Z900 in & out and TXVGSM at R910. No BX EGSM

- 1. Check 26 MHz reference oscillator at G602, 800mVpp/frequency deviation < 100Hz, if not ok, change G602.
- 2. Check 942,6 MHz (CH56) at C912 if not ok, check solderings of Z900, change Diplexer if necessary.

- 3. Check 942,6 MHz (CH56) at L800 if not ok, check/change Z800.
- 4. Check 942,6 MHz (CH56) at V800 in £t out if not ok, check LNA values: VLNAB_G 2,7V at V800, pin 8 and LNA_G 0,7V at pin4, change HAGAR N500 if necessary.

- 5. Check 942,6 MHz (CH56) at L704 if not ok, check/change Z703, R702, T800
- 6. Check RXIQ signals at R509 if not ok, check supply values at HAGAR N500: supply voltages are 2,7V at C513 (VXO), C501 (VRX), C503(VSYN_2) and N501 input 4,8V (VCP). If one or more of these fails - change N102

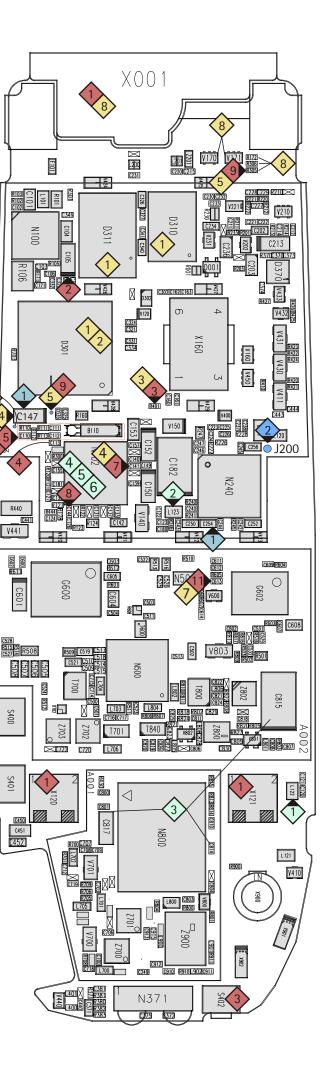
Phone does not switch on

- First check current consumption: off state 0-2.35 mA / sleep mode 2.35-4 mA. If too high continue with section "low standby / operation mode time"
- 1. Check connectors X001 / X120 / X121 if bent or soiled.

- 2. Check VB 3,6V at J103 / C105 if not ok, check L123.
- 3. Check if PWRON at R401 / J102 drops to 0V while pressing powerswitch, if not ok check/change S402, R401.

- 4. Check 32,768kHz at J112 / C113, 3,2Vpp squarewave ok goto 7.
- 5. Check/change B110, R110, R111, R112, R113, C110, C111, C112, C113.
- Change CCONT N102 if necessary

- Check VBB 2,7V at J108 / C147 if not ok, check resistance of line to GND or change CCONT N102
 Check VXO 2,7V at J105 / C141 if not ok, check resistance of line to GND or change CCONT N102

- Check SLEEPX 2,7V at J333 if not ok MAD is faulty in all probability swap the phone, because MAD D301 is not changeable
- 10. Check PURX 2,7V at J101 after pressing powerswitch if not ok, change CCONT N102

- 11. Check 13MHz Clk frequency (RFC) at C613, approximately 800mVpp -
- if not ok, check values around G602 / V600 change HAGAR N500 if necessary try to flash the phone - if not ok - continue with section "FLASH update not possible"

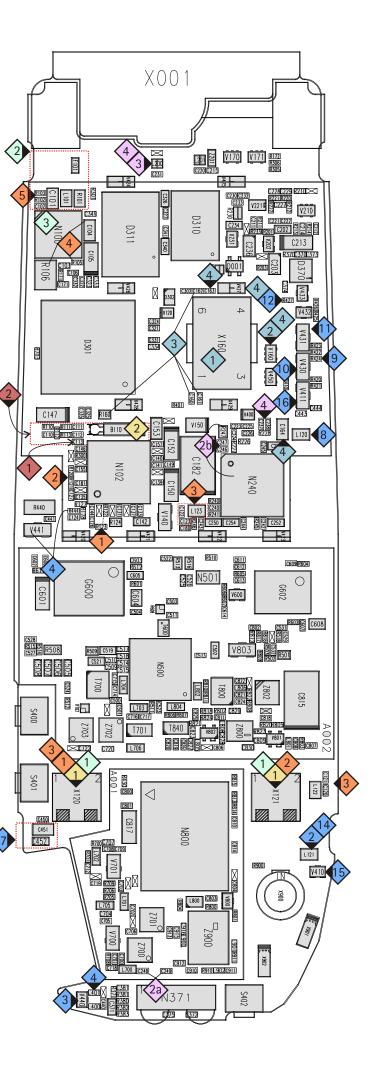
Internal audio faults
	No audio from speaker
1.	Check resistance of speaker B200 (300hm), change speaker if bent (especially membrane) or soiled.
2.	Check connection between speakerpads on PCB to a)C248/C249 and to b)C246/C247. If not ok, check R247 to GND, resistance of both lines should be > 1 Mohm
	If fault persists change COBBA N240.
	Note: Realign Rx/Tx values and rewrite SIMlock data after changing COBBA!
	Microphone does not work
	Check impedance of microphone (0,5-1k0hm), change if necessary.
	Check mechanical condition of connector X001 and MIC itself for dirt etc
	Check MicBias at L200, 2,4V on active microphone.If not ok, check - values around V231.

4.	Check connection between L200- C263 (470 Ohm),-C237 (0 Ohm),-C238 (0 Ohm) if fault remains, change Cobba N240. Note: Realign RX / TX values and rewrite SIMlock data after changing COBBA!
	Clock time problems
	Clock time has to be corrected in short periods
1	Check amplitude and frequency of sleepclock oscillator at C113/J112, should be 3,2Vpp squarewave at 32,768kHz.
	If not ok, change B110 and check parts around oscillator (R110, R111, R112, R113, C110, C111, C112, C113).

2.	Clock time is lost after removing battery
	First try to charge RTC battery, by connecting battery to the phone for app. 10 minutes.
	If fault remains, check contact springs of battery, change RTC battery (LCD unit).
	If fault persists, probably CCONT N102 or CHAPS N100 faulty.
	Note: It is necessary to run energy management calibration after changing CCONT N102!
	For Energy managemant calibration also see general tuning information page!
	Phone intermittend switches off

1.	Check mechanical appearance of connector X120 / X121 - change if necessary .
	Check amplitude of 32,768kHz at J112 / C113, 3,2Vpp squarewave, change B110 if necessary.

2.	If not ok, check parts around (R110, R111, R112, R113, C110, C111, C112, C113), probably broken solderings under CCONT N102 change if necessary.
	the same problem may cause HAGAR N500, because the reference oscillator G602 is divided to 13MHz system clock by HAGAR N500.
	If you suppose broken solderings under HAGAR - rework as described above.
	Note: it is necessary to run energy management calibration after changing CCONT N102!
	NOTE: for Energy managemant calibration see also general tuning information page!
	Not charging
1	Nothing happens if charger is connected.
	Check mechanical appearance of connector X120 / X121. Check resistance of fuse F101.
