CONFIDENTIAL HDa-13/S 893 Introduction Date 2001-03-16 1 (29) Repairhints Version 1.2 Approved

Repairhints

6210/6250 NPE-3/NHM-3 HDa13/S 893

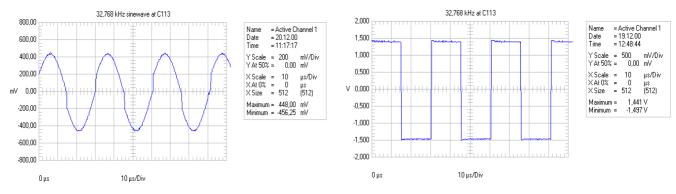
32 kHz before and after C113.

Check amplitude and frequency of sleepclock oscillator at J112 / C113 should be 3,2Vpp squarewave at 32,768kHz. If not ok, change B110 and check parts around oscillator :(R110, R111, R112, R113, C110, C111, C112, C113).

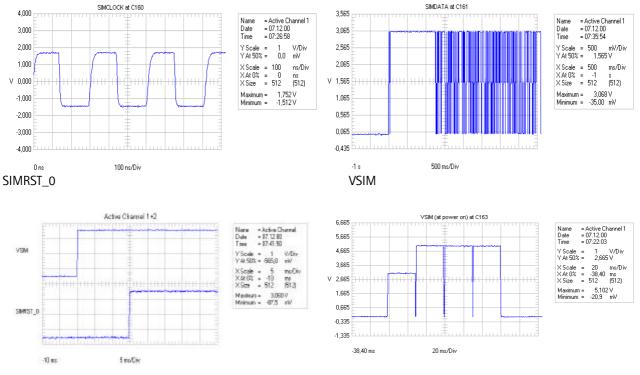
SIMcard Signals

Check X160, if bent or soiled - change if necessary Check BSI A/D values (ok range 340-350) Check V160: pin1 – DATA_0, pin3 – VSIM, pin4 – SIMCLK, pin5 – SIMRST_0 Check also R160, C160, C161, C162

Check resistance of SIMlines to GND - change V160, C163, C164 if necessary, probably broken solderings under CCONT N102 Change CCONT N102 and run energy management calibration, if fault persists - probably MAD D301 or PCB faulty.

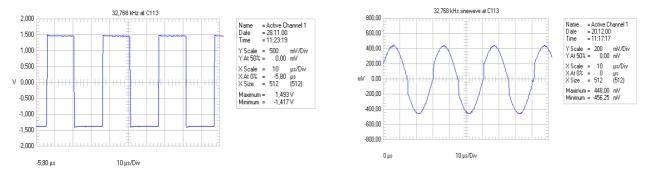
Check 32,768kHz at J112/C113, 3Vpp squarewave – (if it is difficult to measure squarewave, because of Basebandshield,

check 32,768 kHz at the other side of C113, 900mVpp sinewave).

If not ok, check/change components around B110, (R110-R113 & C110-C113) and/or change CCONT N102 if necessary. Check VCORE at C155 – 1,7V – if not ok, change CCONT N102.
