Repairhints

Service-Level 3 & 4

6310

NPE-4

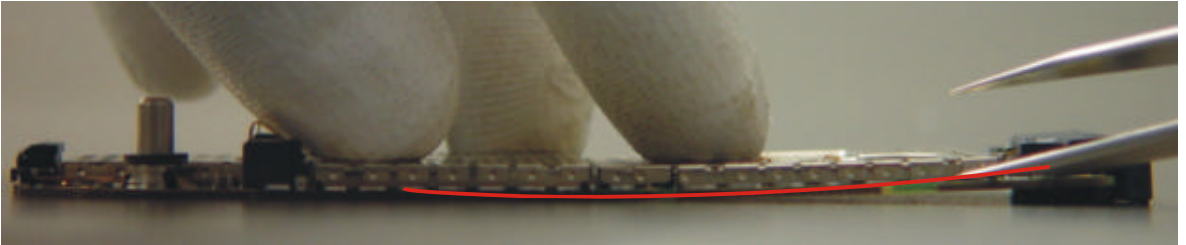
Wrong

For disassembly it is important to lay the PWB on a plane underground so that the bottom connector is hanging free to prevent bending of PWB and cracking of the connector's solderings (See pictures below).

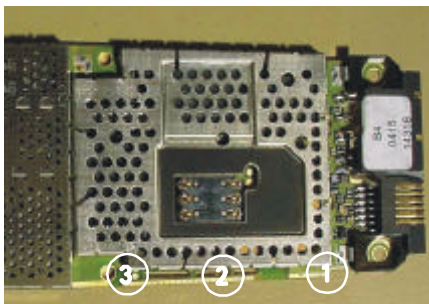
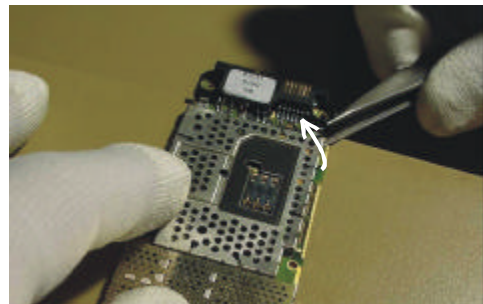
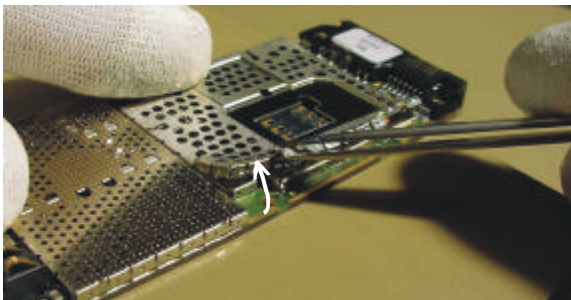
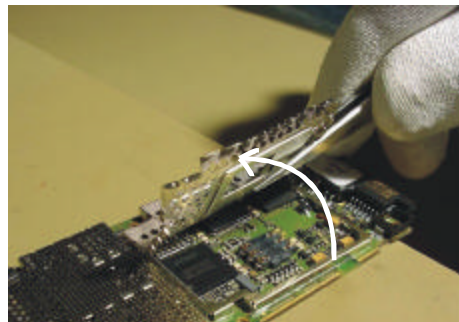
When disassembling the BB shield be very careful because Flash D450 could be damaged. Start by lifting and bending the lid with a tweezer at the marked points 1- 3 (see pictures below). Do not use too much force on the frame because it could be damaged and the PWB also could be mechanical stressed.

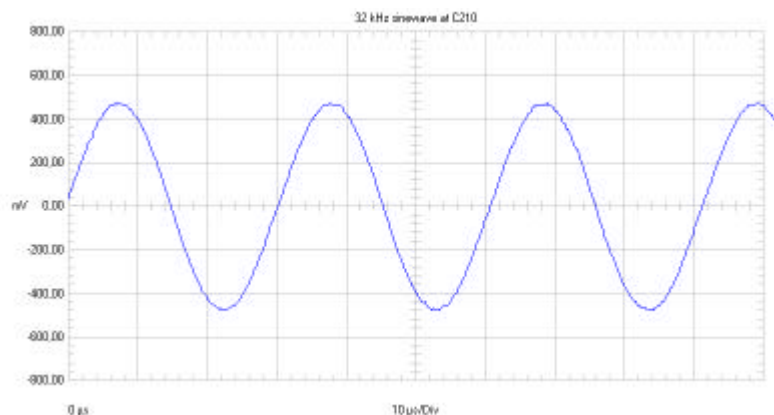
Check VBATIN=3.6 VDC at L260 (depends on workbench supply). If not ok, check X101, X102 battery connectors for mechanical damages or cold solderings. **Refer also to chapter "Additional Information/Different battery connectors".** Check 32.768 kHz sinewave, Vpp = 800 mV at C209 (See picture below).

If there is no signal, check B200 circuit for shorts or disconnection and change faulty components.

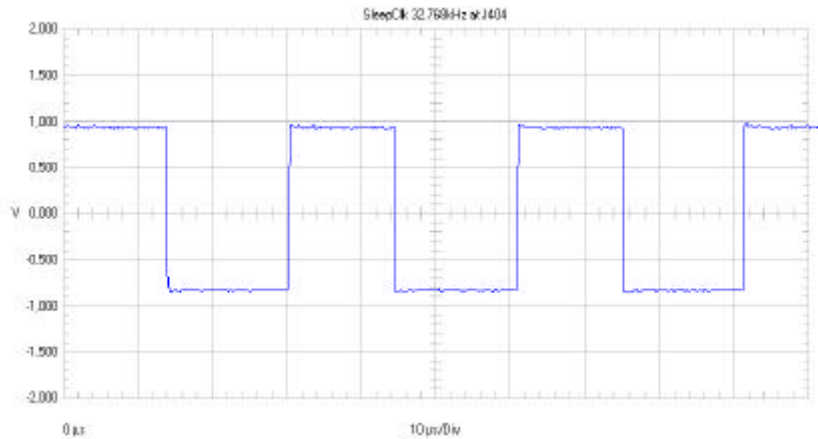
If not ok, check PWRONX-line from S300 to UPP D400 for shorts or disconnections.
Check SleepClk = 32.768 kHz, Vpp = 1.8 V square wave at J404. (See picture below)

If not ok, check B200 circuit for shorts or disconnections.

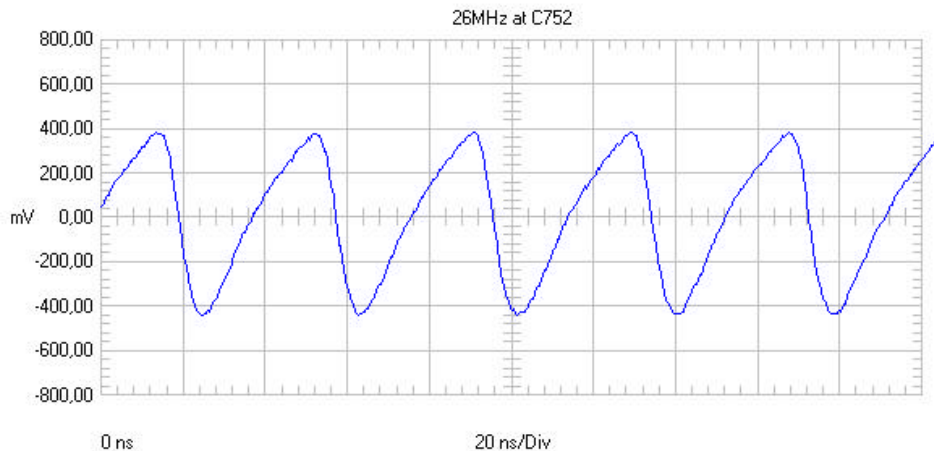
Check VCORE = 1.8 VDC at C400. If not ok, check UEM D200
Check PURX = 1.8 VDC at V130 Pin 44. If not ok, check UEM D200
Check System Clk = 26 MHz, Vpp = 800 mV at C752 (See picture below)

If not ok, check 26 MHz G740 circuit. Refer also to chapter Drop calls

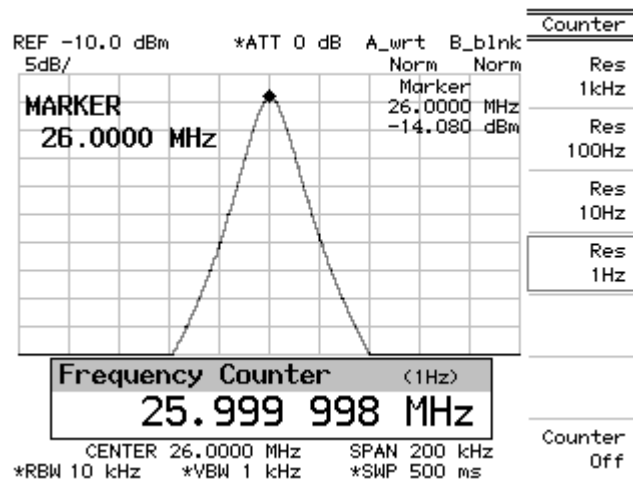
Open the Phoenix menu Testing/ RF controls and activate local mode RX GSM900
Check 26MHz +/- 100Hz between C752 and R752 with spectrum analyzer and active frequency counter (See picture below)

If the frequency drift is higher than +/- 100Hz, check VR3 (VCC) = 2.8 VDC at R740.- If not ok, check UEM D200.

If both voltages are ok but the frequency drift is higher than +/- 100Hz and the fault is getting stronger when pressing the top of the 26MHz oscillator G740, change the faulty component.

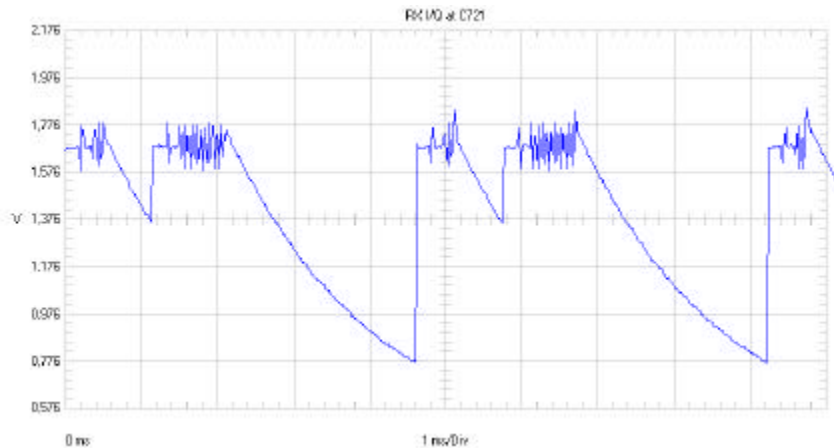
Set the RF generator to GSM 942.4 MHz at channel 37, RF level -55 dBm and also the phone to same frequency and channel.
Check RX I/Q signals at C721, C722 (See picture below)
Always measure in burst mode (with an oscilloscope in DC mode).

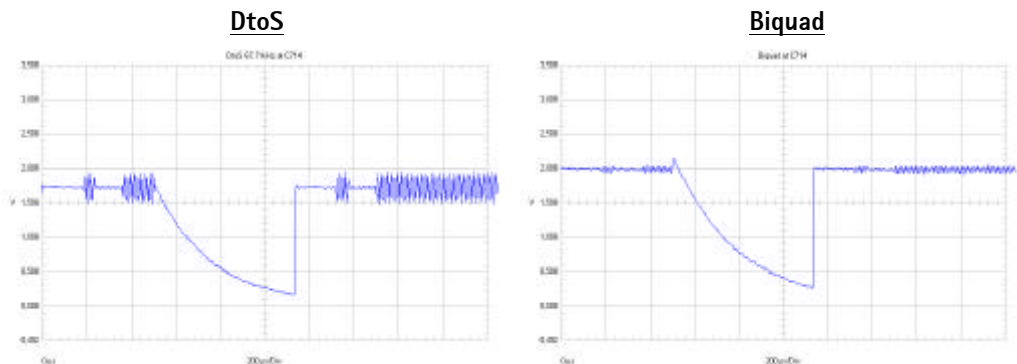
If not ok, check 67.71 kHz at C714 (Dtos and Biquad filter).
Measurement points at C714 count from N600 Hagar side: At first pins (3/4)= Dtos I/Q;
and then pins (1/2)= Biquad (CM_F and CP_F I/Q).

If the signal is not ok, in GSM check RX signal 942.4 MHz at channel 37, RF level -55 dBm at L626.
If the signal is not ok, in PCN check RX signal 1842.4 MHz at channel 700, RF level -55 dBm at L616
If both RX signals not ok, check RX lines from N600 Hagar to X802 antenna connector for shorts or disconnections.

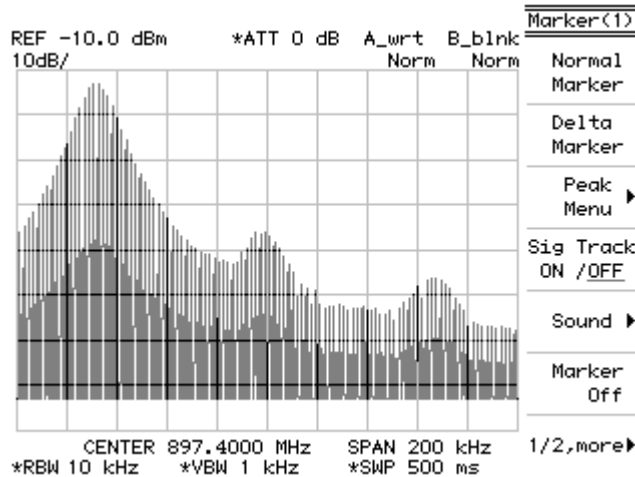
Check EGSM TX signal at R656 / R657 (See picture below)
Set spectrum analyzer to TX EGSM 897.4 MHz, channel 37.
Set phone to TX mode, EGSM 897.4 MHz, channel 37 and power level 10.

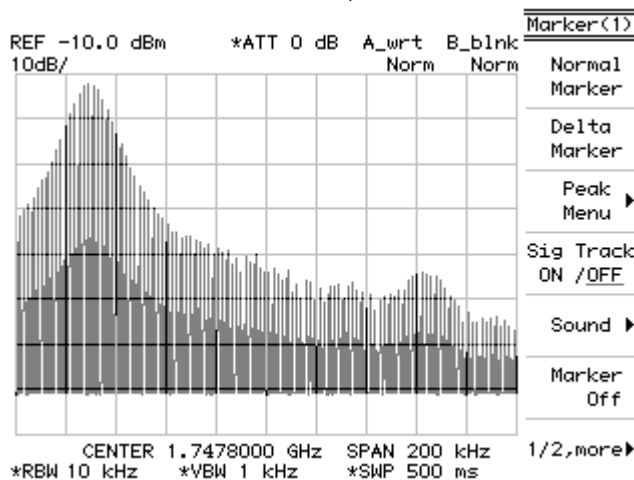
If there is no signal measurable, check PCN TX signal at L662 (See picture below)

Set spectrum analyzer to TX PCN 1747.8 MHz, channel 700.
Set phone to TX mode, PCN 1747.8 MHz, channel 700 and power level 10.

If both TX signals ok, check EGSM/ PCN TX lines between Hagar N600 and antenna connector X802 for shorts or disconnections

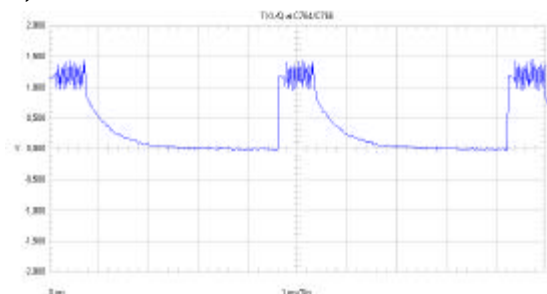
If there is no TX signal at L662 measurable, check TX I/Q at C764 and C766 on both sides of capacitors.
(See picture below)

If the TX I/Q signal is not ok, check UEM D200

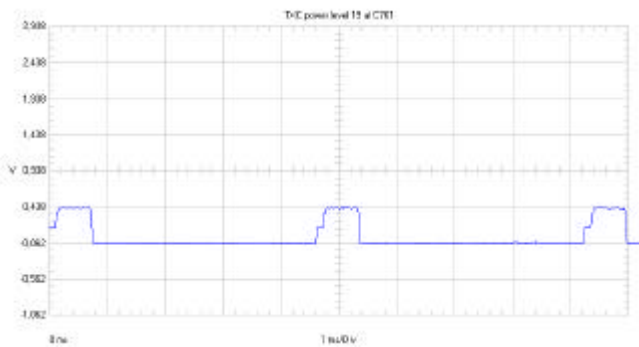
Power level 19

Check TXC at C761, power level 19 and 5. (See picture below)

If the TXC signals are not ok, check UEM D200

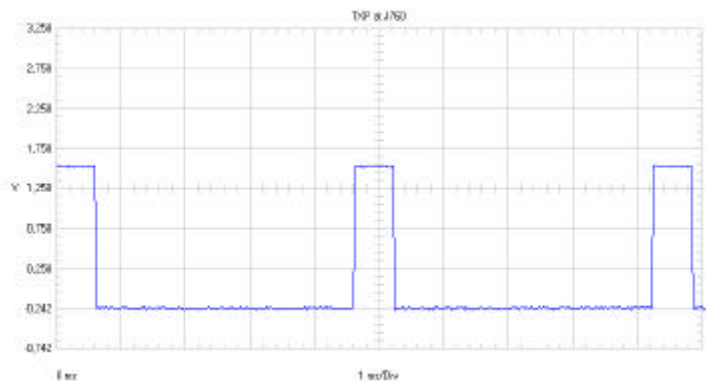
Check TXP signal at J760. (See picture below)

If the TXP signal is not ok, check UPP D400.

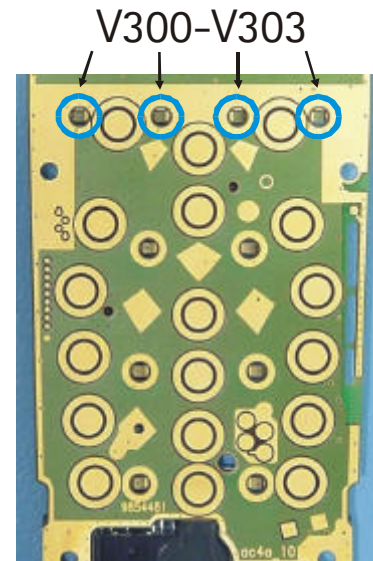
When turning on the phone, the display LED's V300 – V303 (See picture below) shines in different brightness. This is caused by use of different LEDs. In this case change all LEDs and assemble the right one with **spare part code 4864293**.

Note! When changing the LEDs, the RF frame has to be removed at first. Be very careful when lifting the frame. A little drift byside and some small components might be pushed away.

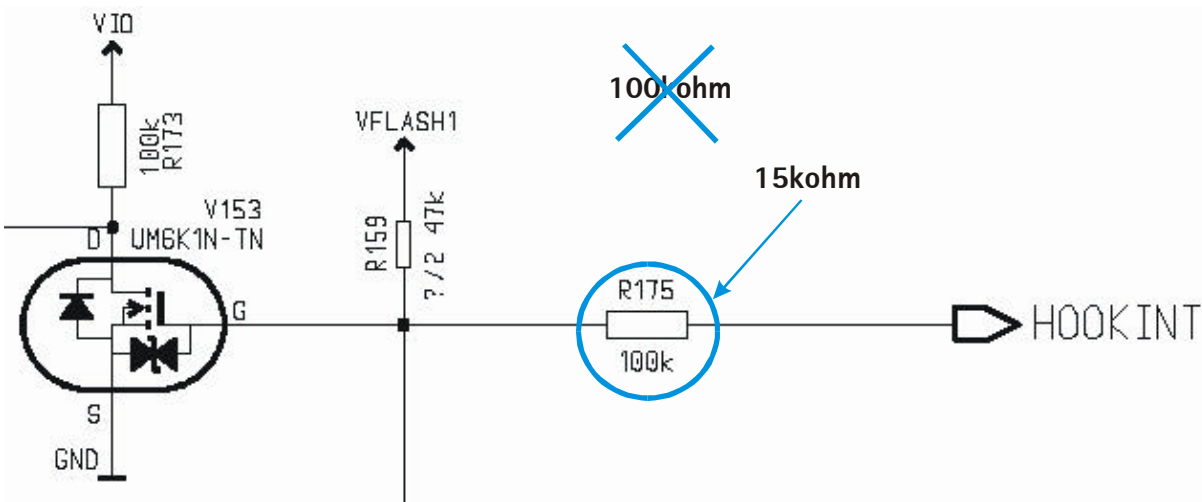
When the headset HDC-9P is connected to the bottom connector of NPE-4 and a call is coming in, often it is not possible to release the call by pressing the hookswitch.

Often it is not possible to initiate the voice call by pressing the hookswitch.

Open the BB-shield and measure the resistor **R175=100k Ω** .

If **R175=100k Ω** , change the resistor to **15k Ω** . (See picture below).
