Repairhints

7110

NSE-5

HD 945

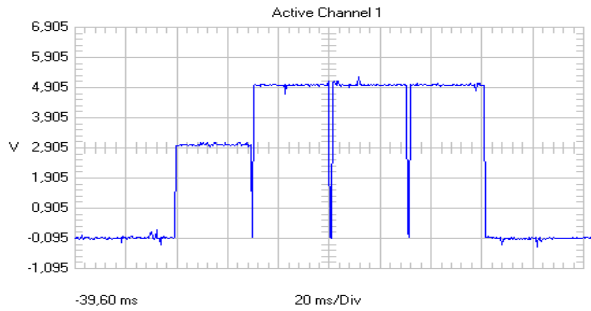
VSIM after switching on the phone without SIMcard. CCONT pulses up VSIM for four times, the first time the amplitude is 3 Volt, the next three times it is 5 Volt.
If the phone is switched on with SIMcard, VSIM stays on the level with which the SIMcard works, expected that SIMcard is not dirty or damaged.

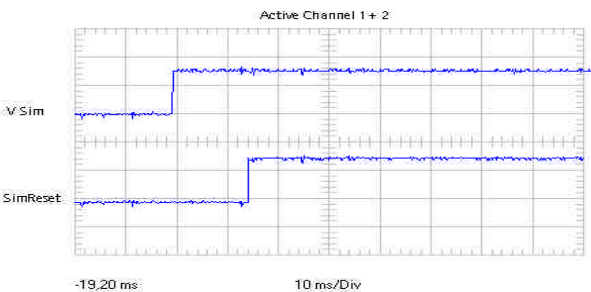
SIMReset is low-active, that means that the SIMcard will be reseted when SIMReset is 0 Volt. This is the case after switching on the phone (diagram above). While VSIM is already high, SIMReset keeps low for a few milliseconds – in this time the card will be reseted.

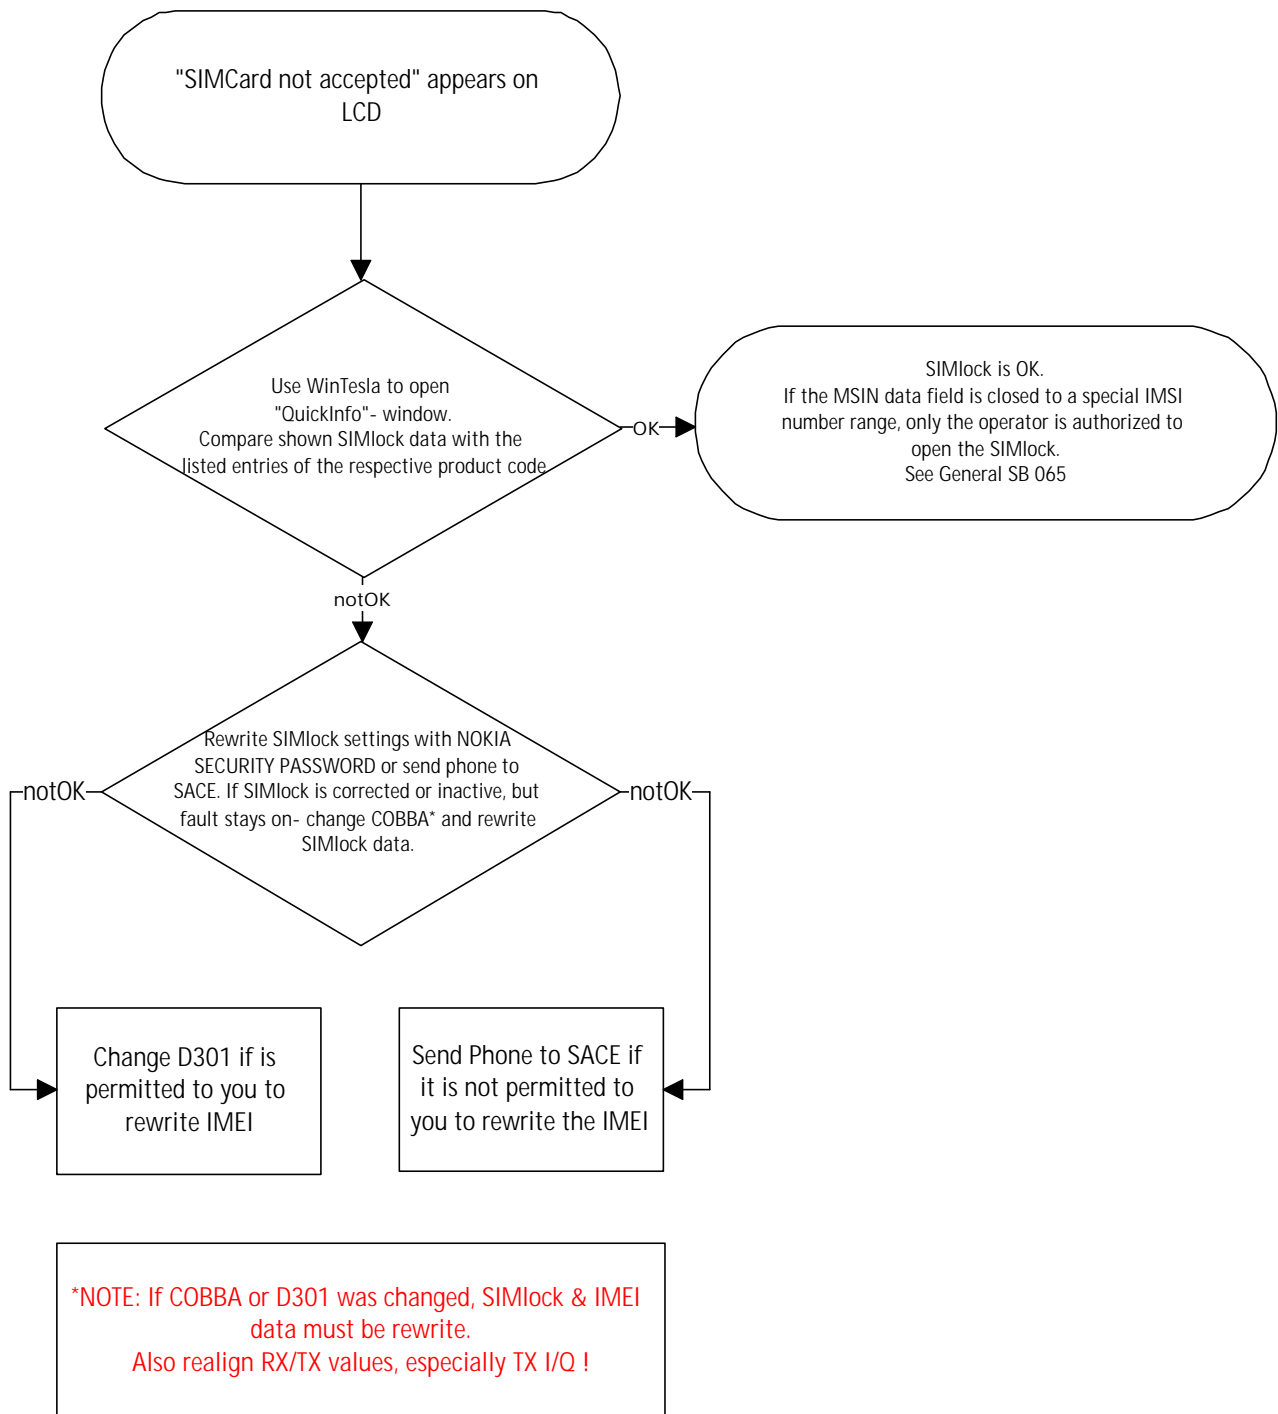
SIMCARD NOT ACCEPTED

X100 SIMcard Reader

SIM lines shorts to GND

N100 CCONT faulty

N200 COBBA faulty

- Check solderings of connector.
- Check if bend or soiled, change if necessary.

- Check resistance of SIM lines to GND at C116, C129, C130, C131,- value should be higher than 100kOhm.
- Check also R120.

- Check SIMClock, SIMData, SIMReset and VSIM.
- It's also possible that broken solderings under CCONT N100 are the reason for this fault. Remove CCONT, tinplate oxidized pads carefully with only a little bit of flux and solder, replace CCONT with μ BGA rework machine.

- If "SIM card not accepted" appears on LCD, but SIMlock-settings are ok or no SIMlock is set, it is necessary to change COBBA N200.
Note that you have to rewrite SIMlock-data and tune Rx/Tx-values of the phone after changing the COBBA,

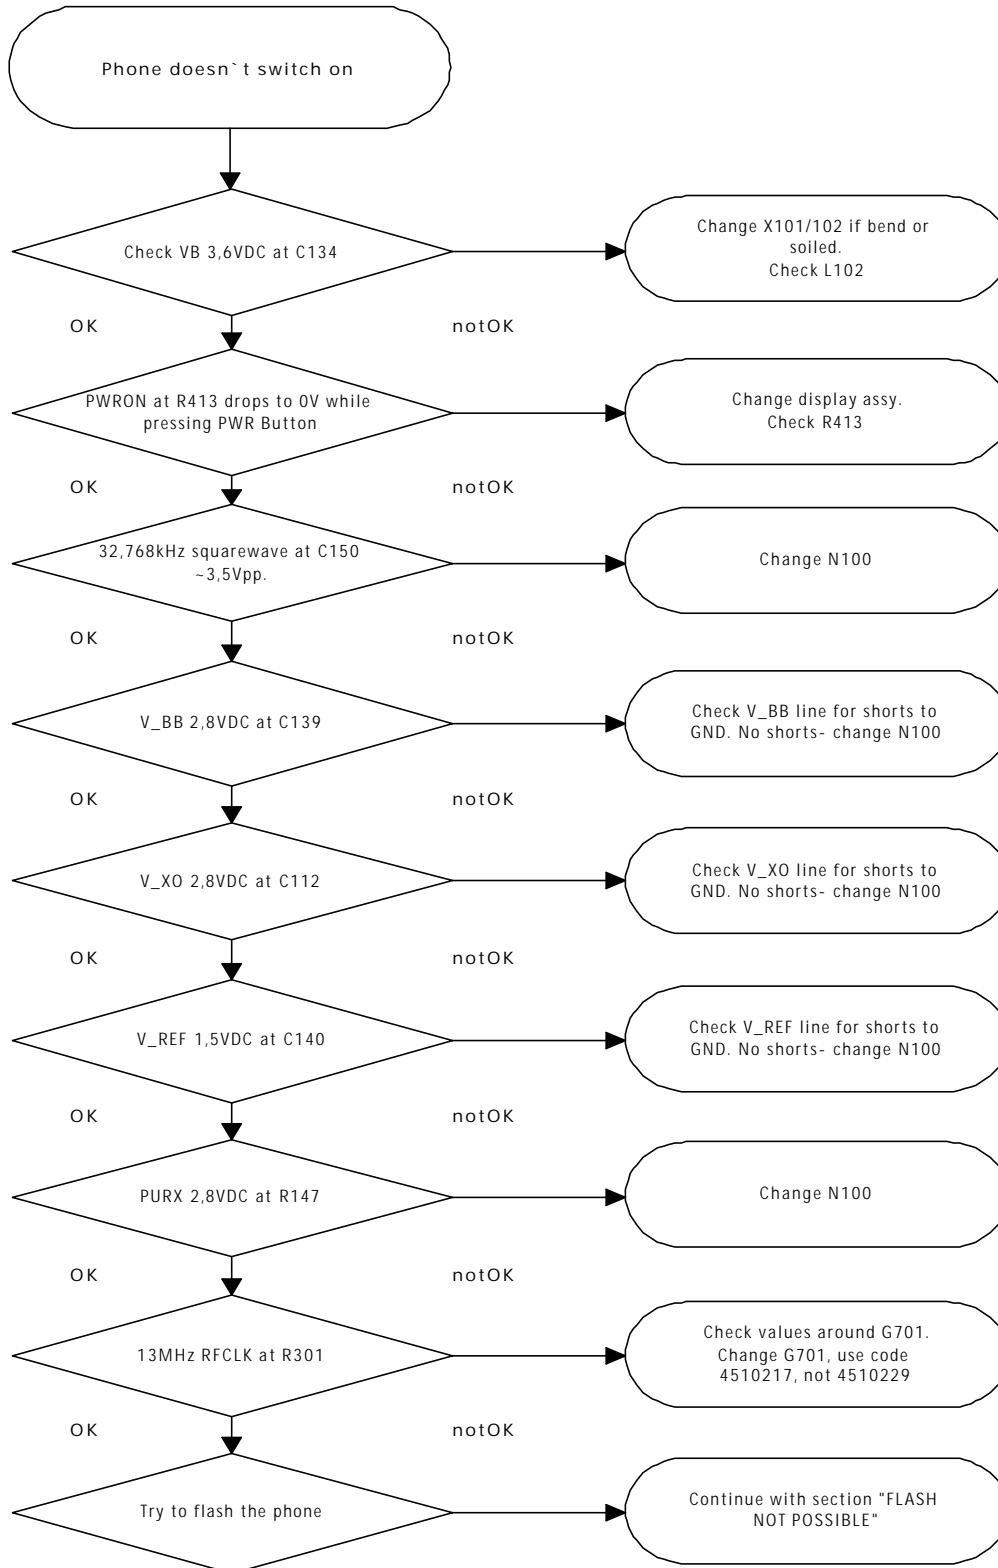
PHONE DOESN`T SWITCH ON

Battery connector X101, X102

Power on/off switch faulty

B100 problems

G701 Reference oscillator faulty

N100 CCONT faulty

D300 MAD faulty

- Check solderings of X101, X102.
- Check if connectors are bend or soiled.

- Check that PWRON at R413 decreases to 0V during pressing the powerswitch.
- Check display connector X400, change display assy if necessary.

- Check voltage at B100, both Pins 1,6VDC.
- Check 32,768kHz sinewave signal level at C104.(700mVpp).
- Check parts around B100 like R117, R118, R121, R135, C103, C104, C149.
- Check 32,768kHz squarewave at J318 (3,3Vpp).

- Check Vcc 2,8V at G701.
- Check Vcont (may vary between 1 and 3.5V).
- note that it is necessary to change G701 if frequency error is higher than 50Hz.

- Check Vb 3,6Vat C134.
- Check that PWRON decreases to 0V at R413 when powerswitch is pressed.
- Check 32,768kHz squarewave at J318.
- Check 13MHz Clk-frequency at R301.
- Check Vbb 2,8V at C139.
- Check Vxo 2,8V at C112.
- Check Vref 1,5V at C140.
- Check PURX 2,8V at R147.
- Probably broken solderings under CCONT. Try to tinplate the oxidized pads careful with only a little bit of flux and solder.

- Check 32,768kHz squarewave at J318.
- Check 13MHz Clk-frequency at R301.
- Check Vbb 2,8V at C139.
- Check PURX 2,8V at R147.
- MAD is probably faulty, swap the phone because MAD is not changeable.

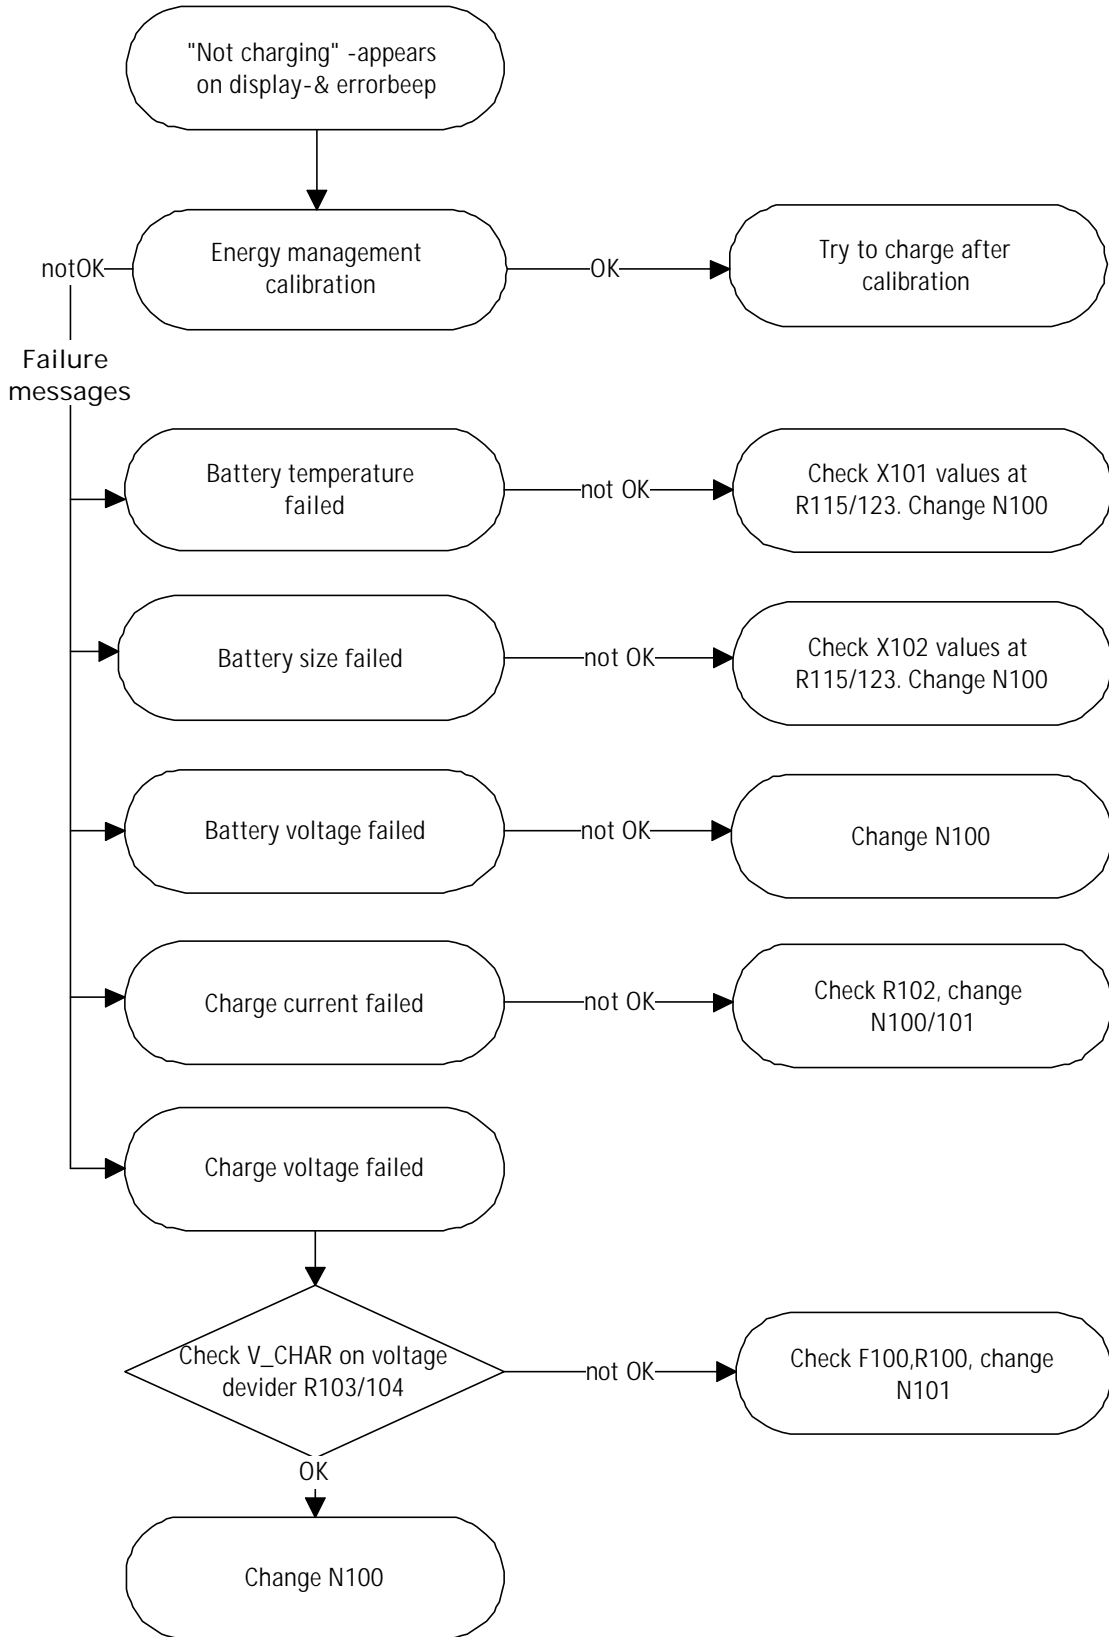
NOT CHARGING (APPEARS IN DISPLAY,- & ERRORBEEP)

X101, X102 Battery connector, X200 system connector

F101 faulty

V_In line short circuit to GND

N100 faulty

Energy management calibration

- Check soldering of connectors.
- Check mechanical appearance of connectors, change if necessary.

- Check resistance of F101 (0 Ohm)

- Check resistance of V_In line to GND (~50 kOhm).
- if resistance is not ok Check R101 / C101 / C144 or change N101.

- Change CCONT / N100 if any A/D value is out of limits but DC voltage is ok.
- If DC voltages are not ok Check corresponding voltage dividers and battery connectors X101/102.
- Probably broken solderings under CCONT / N100. Remove CCONT, tinplate oxidized pads carefully with flux and solder, replace sparepart with μ BGA rework machine.

- Run calibration if charging stops too early.
- If message "not charging" appears on LCD.
- If any part in the charging circuit has been replaced.

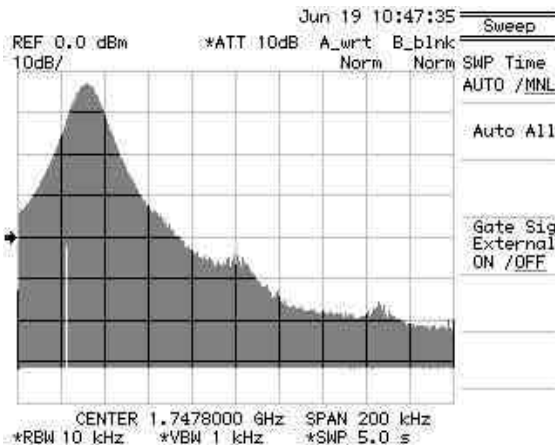
1)

Pic1) Normal Spectrum

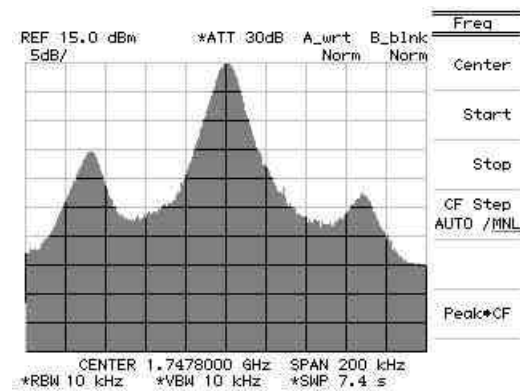
3)

Pic3) Spectrum with faulty COBBA, RSSI-alignment is not possible.

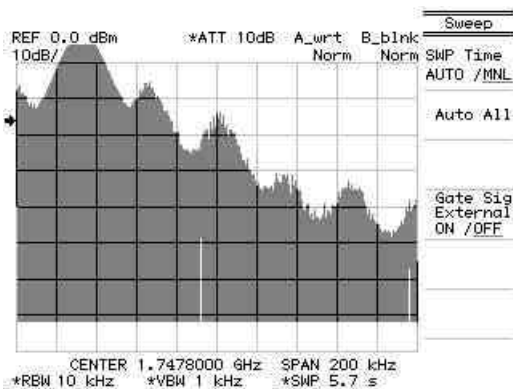
2)

Pic2) Spectrum with broken soldering under CCONT (No PCN_low reference settings in RSSI alignment).

Spectrum turns to pic1 if N100 is pushed carefully with some nonmetal item. This fault can also be measured at N700 pin 15.(13MHz RFCLK).

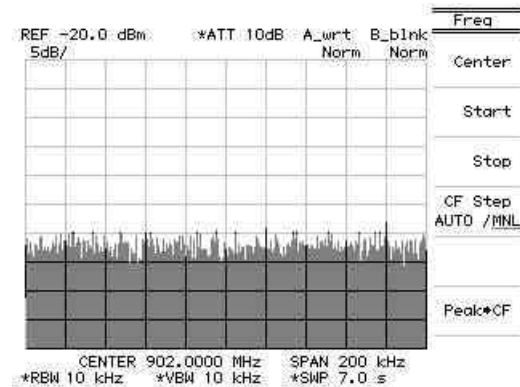
4)

Pic4) Spectrum with broken soldering under COBBA, RSSI- alignment is not possible. Spectrum turns To pic 1 if N200 is pushed carefully with some nonmetallic item.

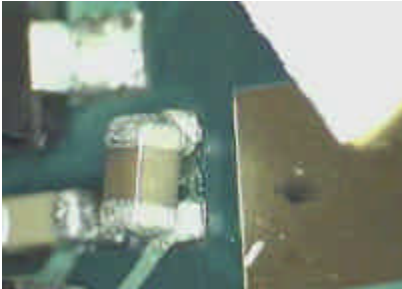
Check C158 (if broken or bend)

In this case : Use a new RTC battery, the length of spring-connectors are the reason for bending the capacitor.

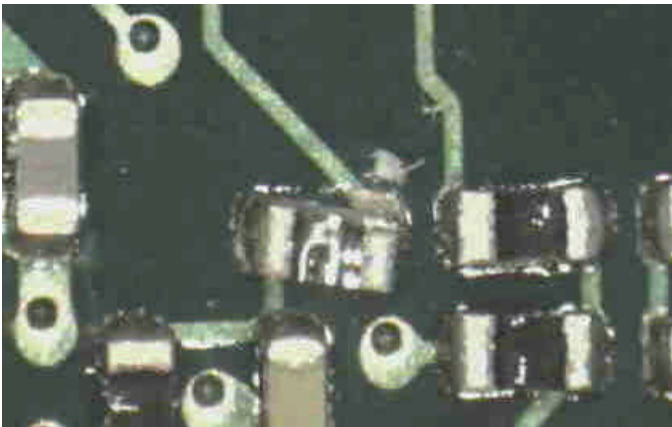
If scrollfunction failed, check R411 on PCB (broken or bend).
Cut the RTC battery holder or change the B-cover.
For more details see **SB 012**

Check connections between R409 and J400, R410 and J401, R412 and J402.

If one of these connections failed, swap PCB.

Check resistance of R407-R412.
