Repairhints

8210/8850/

8890

NSM-2/3 & NSB-6

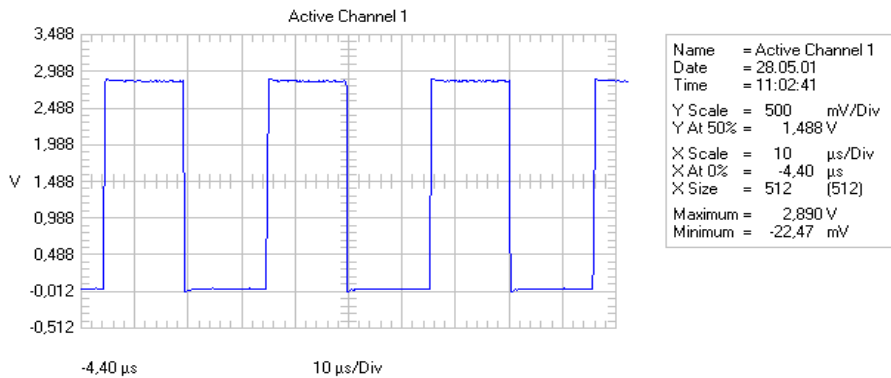
If amplitude and/or frequency of signal is not ok, check periphery of B100 (R100/102/154, C101/102). If ok change crystal B100 or CCONT N100.

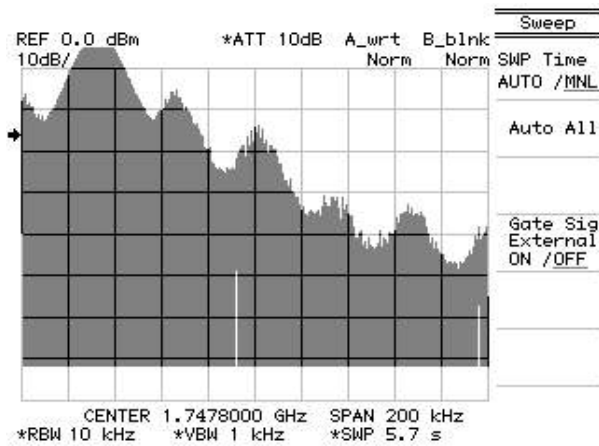
3) Spectrum with broken solderings under CCONT
 Spectrum turns to picture 1 if CCONT is carefully pushed with some nonmetallic item.
