# Repairhints

# 8310

# NHM-7

The purpose of this document is to provide some further service information for NOKIA 8310 phones.

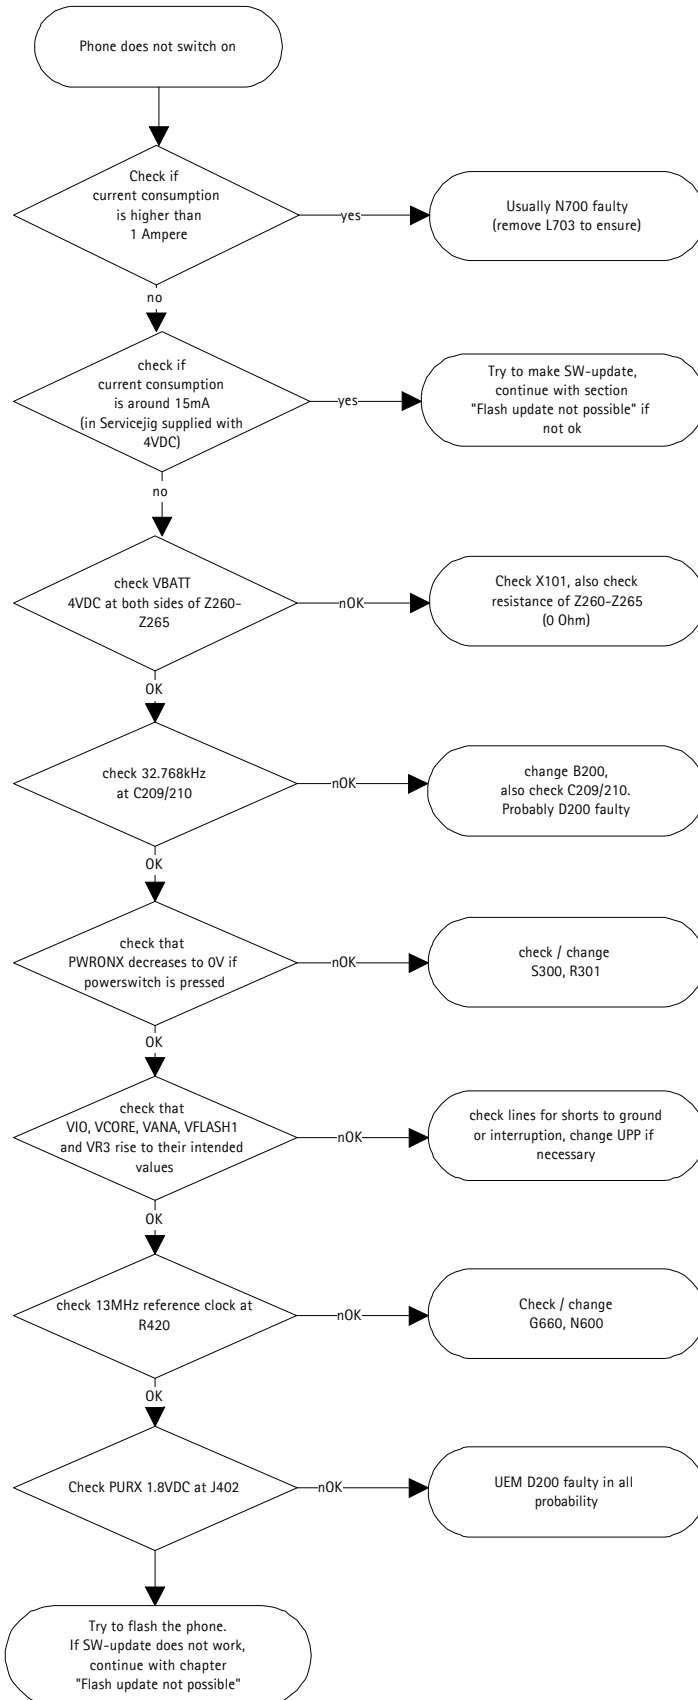
**CHAPTER 1 PHONE DOES NOT SWITCH ON**

**PHONE DOES NOT SWITCH ON****X101**

- check mechanical appearance of battery connector. Change part if it is bent, soiled or corroded.

- check mechanical appearance of powerswitch, change if necessary.
- check voltage at S300, 3.8VDC in case that switch is not pressed. If voltage is not measureable or too low especially check R301 and C312.
- if switch is pressed, voltage at S300 must decrease to 0V. Change switch if necessary.

- check DC-voltages at C209 and C210, normally 0.5VDC. If voltages are not ok check C209/210 for shorts to ground. It also is possible that UEM D200 is defect.
- if DC-voltages are ok but no 32.768kHz signal is measurable at C209/210 change the crystal B200.  
Note that this signal must be always measurable if battery voltage is higher than 3.1VDC, even if phone is switched off! In this case amplitude of 32.768kHz is a bit lower (700mVpp at C209, 550mVpp at C210).

- at this time it is not useful to change this part. IMEI and Simlockdata must be reconstructed in case that UEM has been changed. This is not possible up to now, but it is planned to make this possible in the future.

- in case that phone does not switch on while current consumption stays on 15mA (in Service jig supplied with 4VDC) this indicates that Flash D450 probably is empty. Try to make SW-update. If any failuremessage appears during flashing, try SW-update a second time. It also can be necessary to change D450. Note that in this case you have to rewrite IMEI, Simlock data and Product code, furthermore you have to run all RX/TX-tunings and energy management calibration!

- check voltage at C662, 2.8VDC
- check signal of 26MHz reference oscillator at C660:

With the voltage of 2.8VDC at C662 the oscillator must be able to work on a frequency around 26MHz, else you have to change G660.

- in case you suppose a defect poweramplifier N700 to be responsible for the fault, first of all check the current consumption of the phone. If current rises to more than 1 Ampere directly after connecting the phone to the servicebattery, remove coil L703 and check current consumption again. If current is ok now you have to change poweramplifier N700 with help of µBGA soldering machine and LGA rework kit LRK-1.

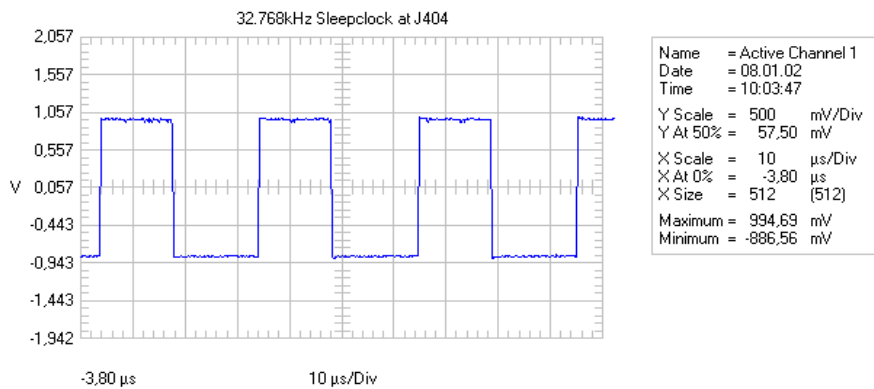
- check mechanical appearance of battery connector X101. Change part if spring contacts are bent, soiled or corroded.
- check amplitude and frequency of 32.768kHz sleepclock-signal at J404, 1.9Vpp:

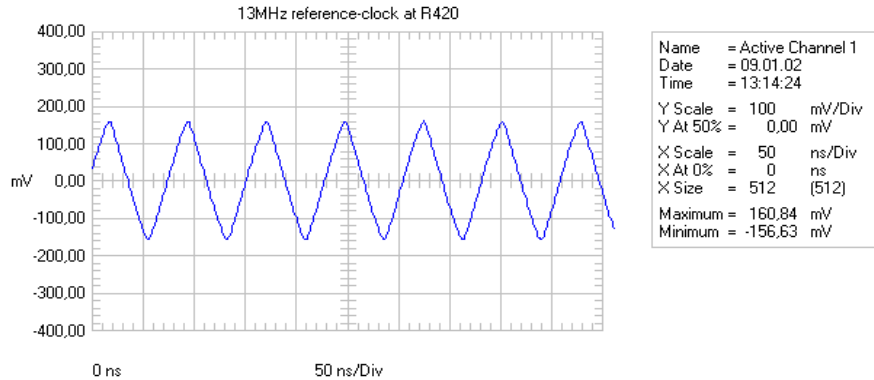
- check amplitude and frequency of 13MHz system clock at R420, 320mVpp:

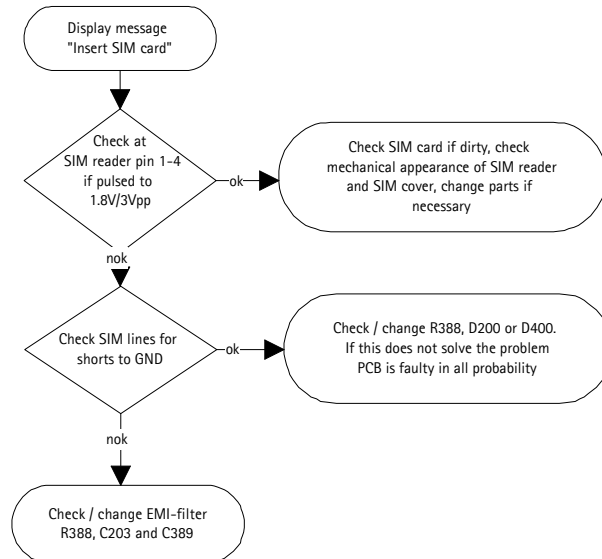
**CHAPTER 4 SIMCARD-FAULTS**

In case that phone messages "Insert SIM card" on LCD, first of all check mechanical appearance of SIM card reader X386. If contact springs are bent, soiled or corroded you have to change the sim reader.

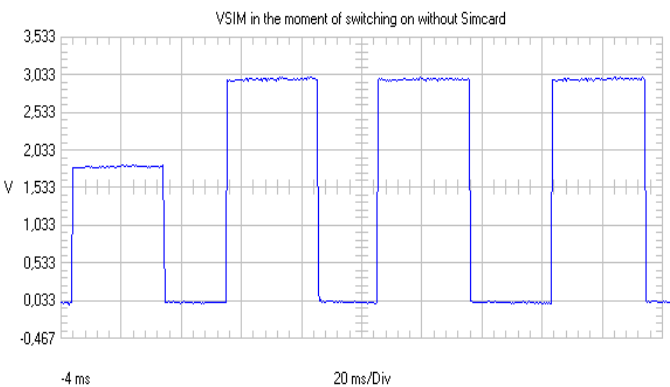
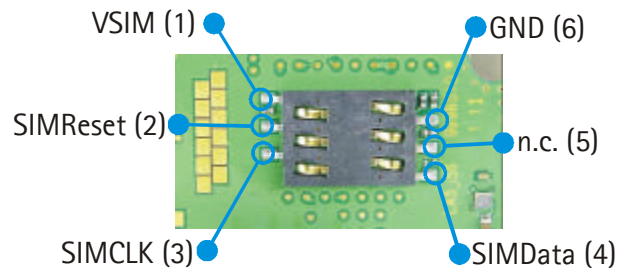
If mechanical appearance of SIM reader seems to be ok but fault persists, check with an oscilloscope if SIM lines at SIM reader pin 1-4 are pulse to 1.8Vpp / 3Vpp as shown in the chart below. Signals are slightly different between pin 1-4 but the amplitude always is 1.8Vpp / 3Vpp.

In case that the above mentioned signal is not measurable at one or more simlines, check SIM lines for shorts to ground. Resistance of simdata- and VSimline normally is > 200kΩ, resistance of SIM reset- and SIM clock line normally is ~ 4.5MΩ. If resistance of any line is not ok check parts the SIM lines consists of (R388, C203, C389). In case that resistance of all lines is ok but fault persists, EMI-filter R388 may have internal interruption. Change part and retest the phone. It also is possible that UEM D200 or UPP D400 are responsible for this fault. Due to the missing possibility to rewrite phonedata after changing UEM D200 you should not change this part.

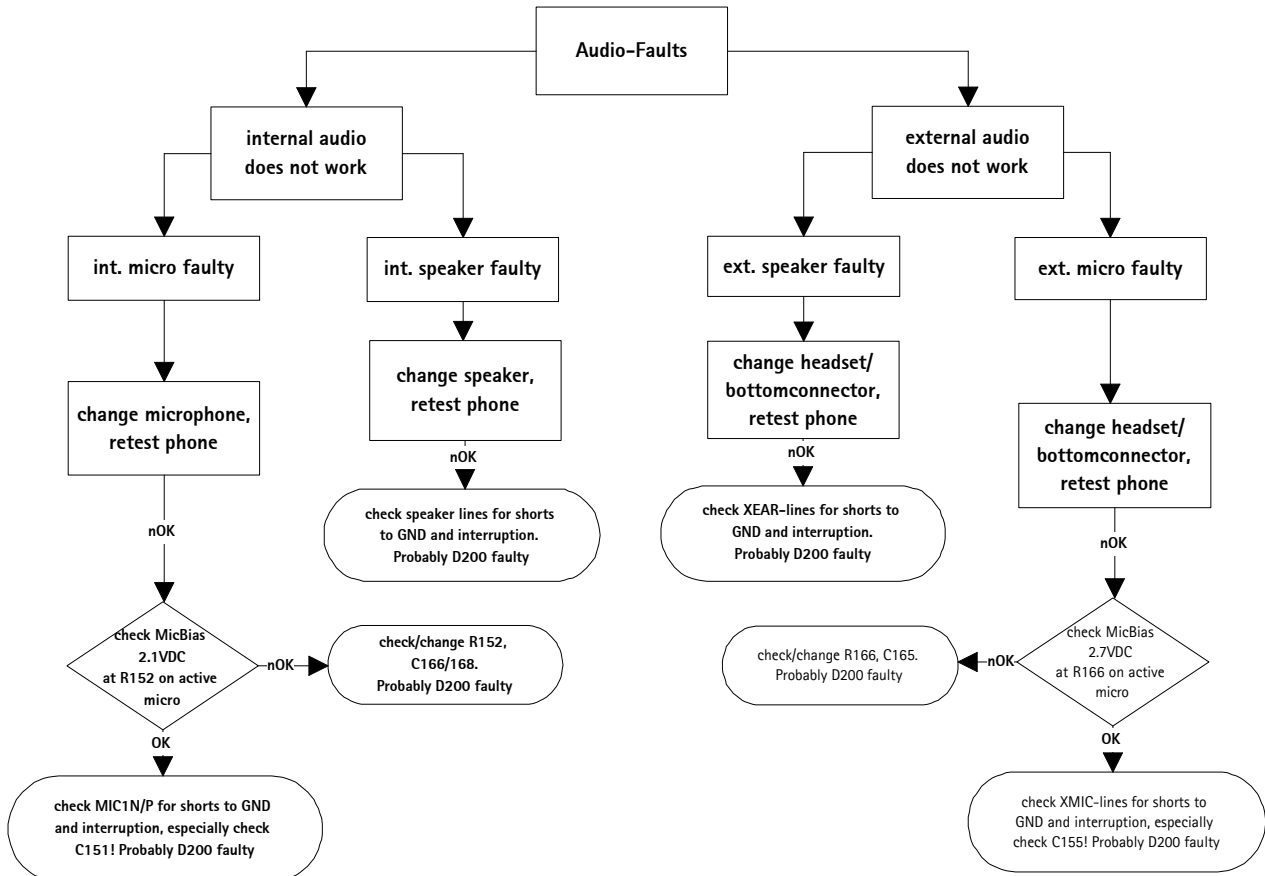
**CHAPTER 5 AUDIO-FAULTS**

- check mechanical appearance of bottomconnector I009 in case that internal microphone does not work, external audiopath seems to be interrupted or headset is not recognized. Retest phone with new connector in case of doubt. Also ensure that contact pads for connector on PCB are clean.

- check mechanical appearance of speaker. Change part if spring contacts are bent or soiled. Resistance of speaker normally is 30Ω. Also ensure that contact pads on PCB are clean.

- check resistance of the double capacitors, which normally is > 20MΩ. Both parts have tendencies to leak and often are responsible for missing uplink audio (C151 in case of internal -, C155 in case of external audio faults).

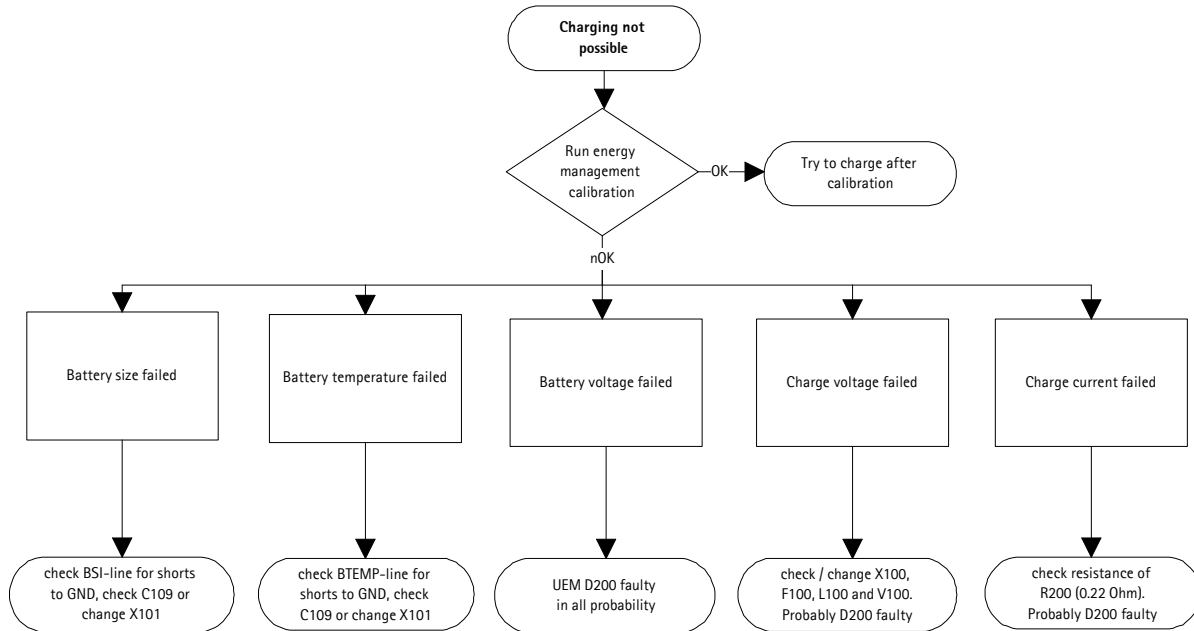
**CHAPTER 6 CHARGING FAULTS**

First thing you should do in case that charging of battery is not possible is to run energy management calibration. Note that calibration only works with JBV-1. In Service jig it is not possible because of missing bottom connector I009.

Also check whether charging is only from time to time not possible or if charging does not work permanently. In case that fault appears from time to time only, especially check spring contacts of bottom connector I009 and battery connector X101 if bent, soiled or corroded. Also make sure that contact pads for bottom connector on PCB are clean. If necessary clean PCB with an appropriate amount of alcohol. Do not use any scratching or rubbing tools!

- check mechanical appearance of battery connector and bottom connector, change parts if bent, soiled or corroded. also ensure that contact pads for bottom connector on PCB are clean.

- check resistance of fuse. Must be  $0\Omega$

- check that V100 does not cause a short circuit to ground. Resistance of VCHAR-line to ground normally is  $\sim 2.8k\Omega$

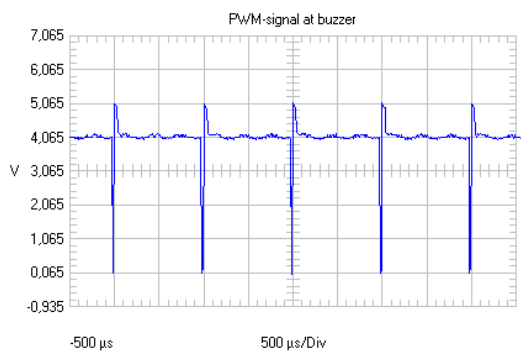
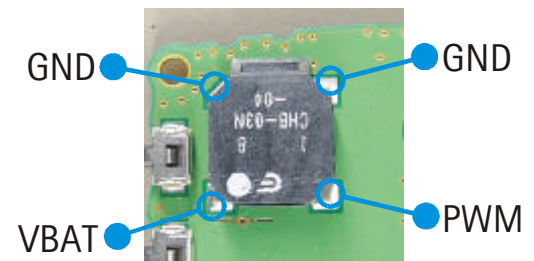
- ensure that fault is no result of too old phonesoftware. SW-version should be 4.04 or newer.
- if SW-update does not solve the problem, activate buzzer with Phoenix in menu "Maintenance/Testing/Audio Test".  
Check VBAT 4VDC and PWM-signal coming from UEM at buzzer, change buzzer if necessary
- it also is possible that UEM D200 is defect, but since there is no possibility to rewrite phonedata after reworking UEM you should not change this part.

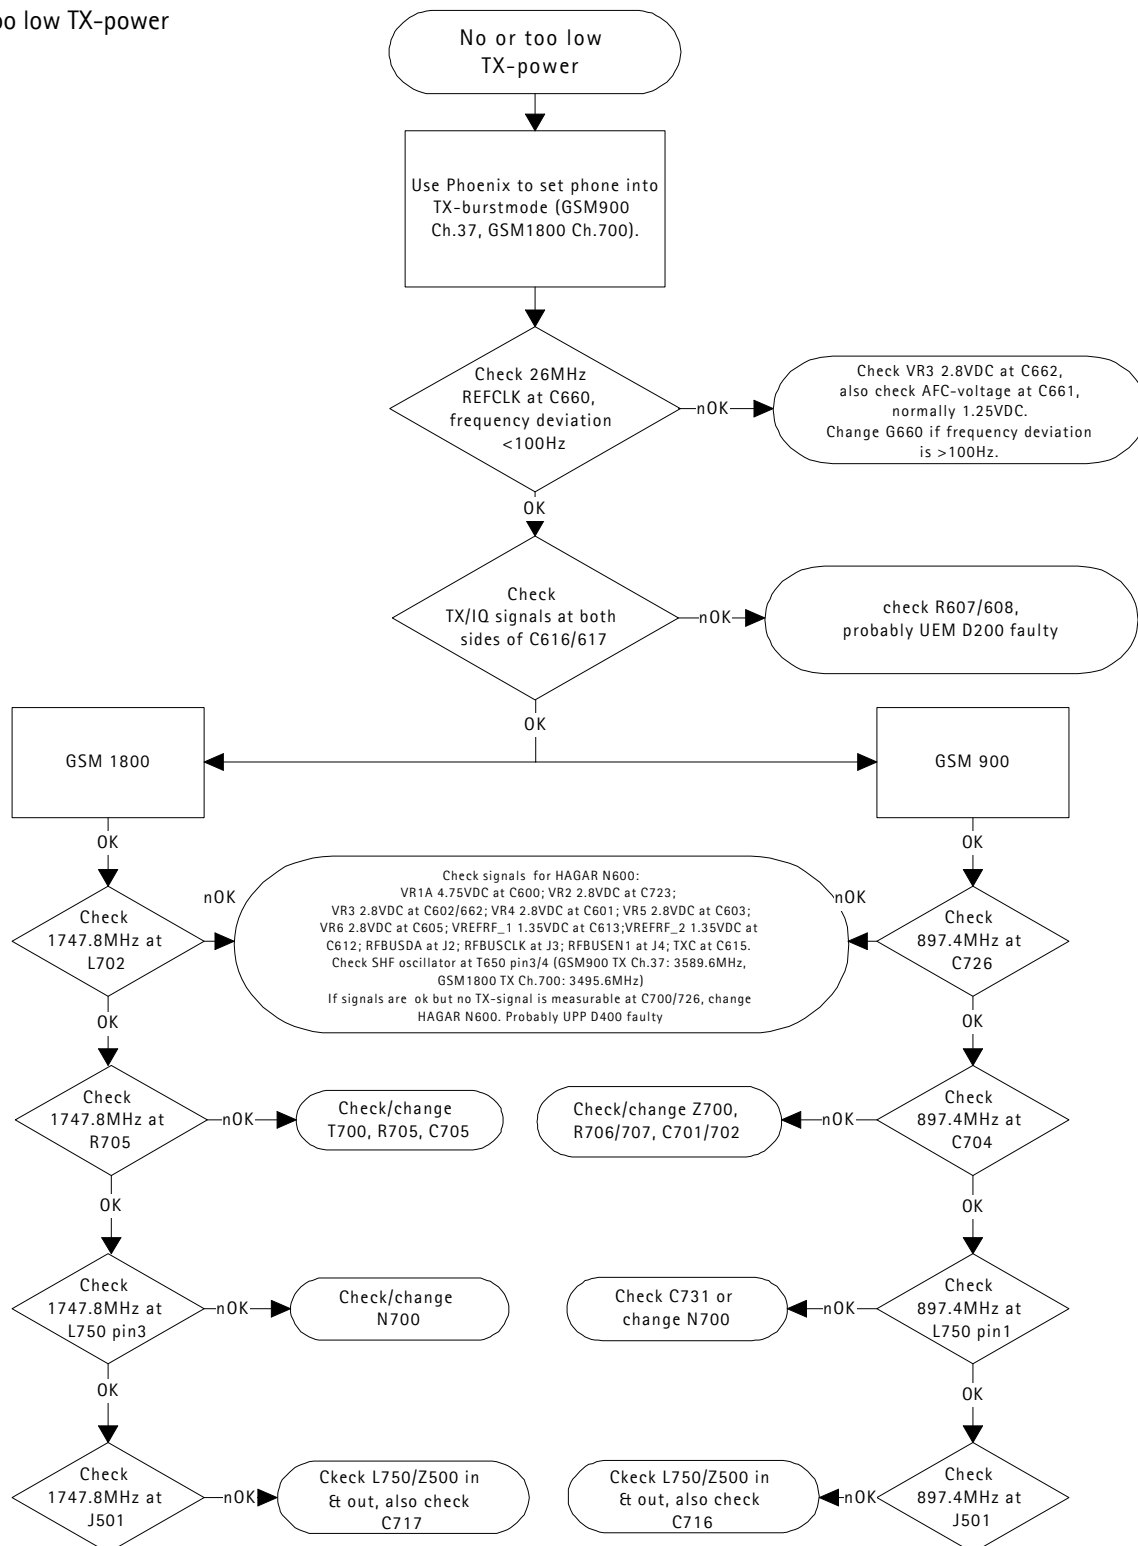
No or too low TX-power

In case that this fault occurs with your phone, the first thing you should do is to calibrate RX/TX-values of the phone. If for example TX-power is not measurable or too low, continue with the chapter below. If RX does not work, continue with the corresponding chapter on page 16. If RX and TX do not work check parts which are needed for both signalpaths (e.g. oscillators G650/660, Hagar N600 or UPP D400).

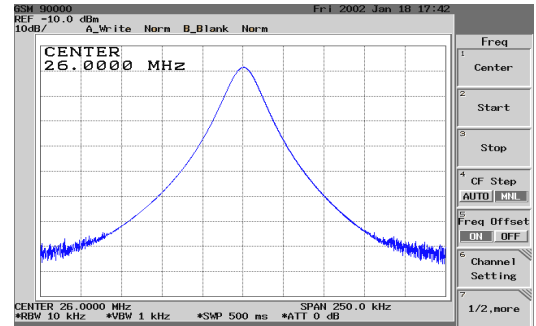
- set phone with Phoenix on local mode
- check VR3 2.8VDC at C662. With only this voltage the oscillator must be able to work on a frequency of 26MHz, Otherwise you have to change G660. Check signal at C660:

AFC-voltage at C661 normally is 1.25VDC, but may vary between 0.05VDC and 2.5VDC.  
 If frequency deviation of G660 is >100Hz it is necessary to change the oscillator!

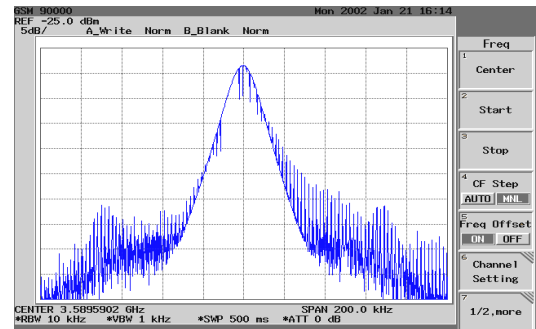
- to check if the SHF-oscillator G650 is working you have to activate with Phoenix e.g. TX-burstmode Ch.37. After that check signal (3589.6MHz) at T650 pin 3 and 4 as shown below:

If no signal is measurable at T650 check VR7 2.6VDC at C650. If OK, set span of your analyser to e.g. 250MHz to check if the oscillator works on any other frequency as on the supposed. If this is the case check control voltage at C652 which normally is 2.1VDC on channel 37. In case of noise on the control voltage especially check C653 (tendency to leak).  
 If the oscillator does not work at all, change G650 and retest the phone.

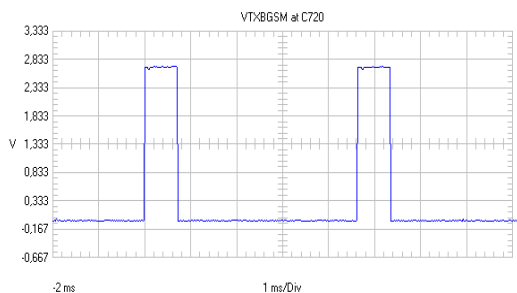
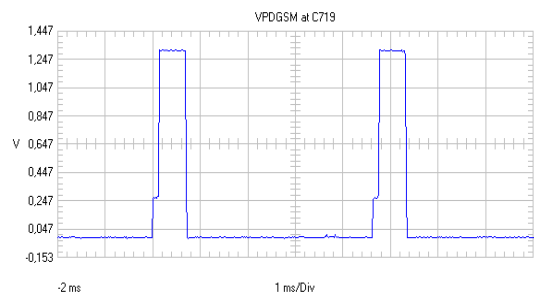
- set phone with Phoenix to local mode and activate TX-burstmode Ch.37 (Ch.700 for GSM1800). Data in parenthesis are mentioned for GSM1800.
- check VBATTRF 3.9VDC on both sides of L703
- check incoming RF-signal of 897.4MHz at C731 (1747.8MHz at R705)
- check VTXBGSM 2.8Vpp at C720 (VTXBDCS 2.8Vpp at C714) and VPDGSM 1.3Vpp up to 2.5Vpp depending on TX-power-level at C719 (VPDDCS 1.2Vpp up to 2.1Vpp at C718):

If the above mentioned signals are ok but no or too low TX-power signal is measurable at L750 pin 1 (pin 3 in GSM1800), it is necessary to change the poweramplifier N700.

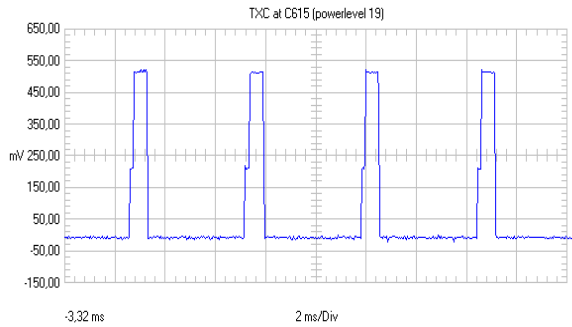
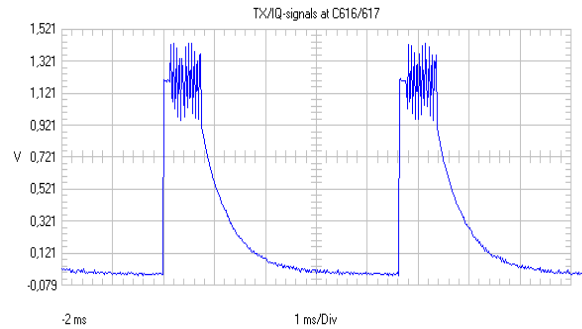
- set phone with Phoenix to local mode and activate TX-burstmode Ch.37 (Ch.700 for GSM1800).
- check 26MHz reference clock at C660, refer to signal shown on page 14.
- check VR1A 4.75VDC at C600, VR2 2.8VDC at C723, VR3 2.8VDC at C662, VR4 2.8VDC at C601, VR5 2.8VDC at C603, VR6 2.8VDC at C605 and VR7 2.8VDC at C650
- check with an oscilloscope TXC at C615 (0.5Vpp – 2.1Vpp depending on TX-powerlevel), also check TX/IQ-signals at C616/617:

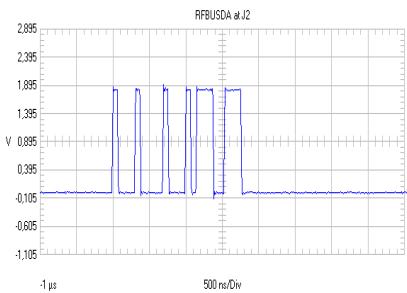
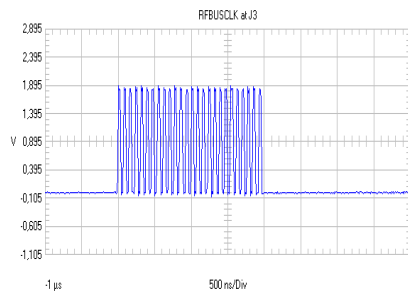
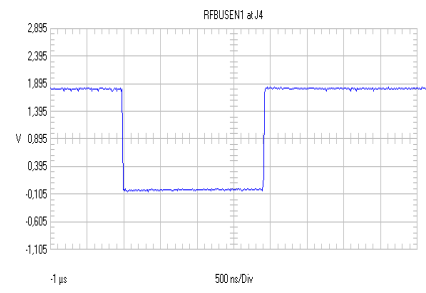
- check with an oscilloscope RFBUSDA at J2, RFBUSCLK at J3 and RFBUSEN1 at J4:

If these signals are ok but no TX-signal is measurable at C726 (C700 in GSM1800), you have to change Hagar N600. Unfortunately TXP and Hagar reset, which also are necessary for a working Hagar are not checkable because of missing testpoints. Change UPP D400 in case of doubt and retest the phone.

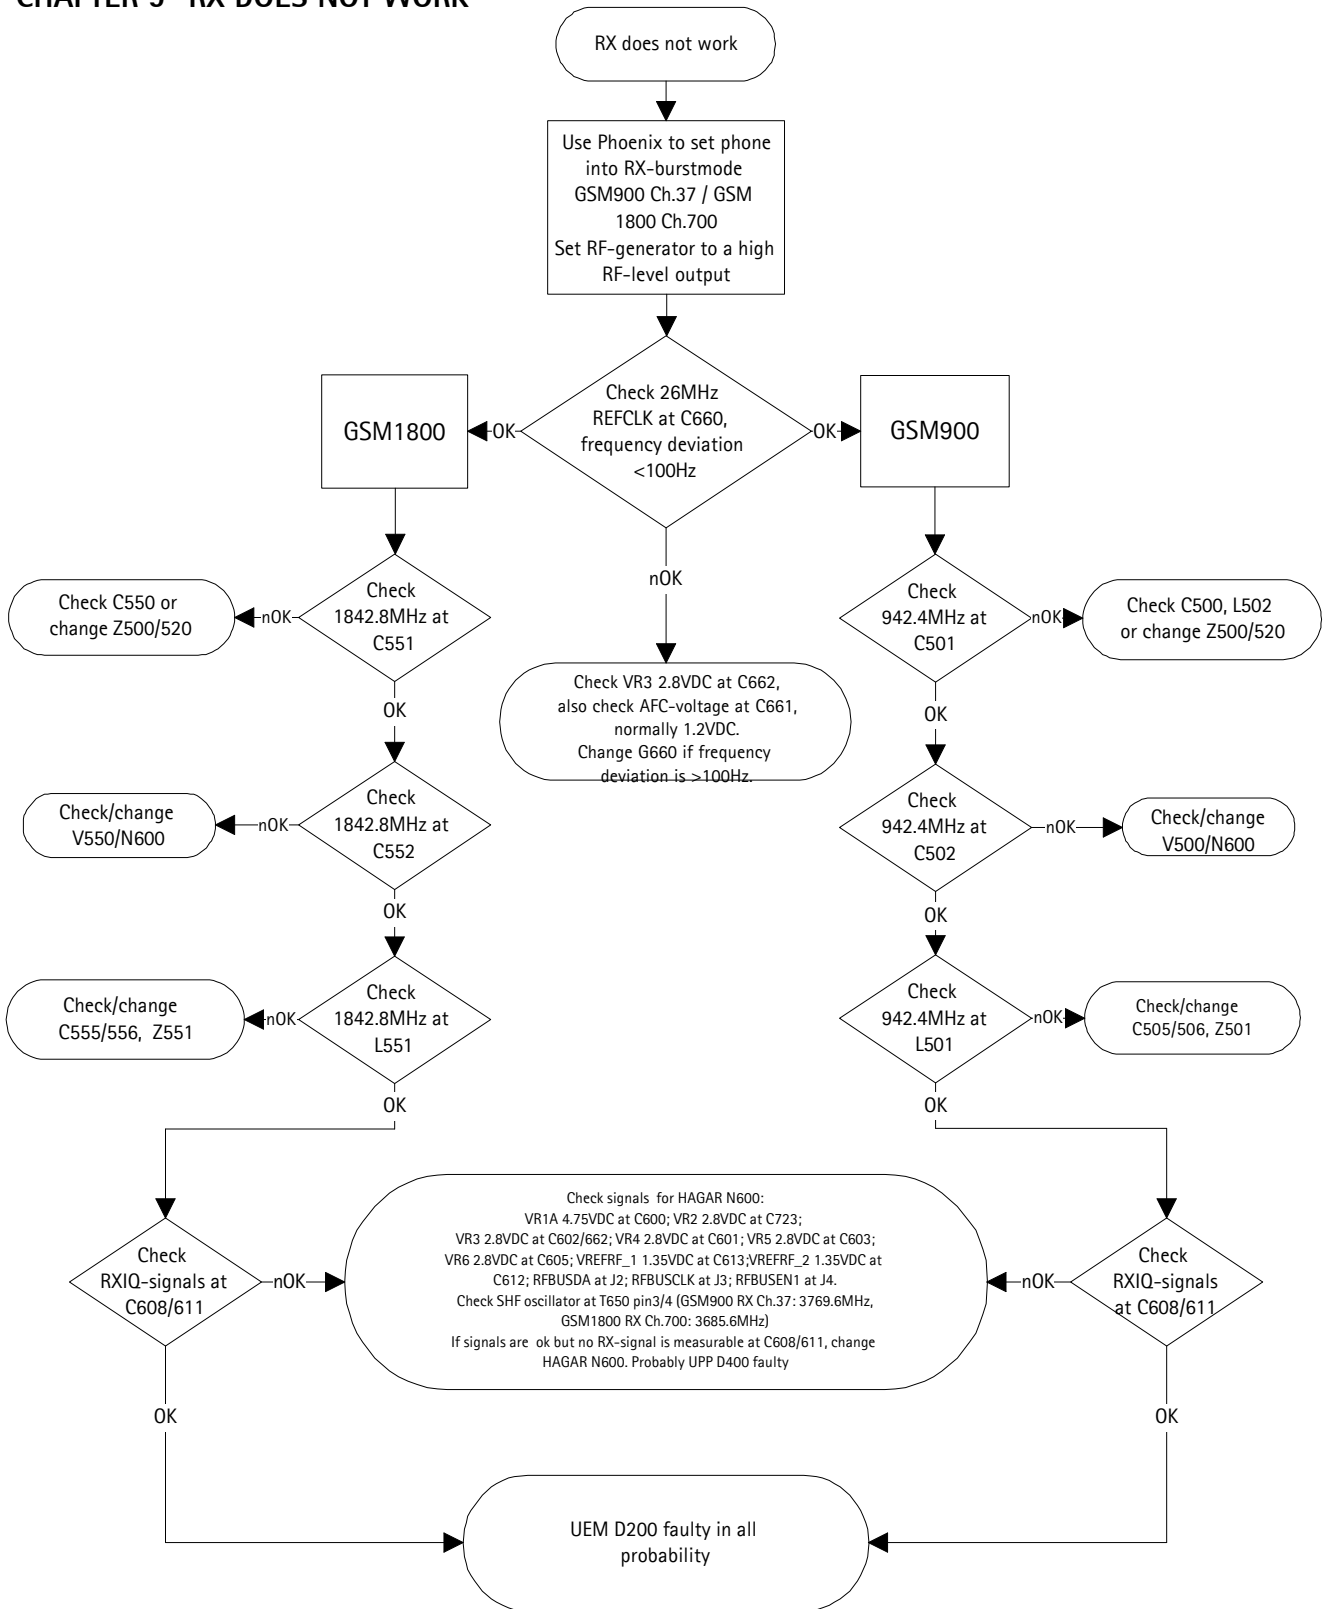
**CHAPTER 9 RX DOES NOT WORK**

- first thing to do as in case of TX-faults is to set phone with Phoenix to local mode, activate RX-burstmode Ch.37
- check VR3 2.8VDC at C662. With only this voltage the oscillator must be able to work on a frequency of 26MHz. Otherwise you have to change G660. Signal of G660 at C660 is shown on page 14. AFC-voltage at C661 normally is 1.25VDC, but may vary between 0.05VDC and 2.5VDC. If frequency deviation of G660 is >100Hz it is necessary to change the oscillator!

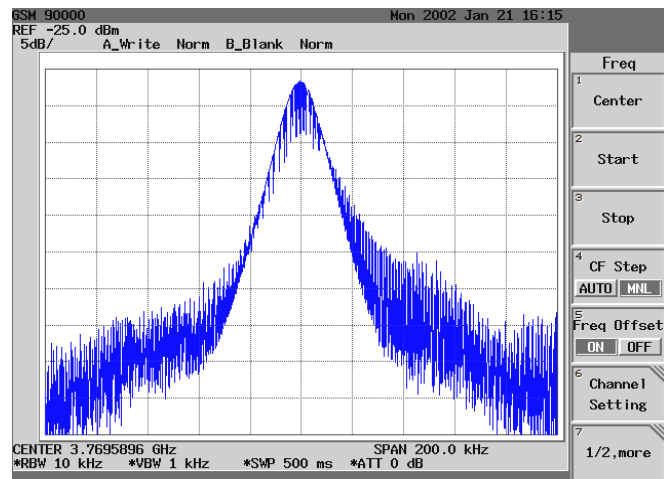
- to check if the SHF-oscillator G650 is working you have to activate RX-burstmode Ch.37. After that check signal (3769.6MHz) at T650 pin 3 and 4 as shown below:

If no signal is measurable at T650 check VR7 2.6VDC at C650. If OK, set span of your analyser to e.g. 250MHz to check if the oscillator works on any other frequency as on the supposed. In case of that check control voltage at C652 which normally is 3VDC on channel 37. Especially check C653 (tendency to leak) in case of noise on the control voltage. In case that the oscillator does not work at all, change G650 and retest the phone.
