Repair-Hints

8210/8850

NSM-2/3

HD 914/916

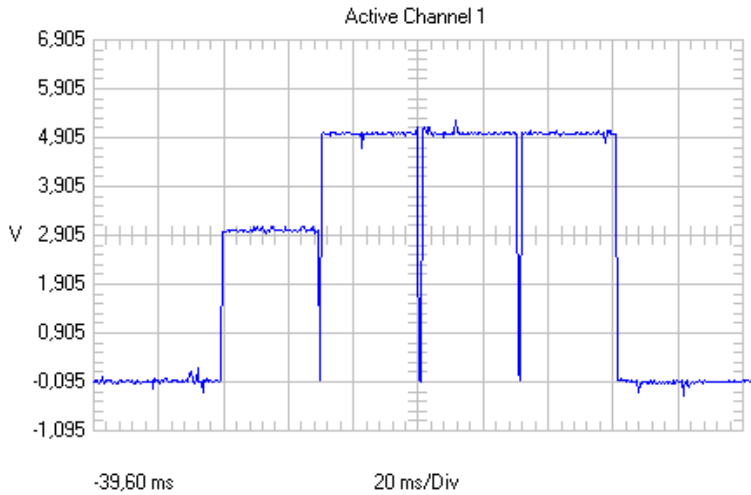
VSIM after switching on the phone without SIMcard. CCONT pulses up VSIM four times, at first the amplitude is 3 Volt, the next three times 5 Volt.

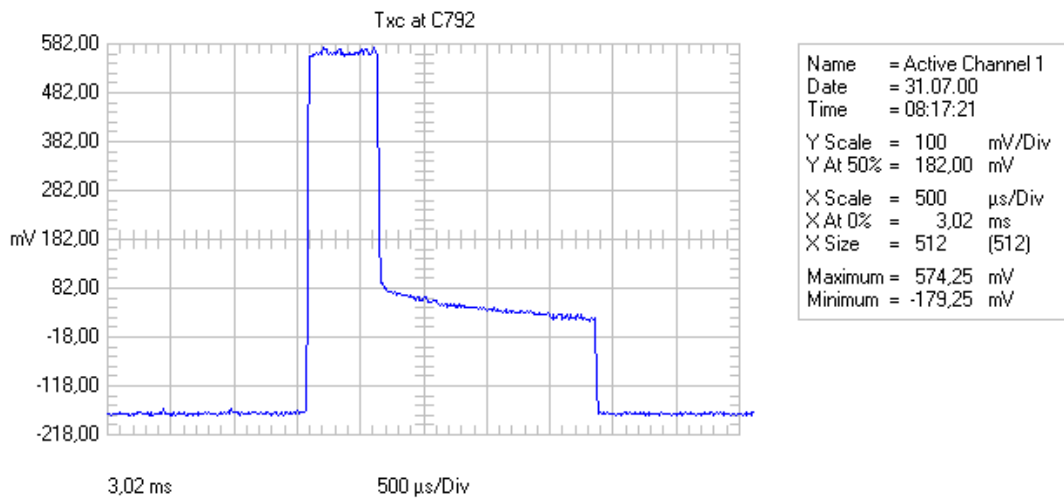
The amplitude of TXC depends on the chosen powerlevel. It varies between 0,4Vpp on powerlevel 19 and 1,6Vpp on powerlevel 5.

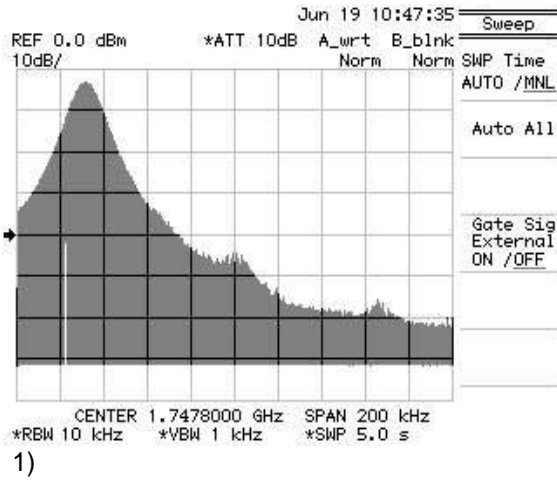
Pic.1: Normal spectrum

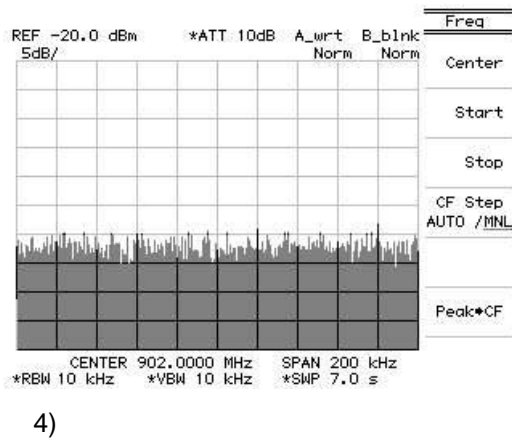
Pic.4: Spectrum of faulty oscillator G800, both COBBA or HAGAR can be the reason.

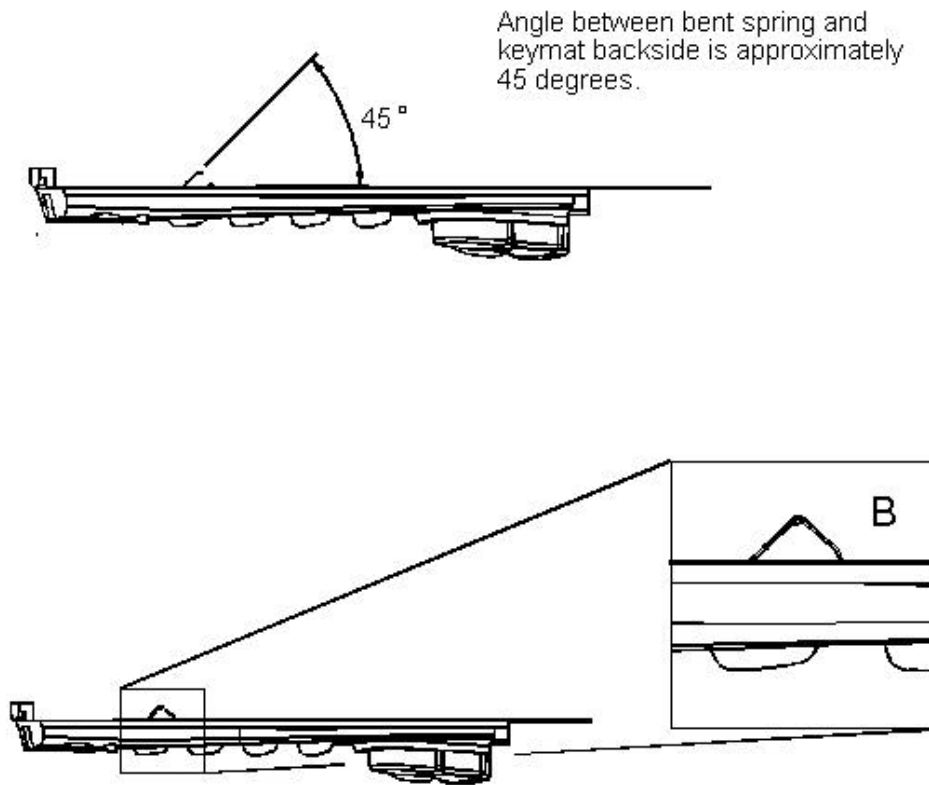
Check mechanical appearance of RTC-battery, especially the angles of the battery springs.
If necessary bend them as shown in the first picture for the plus (short) spring and in the second for the minus (longer) spring with help of tweezers. Also see NSM2 service bulletin 20.

The bending of the battery-spring should be always done, also with new batteries!
After changing the RTC-battery it is necessary to charge it. This can easily be done by putting the battery on the phone for 10 to 15 minutes (It is not necessary to switch on the phone).After that, RTC-battery should be able to save the clocktime.
If the fault still remains, it is probably necessary to change CCONT (N100) or CHAPS (N101).
Note that you have to run energy management calibration after changing CCONT!
