Repairhints

8210/8850/

8890

NSM-2/3 & NSB-6

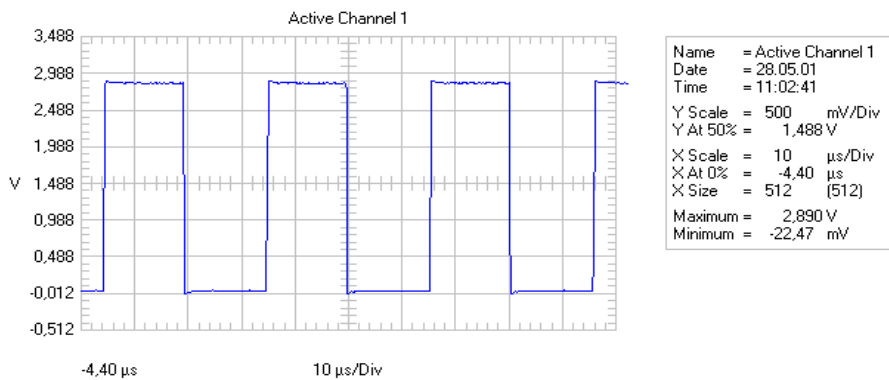
- Check mechanical appearance of battery-connector, especially check contact-springs if bent, soiled or corroded, change connector if necessary.
 Check contact-pads of battery-connector on PCB for dirt. If necessary clean them with a lint-free cloth and an appropriate amount of IPA. **DO NOT USE ANY SCRATCHING OR RUBBING TOOLS!**
 If you have to clean battery-connector's contact-pads on PCB, always check appearance of contact-springs of connector and vice versa.
- Check amplitude of sleepclock-oscillator 32.768kHz at J228, 3Vpp squarewave:

If amplitude and/or frequency of signal is not ok, check periphery of B100 (R100/102/154, C101/102). If ok change crystal B100 or CCONT N100.

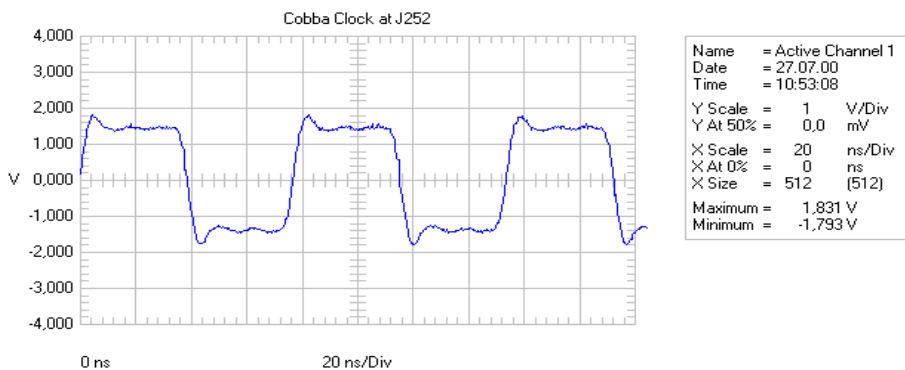
Check VBB 2.8V at C107 and VCOBBA 2.8V at C248.
 Check COBBACLK at J252, 3.6Vpp squarewave at 13MHz:

Probably broken solderings under COBBA N250 – remove part with soldering machine, clean oxidized pads and replace new COBBA with soldering machine. If fault remains after changing COBBA, MAD or PCB faulty in all probability. Note that SIMlock must be rewritten after changing COBBA. You also have to make SW-update and retune RF-values!

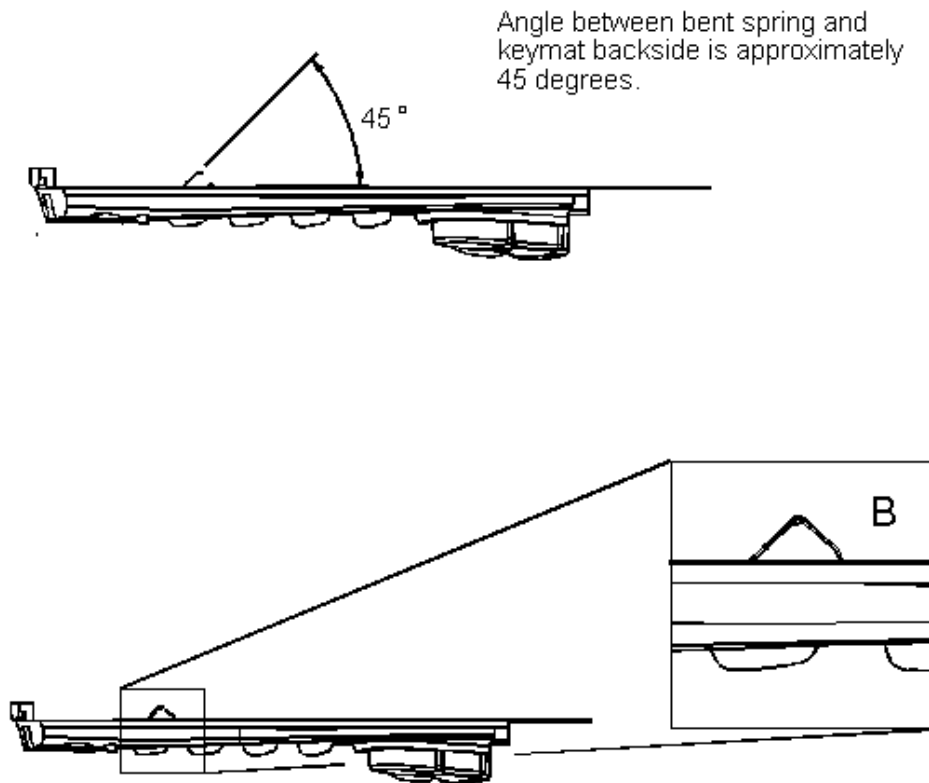
Check mechanical appearance of RTC-battery, especially check the angles of the battery springs.
 If necessary bend them for the plus (short) spring as shown in the first picture and for the minus (longer) spring in the second with help of plastic tweezers. Also see NSM 2 service bulletin 20.

The bending of the battery-spring should always be done, also with new batteries!
 After changing the RTC-battery it is necessary to charge it. This can easily be done by assembling the BLB-2 battery to the phone for 10 to 15 minutes (It is not necessary to switch on the phone).
 After that, RTC-battery should be able to save the clocktime.
 If the fault still remains, change Chaps N101 and try charging RTC-battery once more.

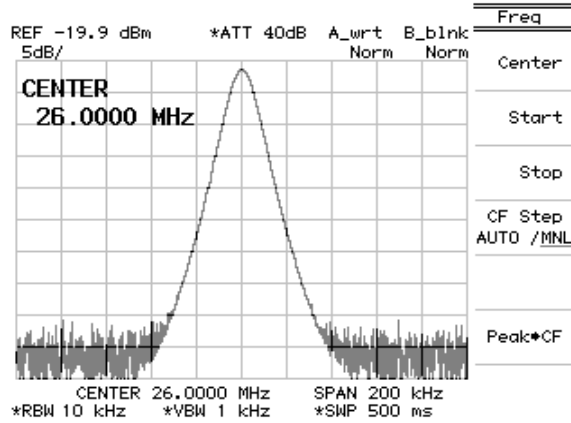
First of all check 26MHz reference oscillator at C830:

Amplitude of spectrum approximately is -12dBm.

If signal is not ok, check VXO 2.7V DC at C831 and AFC-voltage at C832, which normally is 1.3VDC but may vary between 0.3V and 2.3V DC. If AFC-voltage is 0V, especially check R832 if torn off or defect.

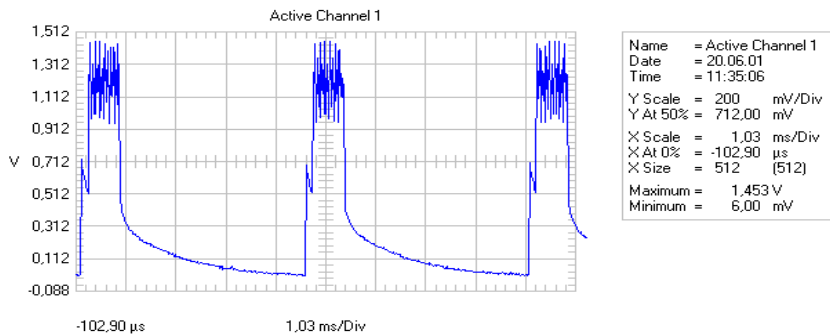
If reference oscillator is working properly, check TXIQ-signals at R541/546:

If TXIQ-signals at R541/546 are not measurable or somehow corrupted, check the following signals for COBBA N250: check VBB 2.8V DC at C107, VCOBBA 2.8V DC at C248 and 13MHz COBBACLK at J252:

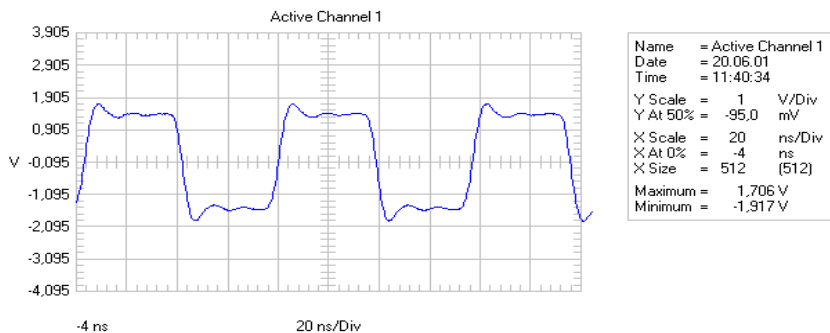
If the above mentioned signals for COBBA N250 are ok but TXIQ-signals are not measurable, probably COBBA is faulty or has broken solderings under it. Remove COBBA, clean pads if necessary with flux and solder and replace sparepart with μBGA rework machine.

Note that it is necessary to rewrite SIMlock-data, make SW-update and retune RX/TX-values of the phone after changing COBBA N250!

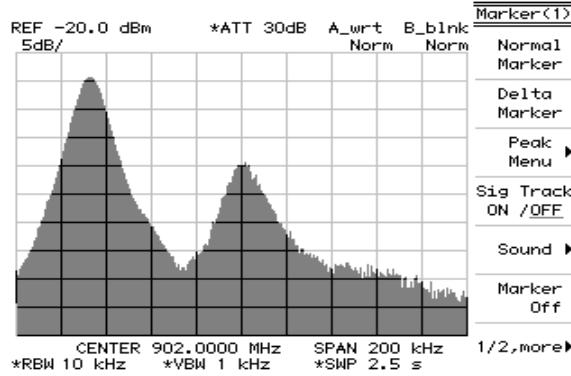
If TXIQ-signals at R541/546 are ok, check 902MHz TX-spectrum at both sides of L504:

Amplitude of 902MHz TX-spectrum is -3dBm. If this spectrum is not measurable, you have to check a lot of signals, which HAGAR N505 needs to work. These are:

- VTCXO 2.8V DC at C550
- VCHP 4.7V DC at C560
- VSYNTE 2.8V DC at C561
- VRXRF 2.8V DC at C557
- VREF_2 1.35V DC at C535
- RXREF 1.2V DC at C534

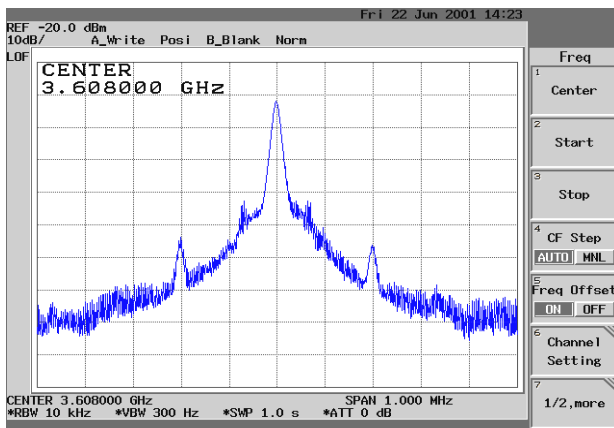
Spectrum OK

Check last but not least signal of SHF-oscillator at R805 (left spectrum):

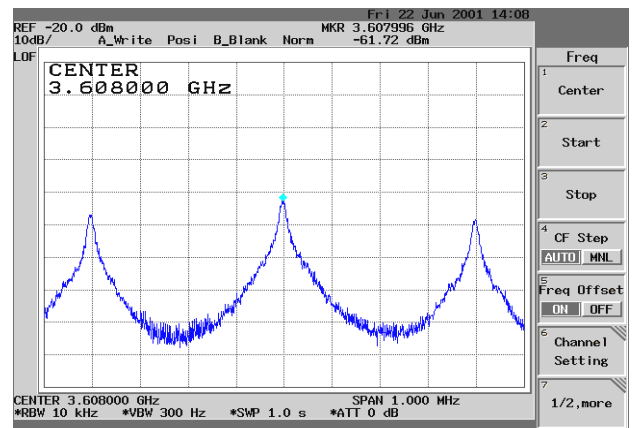
Spectrum not OK

If SHF-oscillator does not work, check whether voltage at C804 is 2.7V DC. Also check control voltage at C803, which varies between 0.7V and 3.8V DC. If control voltage is 4.8V DC, the oscillator is faulty or the control loop is open. Especially check C802 if spectrum of SHF-oscillator looks like the one shown on the right. A faulty C802 often is the reason for poor service with high phase/frequency errors in combination with the shown spectrum. If all signals mentioned on the last two pages are ok but no TX-signal is measurable at L504, change HAGAR N505.

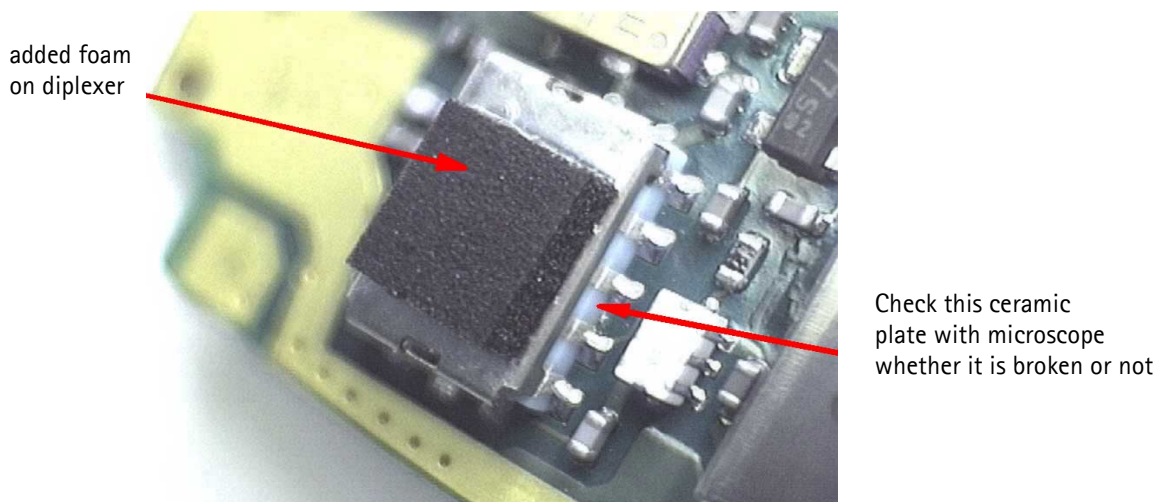
If amplitude is too low, check mechanical appearance and solderings of coupler L553. But in most cases the diplexer Z670 is responsible for this kind of fault. Therefore check TXVGSM 1.7Vpp at C746 (near HAGAR), which sets the diplexer into TX-mode. Especially check if the ceramic bottom plate of the diplexer is broken, what easily happens if phone has been dropped.

If it is necessary to change Z670, do not forget to replace foam on spare part (NSM-2 only, see also SB 022).

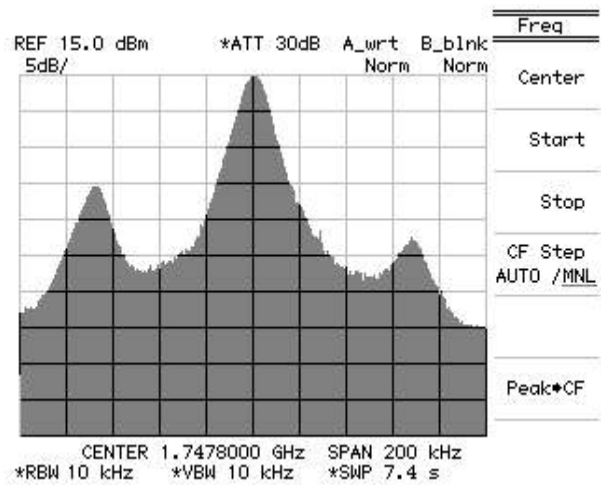
2) Spectrum with faulty COBBA

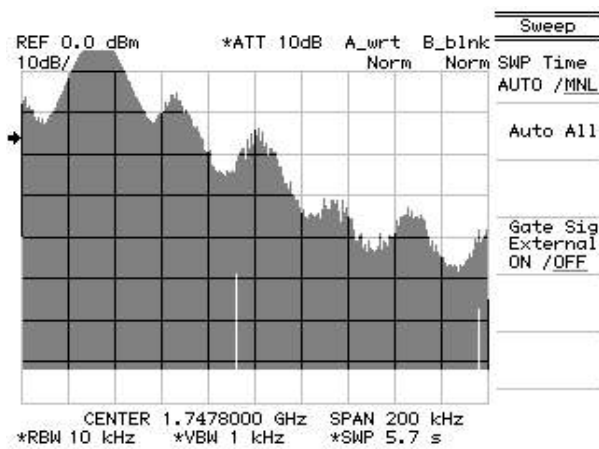
3) Spectrum with broken solderings under CCONT
 Spectrum turns to picture 1 if CCONT is carefully pushed with some nonmetallic item.

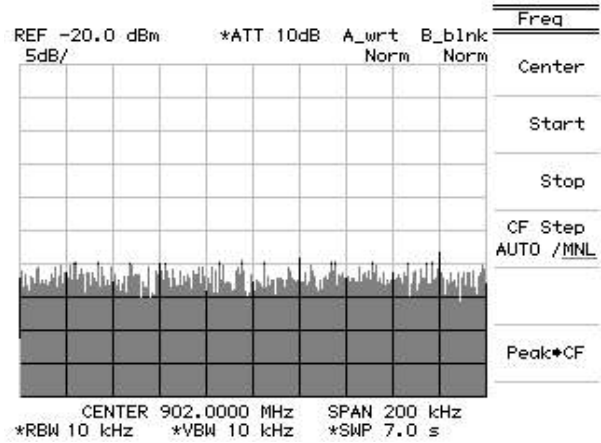
4) Spectrum with faulty oscillator G800

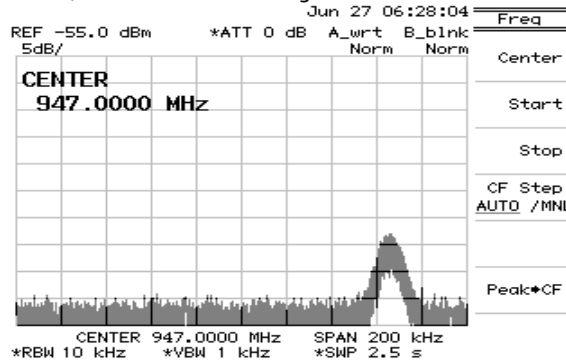
If reference oscillator works well, check 947MHz RX-signal at Z620 GSM900 out:

Amplitude of RX-signal at GSM900 output pin is -68dBm. If signal is not measurable or amplitude is too low, check solderings of Z620, Z670 and C645. Change parts if attenuation is too high. Especially check ceramic bottom plate of diplexer Z670 if broken.

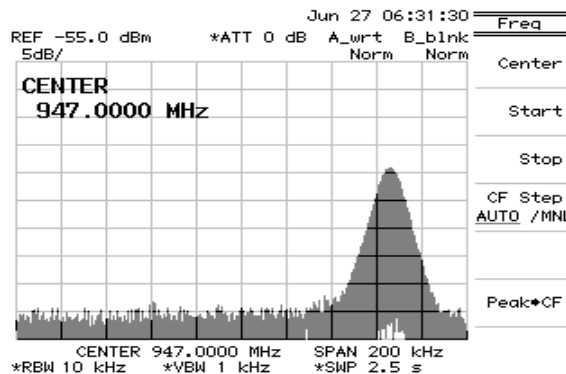
If 947MHz RX-signal at Z620 is ok, check same signal at Z600 GSM900 out:

Amplitude here is approximately -53dBm. If not ok, check solderings of C615 and check that LNA works. Therefore check signals shown on next page:

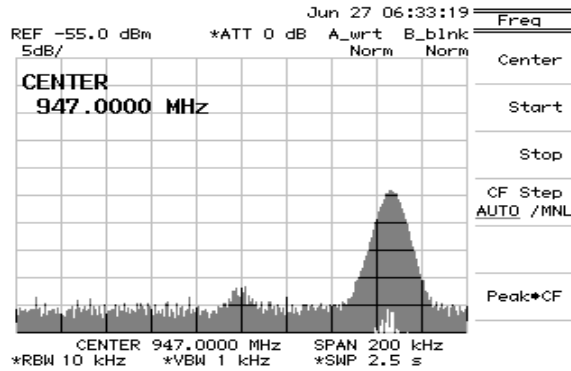
If 947MHz RX-signal at Z600 is ok, check same signal at both sides of L600:

Amplitude at L600 approximately is -59dBm. If signal is not ok, check appearance and solderings of T600, L600 and C600/601.

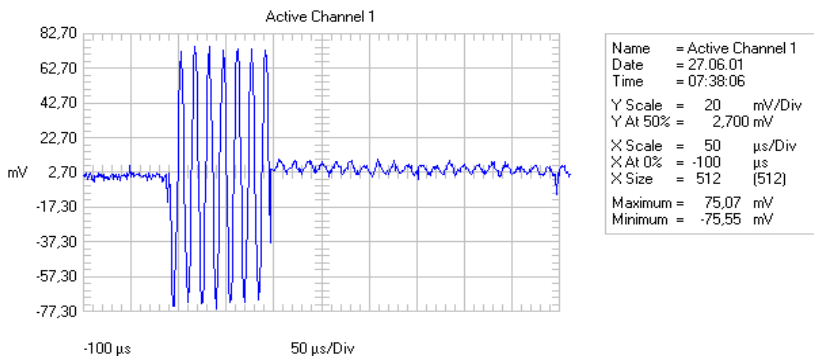
Check 67.708kHz at all four lines of R510:

If signal is not ok, check C510- C513 for shorts to ground, check resistance of R510 (4 * 100Ω) or change HAGAR N505.

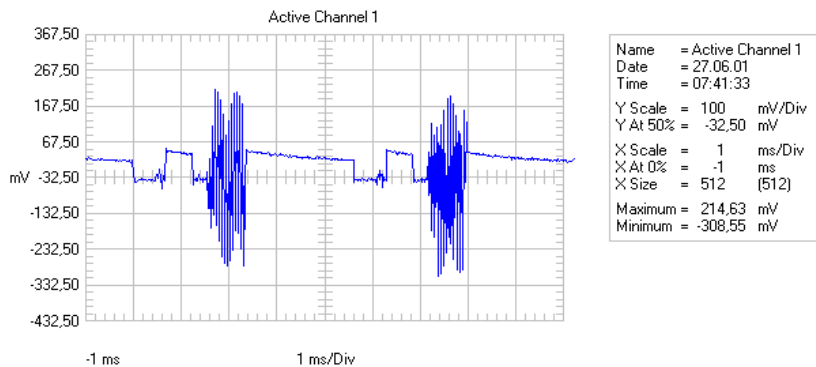
Check 67.708kHz at R530:

If signal at R530 is not measurable, check VREF 1.35V DC at C535 and RXREF 1.2V DC at C529. Also check C530- C533 if broken or cold soldered or change HAGAR N505.

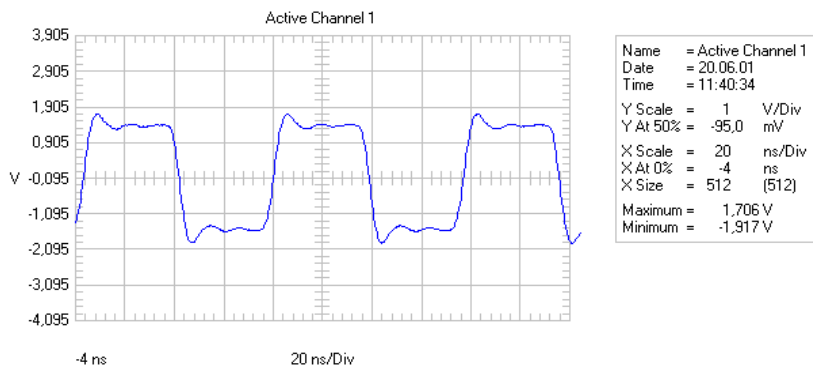
- check VBB 2.8V DC at C107
- check VCOBBA 2.8V DC at C248
- check 13MHz COBBACKL at J252:

If these signals are ok, change COBBA N250.
 In case that oxidized pads exist under COBBA, rework them with a few flux and solder, then replace the sparepart with μ BGA soldering machine.
 Note that rewriting of SIMlock-data is necessary after changing COBBA, further more you have to make SW-update und retune RX/TX-values of the phone!

If fault persists after changing COBBA, MAD or PCB faulty in all probability.
