Repairhints

Communicator 9210 RAE-3

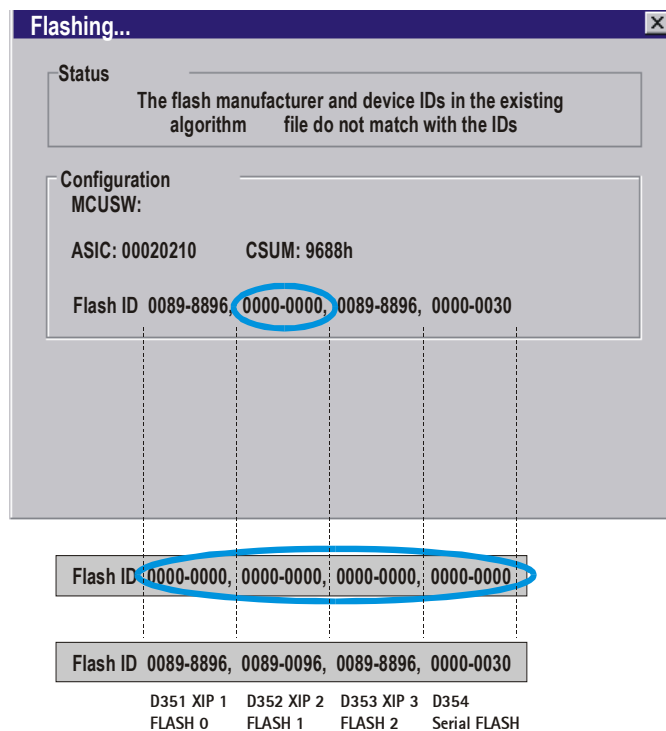
1) **Corrupt**
FLASH 1 (D352) defect

2) **Corrupt**
FLASH 0 (D351) defect

3) **OK**

- To 1) - The flash 1 (D352) is faulty. This can be seen at the second flash ID (**0000-0000**) in the first case.
- To 2) - In the most cases D351 is faulty, but also the whole Flash (D351- D354) or D300 MADLINDA could be faulty.
- To 3) - In this case all flash IDs and MADLINDA are OK.

- If one of the IDs is **0000-0000**, check Vcore = 1.8 VDC and VBB = 2.8 VDC at following components:

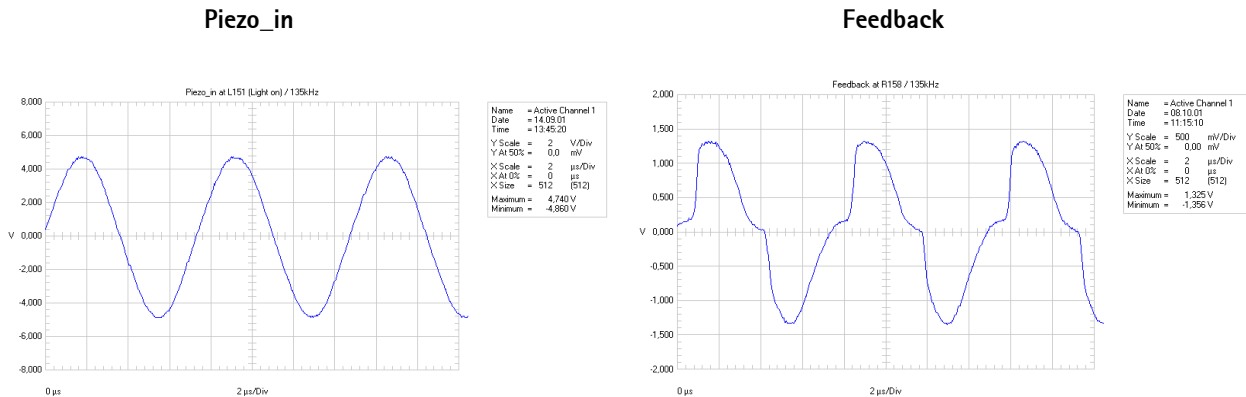
- If the PDA starts up (startup logo is seen), but the illumination is off, probably the piezo is broken or the backlight circuit is faulty.
- Check **Piezo_in** frequency around 135kHz (Vpp = 10 VAC) at L151 and **Feedback** frequency around 135kHz (Vpp = 2.7 VAC) at R158. (See picture below)

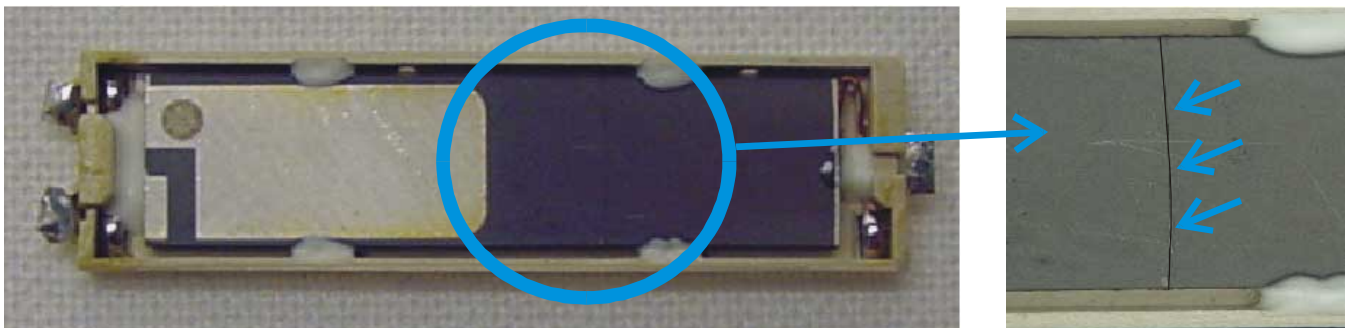
- If **Feedback** frequency is around 0Hz or **Piezo_in** frequency is around 100kHz, change CCFT (See SB-014), because the piezo is broken (see pictures below)

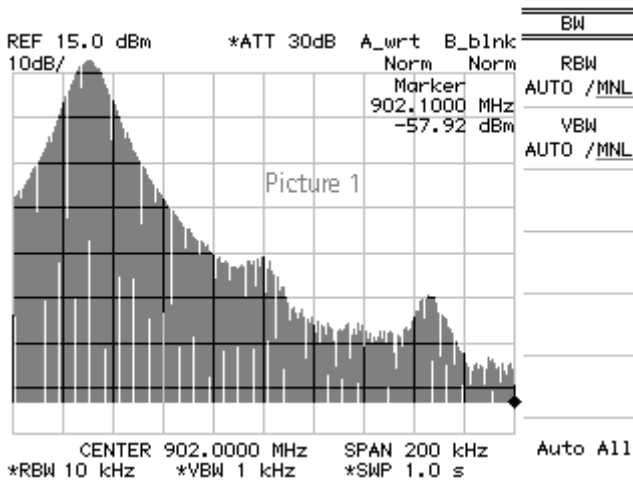
The G800 SHF Oscillator is working well

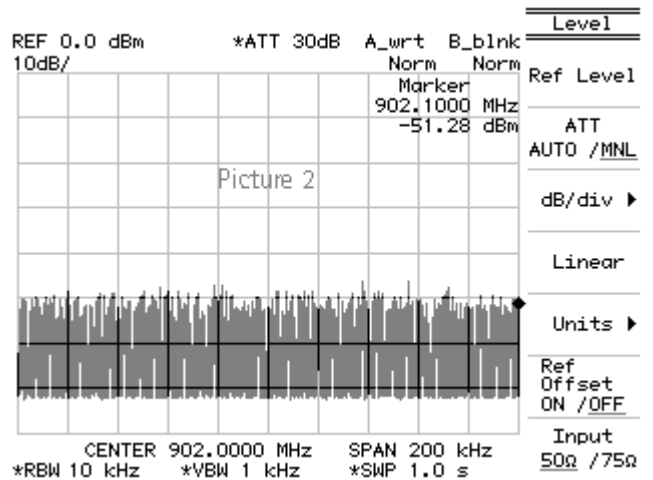
The Oscillator is not working

- If Picture 2 is appearing on spectrum analyser, check following voltages:
- Check Vsynte (VSYN_2/VCC) = 2.8 VDC at R808. If not ok, lift R808 and measure the voltage on the pad to HAGER's side. If Vsynte is ok, check G800 SHF oscillator and surrounding components for shorts or cold soldering and change or resolder the faulty ones.
- If Vsynte (VSYN_2/VCC) is not ok after lifting R808, check N100 CCONT.
- Check VC = 2.2 VDC at R802.
- Check Vchp = 4.7 VDC at C560. If not ok, check VCP = 4.9 VDC at N600 Pin 6. If not ok either, check N100 CCONT.
- If VCP is ok, check N600 voltage regulator and surrounding components for shorts or disconnections and change the faulty ones. If the surrounding components are ok, change G800 SHF oscillator.
- If VC is not ok, refer to N505 HAGAR faulty.

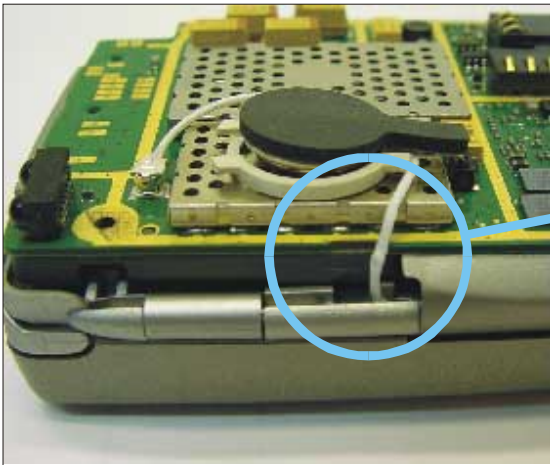
Figure 1

False

- When assembling the RAE-3 communicator pay attention to the coaxial cable. Be very carefull when closing the back cover. Make sure that the coaxial cable is routed correctly as shown in **figure 3** and **4** below. If the routing is not correct the coaxial cable can be crushed (**Figure 1** and **2** below).

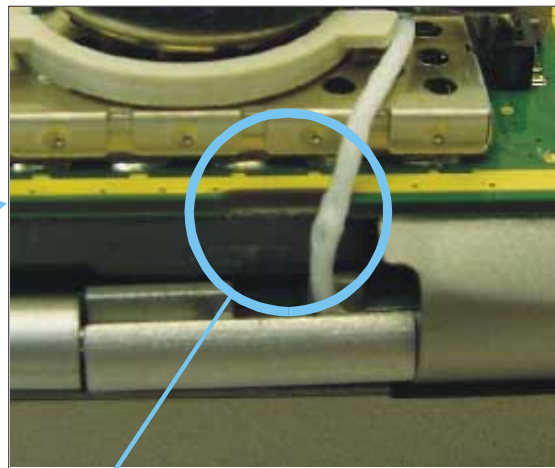
Figure 2

Coaxial cable crushed because wrong routed

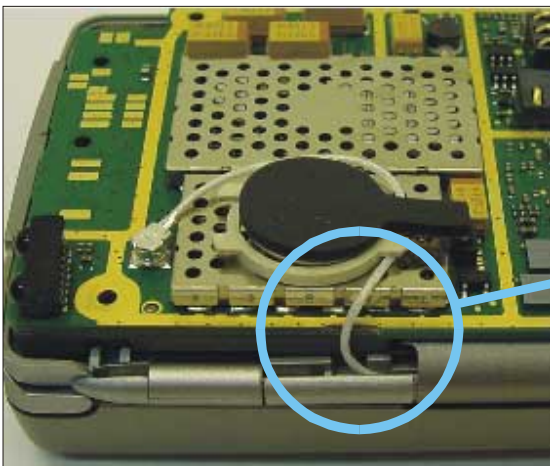
Figure 3

Correct

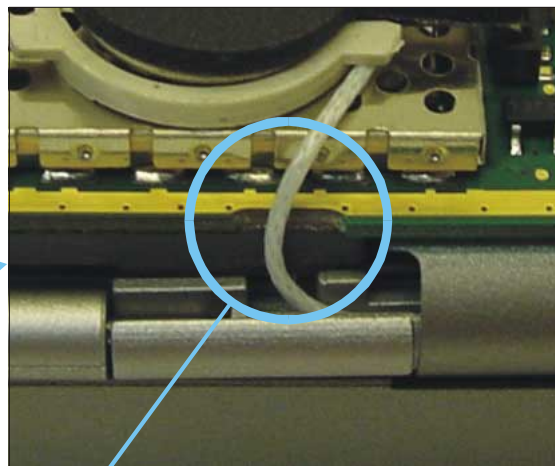
Figure 4

Coaxial cable must be routed in center of leave out

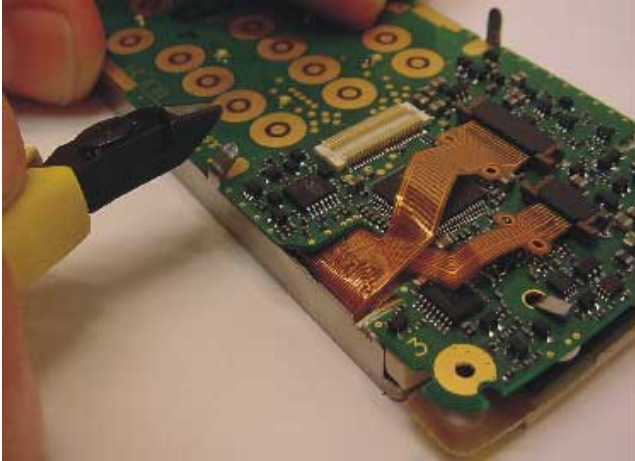
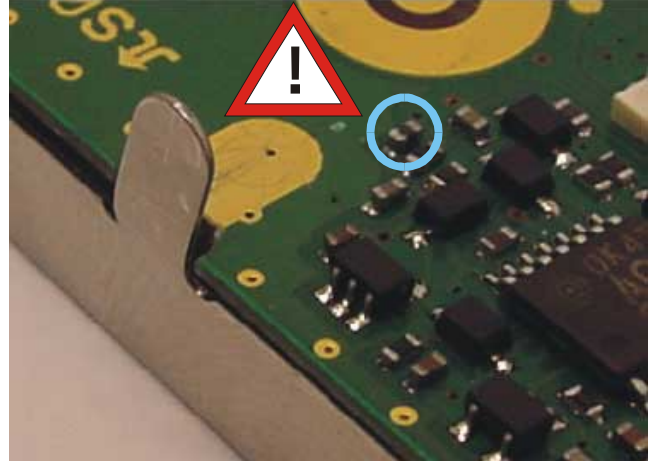
- When the changing of the PDA display is necessary be very carefull when closing the metal clips of the changed PDA display. You may slip down and scratch the PCB or may lift some components, e.g. L051 (SCLK for display). See pictures below. A good solution is the use of a small sidecutter for bending the clips down gently.

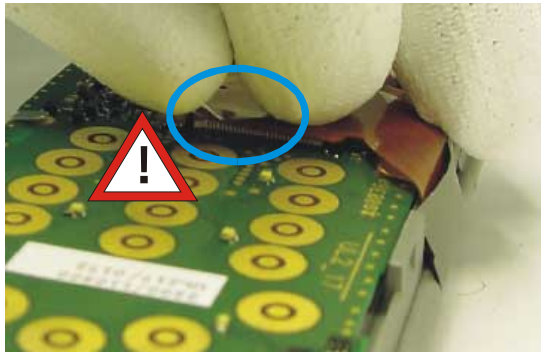
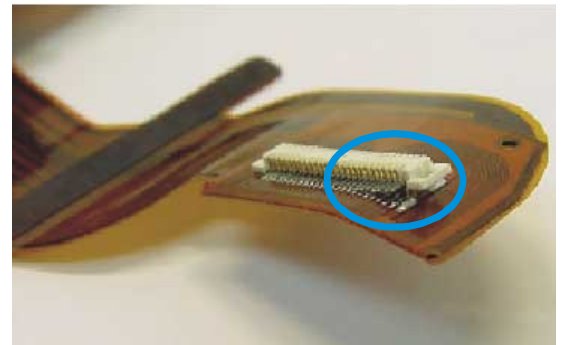
Not OK

- When opening the Qwertyflex connector on UI module be very careful because it could be damaged.

Do not open the Qwertyflex connector by lifting it from the side. (See picture below)
